NAUGATUCK RIVER BASIN
TORRINGTON - GOSHEN, CONNECTICUT

WHIST POND DAM
CT 00102

PHASE I INSPECTION REPORT
NATIONAL DAM INSPECTION PROGRAM

DECEMBER 1980

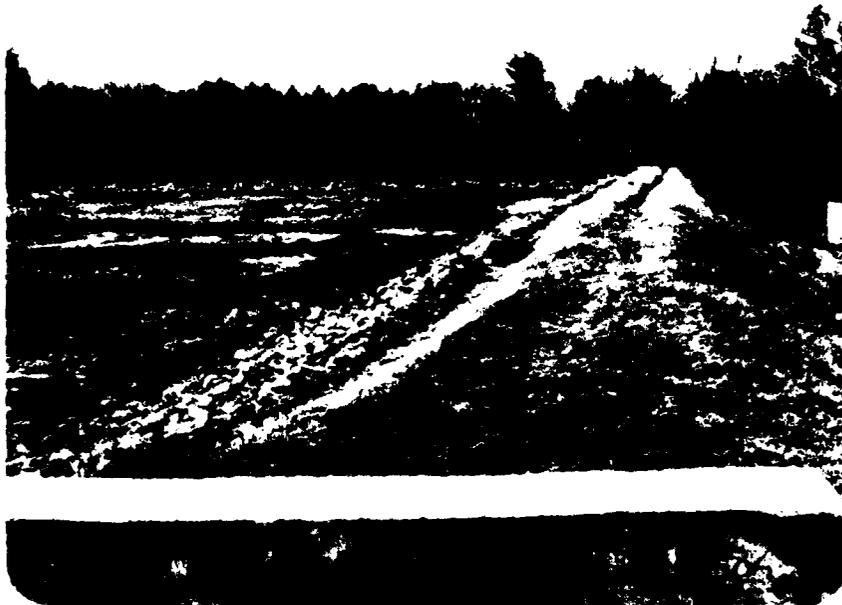
PHOTO NO. 1

The crest of the dam is generally level and covered with grass, Photos 1 and 4. There is a foot path at approximately the center line of the crest along the entire length of the dam. Tree roots were observed at several locations along the crest of the dam, Photo 5, and appear to originate from trees located downstream of the embankment, Photo 4.

The downstream slope of the dam is grass-covered, Photos 1 and 4. Several ruts due to mowing equipment were observed on the downstream slope.

VIEW OF DAM FROM
RIGHT END OF SPILLWAY

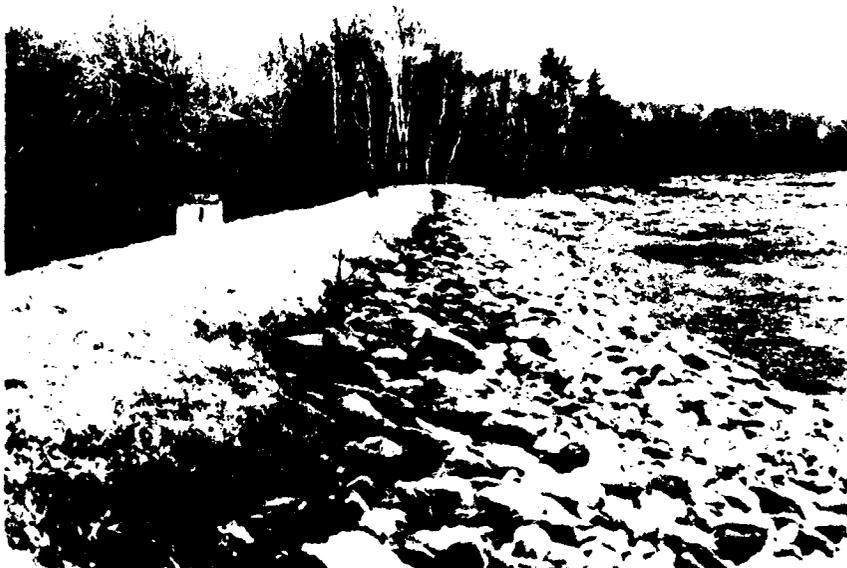
PHOTO NO. 2

RIPRAP ON UPSTREAM SLOPE

1. Investigate the slumping of the riprap slope protection, and design remedial measures as required.
2. Investigate the condition of the spillway weir and training walls, and design required repairs.
3. Clear trees from the area downstream of the dam to within 20 feet of the toe.
4. Design an upstream gate for the low level diversion outlet in order to relieve full reservoir water pressure in the pipe under the dam.
5. Inspect the dam for seepage when the impoundment is full.
6. Investigate freeboard requirements for the dam.

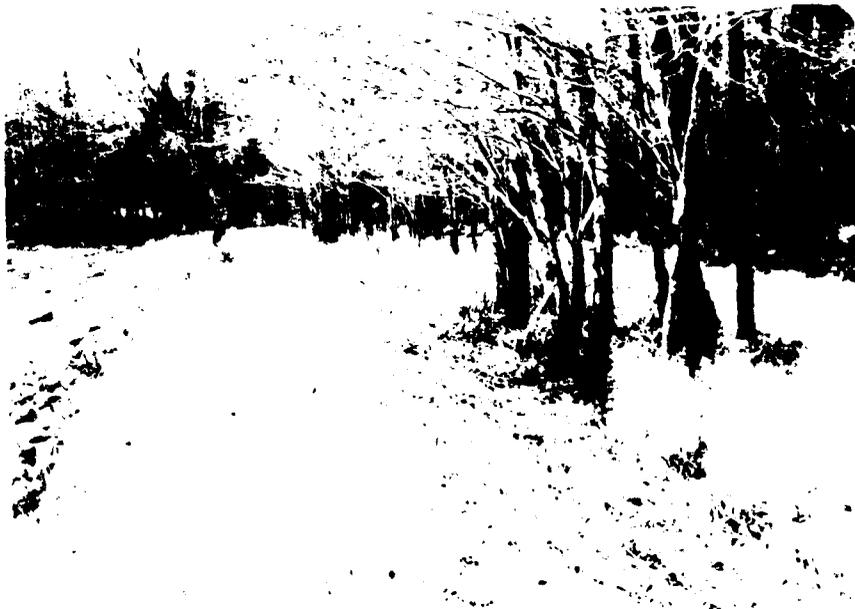
PHOTO NO. 4

LEFT SECTION OF DAM. NOTE SLUMPING
RIPRAP CUTTING INTO CREST.

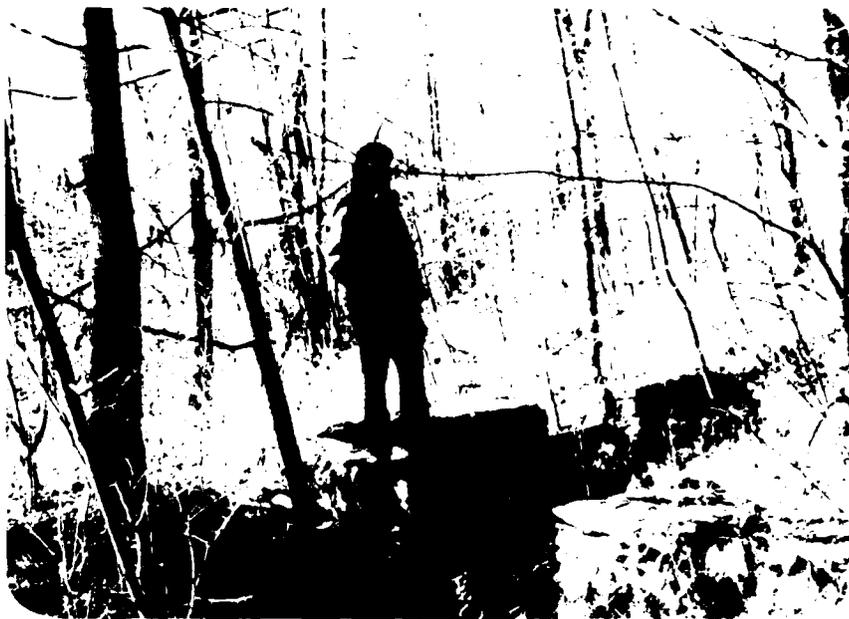
PHOTO NO. 11

DIVERSION STRUCTURE. FLASHBOARDS IN BACKGROUND
DIVERT WATER FROM NATURAL STREAM TO WHIST POND.

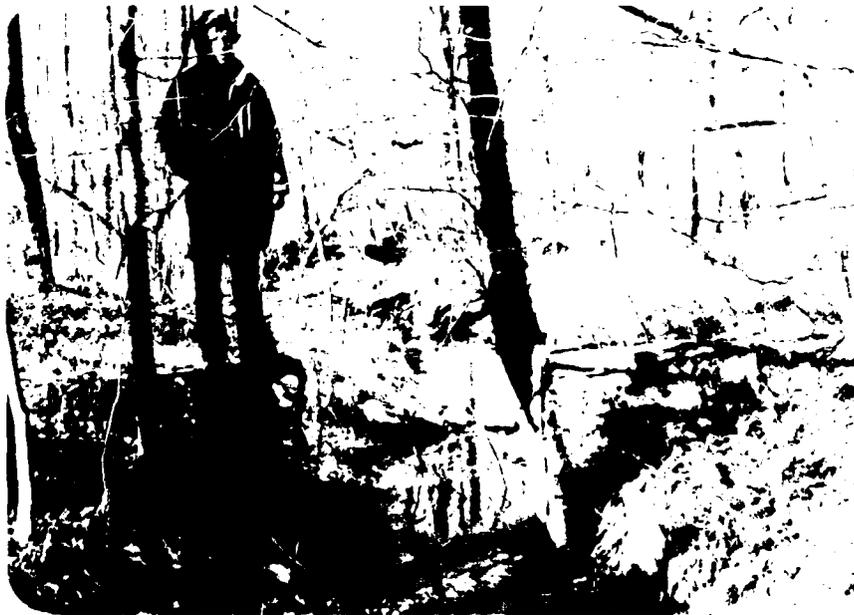
PHOTO NO. 12

DIVERSION STRUCTURE. LOOKING
DOWN CHANNEL TOWARD WHIST POND.
