**CONNECTICUT RIVER BASIN
AVON, CONNECTICUT**

STUB POND DAM

CT 00265

**PHASE 1 INSPECTION REPORT
NATIONAL DAM INSPECTION PROGRAM**

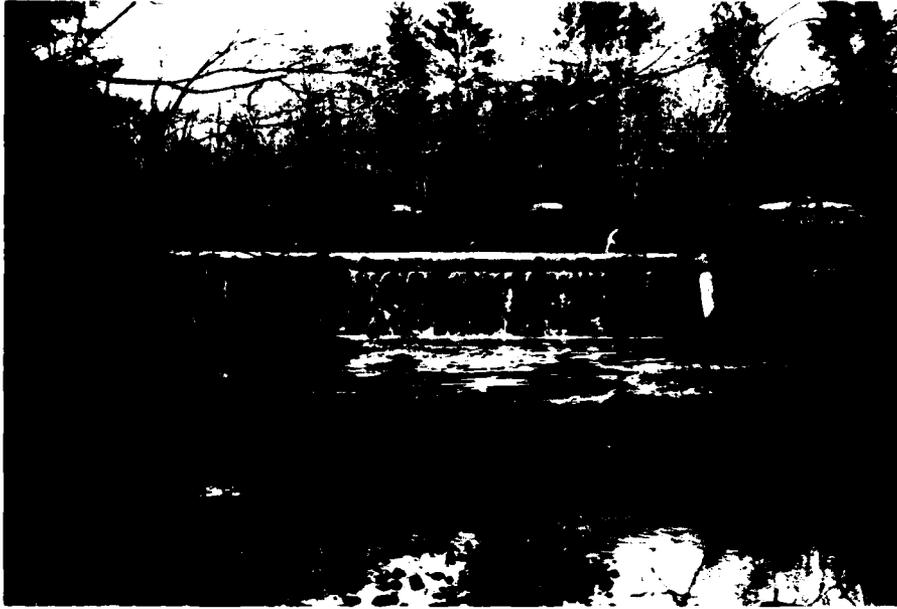
1. **Spillway:** The concrete spillway is 40 foot long and has 15 inch high permanently attached timber flashboards which appear in sound condition (Photos C-1, C-3, C-5). Considerable debris was caught on the spillway at the western end. Water was flowing over the entire spillway on the day of the inspection. The concrete spillway wingwalls are also cracked at the base where they joint the spillway.
2. **Gate House:** The timber gate house is located at the eastern end of the dam (Photo C-9, C-10). The exterior of the house is in fair condition. There is a vent for the 36 inch pipe just east of the house, and no flow was observed in the pipe. The house was locked and the interior and control mechanism could not be inspected. The representative of the owner indicated that the key to the lock on the gate house could not be located.

C-1 SPILLWAY - LOOKING NORTH

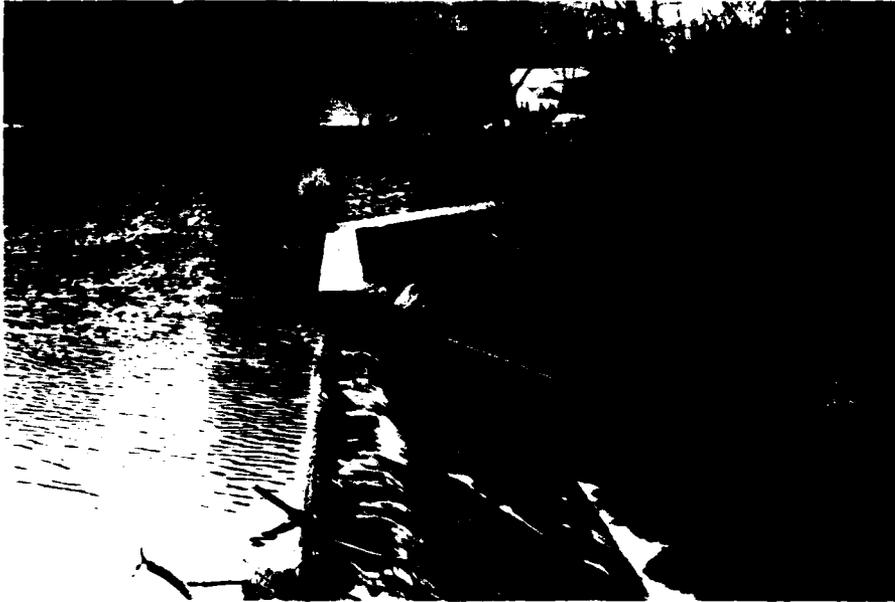
4. **Concrete Wall:** The area immediately downstream of the eastern wall is severely eroded (See Plan Page B-9) exposing much of the downstream face of the wall (Photo C-3). This wall is severely cracked and spalled with grass growing in the cracks (Photo C-4). The cracks extend from the spillway approximately 45 feet east. Approximately 1 to 2 gallons per minute of clear water is seeping through the wall (Photo C-4). The area below the western wall is also eroded (Photo C-6), and the wall is broken at the top of the eastern end with a large reinforcing bar exposed.

The most significant area of distress noted for this dam was the severe erosion downstream of the eastern concrete wall. This erosion is apparently caused by water flowing over the top of the wall and then parallel to the wall to the downstream channel.

C-3 EAST CONCRETE WALL - SHOWING ERODED
AREA BELOW WALL

- a. All trees and their respective root systems be removed from the dam and within 15 feet of the downstream toe, and backfill with suitable compacted material.
- b. An analysis of the structural integrity of the broken and cracked concrete walls and concrete wingwalls be conducted and repairs designed as required.
- c. Investigate the upstream face of the embankment and concrete walls with the pond lowered and make appropriate recommendations.
- d. The eroded areas downstream of the concrete walls be filled and erosion control be provided.
- e. A detailed hydrologic/hydraulic investigation to determine the need for and the means of increasing the discharge capacity of the spillway and/or providing additional freeboard.
