CONNECTICUT RIVER BASIN  
EAST HAMPTON, CONNECTICUT  
**BEVINS POND DAM**  
CT 00360

PHASE I INSPECTION REPORT  
NATIONAL DAM INSPECTION PROGRAM

AUGUST, 1980

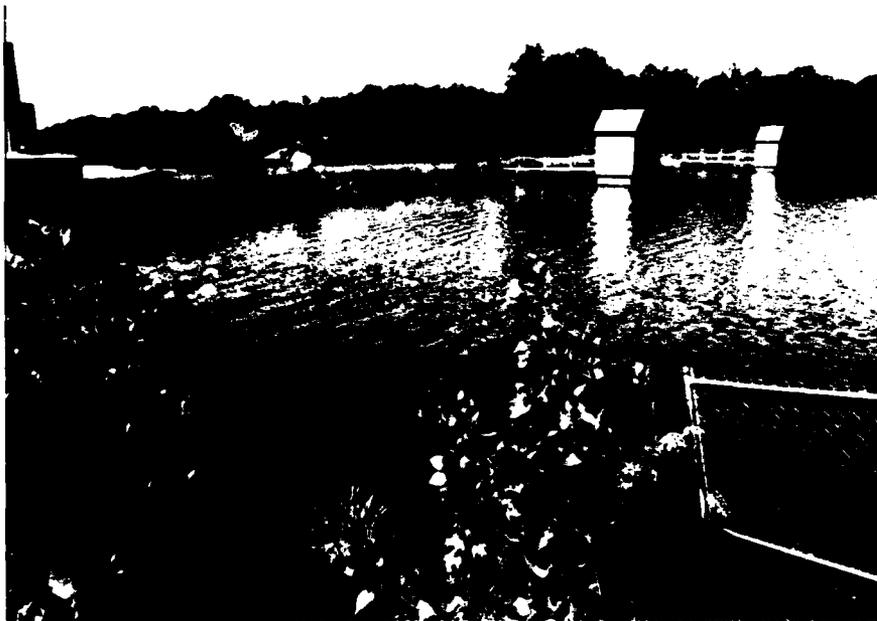
Photo 1 - Upstream slope of dam and gatehouse structures (7/7/80).

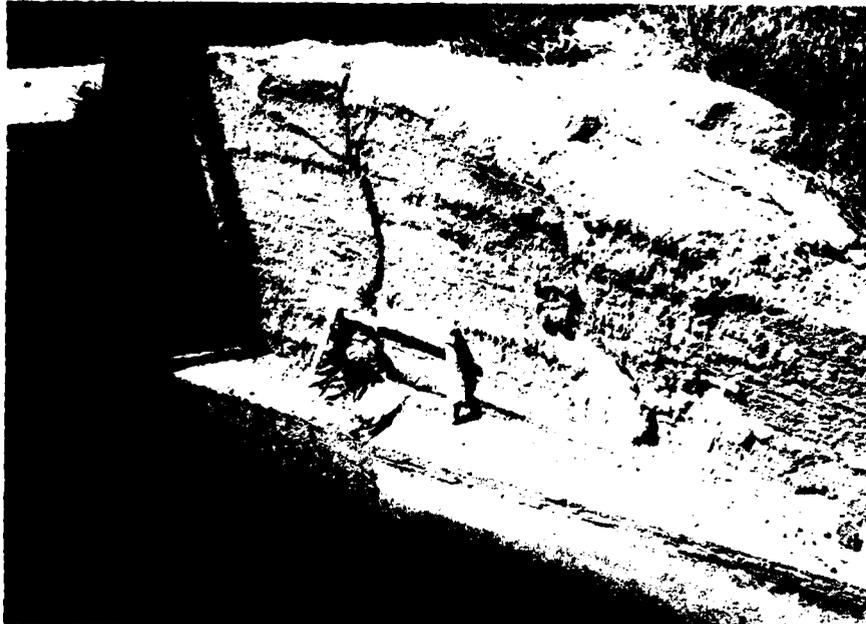
Photo 7 - Cracks and displacement of right spillway training wall (7/7/80).

4. Cracks in the concrete of the spillway training walls should be repaired.
5. Grass growing through the joints of the wing walls should be removed and joints repointed.
