FARMINGTON RIVER BASIN
BARKHAMSTED, CONNECTICUT

SAVILLE DAM
CT. 00376

PHASE I INSPECTION REPORT
NATIONAL DAM INSPECTION PROGRAM

SEPTEMBER 1978

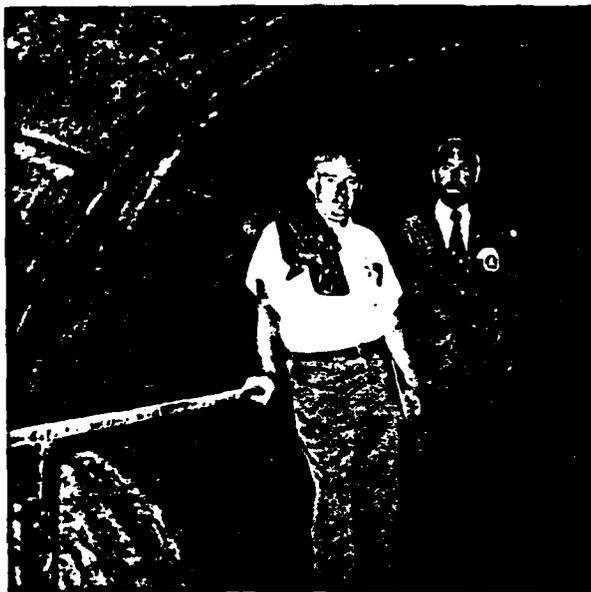
#11 Conduit between Houses,
showing minor leak in
roof, and handrail

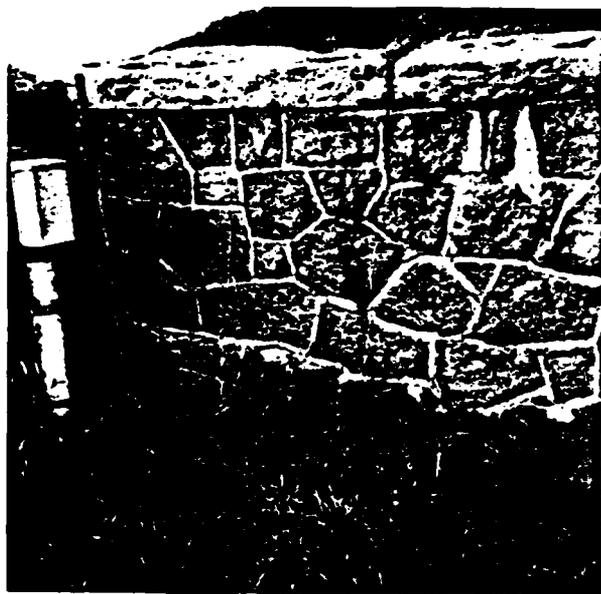
#18 Cracks on East Side of causeway wall.

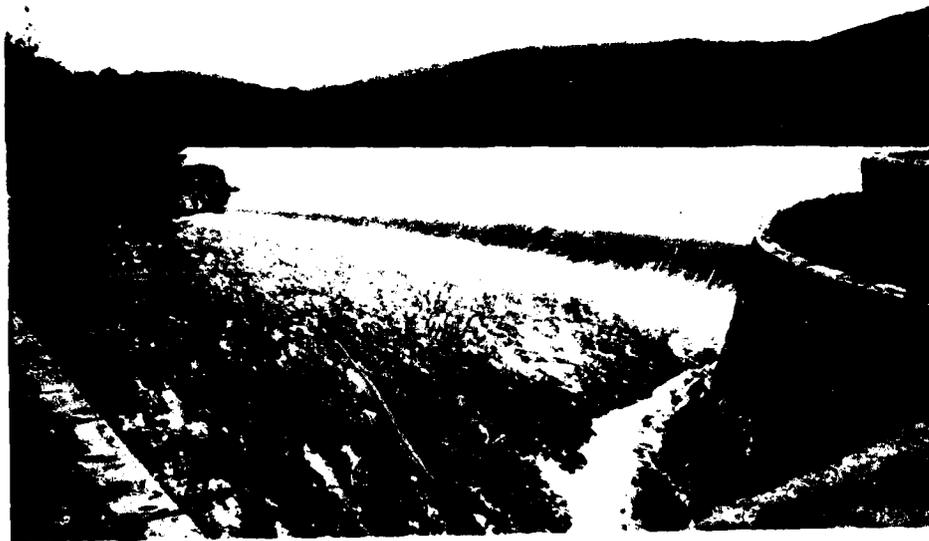
PHOTO 3
SPILLWAY WEIR

e. Downstream Channel - The spillway and downstream channel are cut into ledge rock (Appendix C, Photos 3 and 4) and are in good condition. There is no visible erosion or sloughing of the floor or walls.

c. Visual Observations - The spillway and channel at the time of the inspection were in good condition. There are presently plans by the Metropolitan District to regrout the joints in the granite lined portion of the spillway and channel.

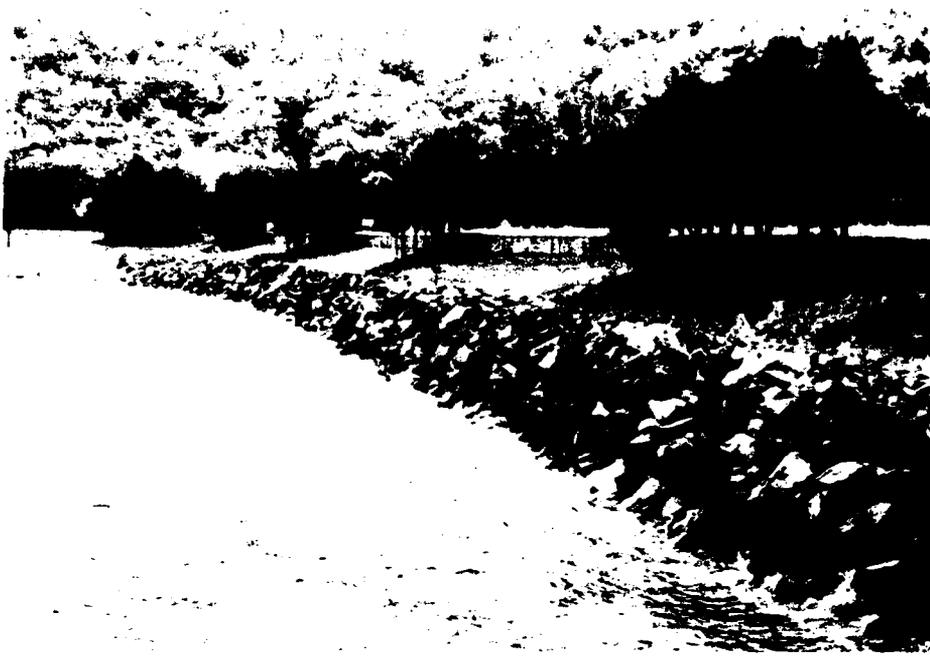
PHOTO 5
UPSTREAM FACE OF DAM

d. Reservoir Area - An inspection of the upstream reservoir area by boat showed that the riprap is in satisfactory condition with no evidence of shifting or repair (Appendix C, Photo 5). The area immediately upstream of the dam embankment seem to be in a very natural state with no visible signs of erosion, sloughing or distress.
