CONNECTICUT RIVER BASIN  
NEW HARTFORD, CONNECTICUT  
**LAUREL LAKE DAM**  
**CT 00372**

PHASE I INSPECTION REPORT  
NATIONAL DAM INSPECTION PROGRAM

DEPARTMENT OF THE ARMY  
NEW ENGLAND DIVISION, CORPS OF ENGINEERS  
WALTHAM, MASS. 02154

SEPTEMBER, 1980

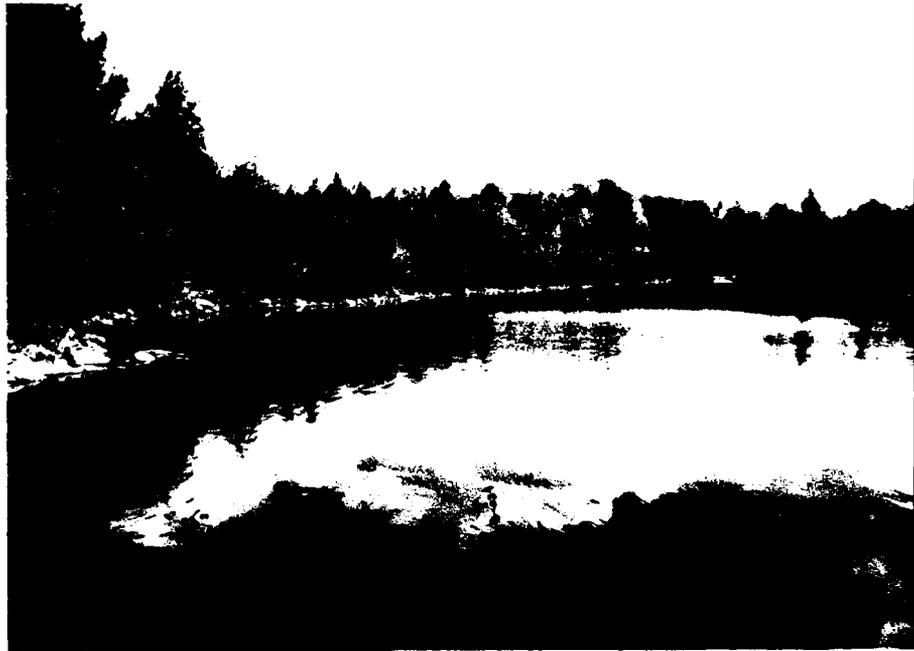
Upstream Slope - The upstream slope is also heavily vegetated and has dumped riprap present below elevation 101+ (Photo 1). No sloughing, washouts, or depressions were noted although some erosion from trespassing is present where paths lead to the edge of water (Photo 6). The riprap is in fair condition with some areas of displacement.

Photo 1 - Upstream slope from left shore, (May, 1980).

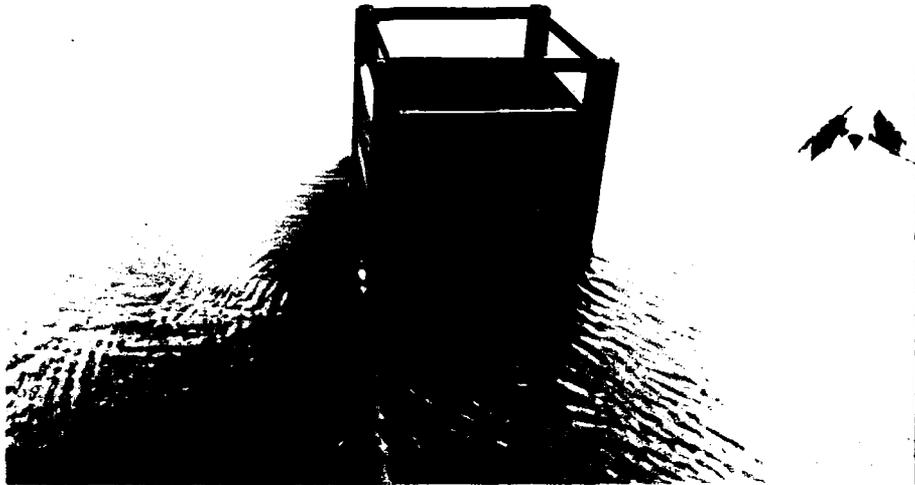
Intake Structure - The intake structure is a 24 inch cast iron drop inlet pipe and a steel framed structure with wooden boards to control the lake level. (Photo 5). It is located approximately 10 feet upstream from the top of the slope. Some wood and boulders were noted at the base of the drop inlet. No low-level outlet for lowering the pond was found during the inspection.

Photo 5 - Drop inlet (2' x 2') with metal frame, wood slats and pipe for control mechanism, (May, 1980).

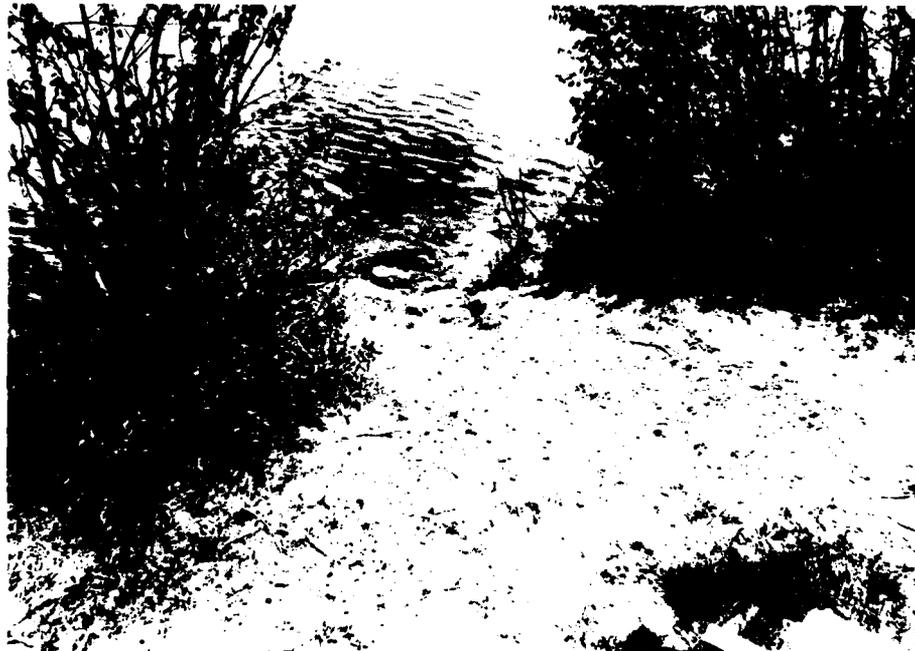
Photo 6 - Area of erosion from trespassing on upstream slope, (May, 1980).
