| REPORT DOCUMENTATION PAGE | | READ INSTRUCTIONS BEFORE COMPLETING FORM |
|--|---|---|
| 4. TITLE (and Subtitle) Silver Lake Dam NATIONAL PROGRAM FOR INSPECTION OF NON-FEDERAL DAMS | 5. TYPE OF REPORT & PERIOD COVERED INSPECTION REPORT | |

**CONNECTICUT RIVER BASIN
 BERLIN, CONNECTICUT**

JUNE 1979

SILVER LAKE

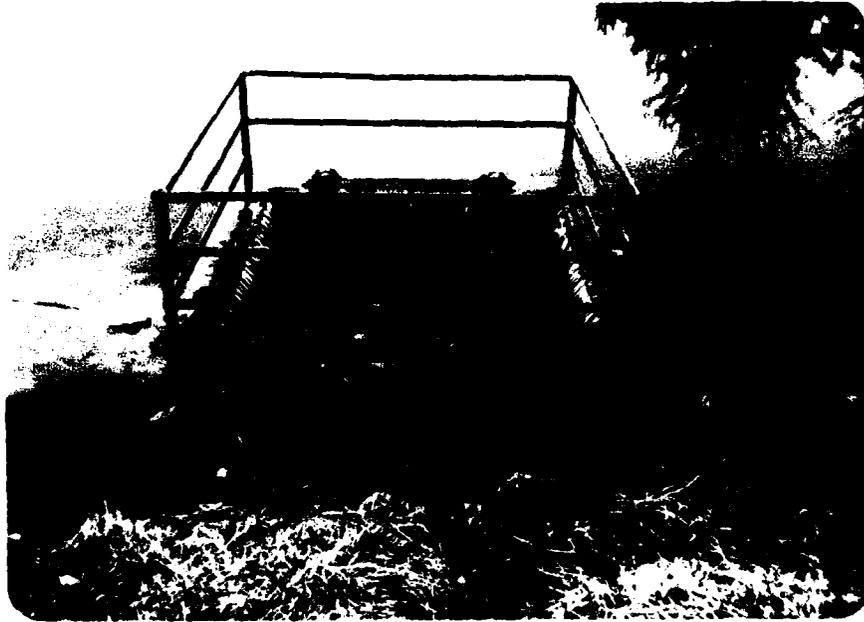
d. Visual Observations - The capacity of the spillway discharge conduit has been reduced due to siltation. Potentially, the already damaged conduit could be totally blocked if the temporary repairs were to fail or if the conduit were to suffer further collapse. In times of severe weather and high water, the drop inlet/conduit would be highly susceptible to partial or total blockage by floating logs or debris.

PHOTO 3 - Drop inlet. Note gate on far side of inlet and log floating toward inlet crest.
