**CONNECTICUT COASTAL BASIN  
GUILFORD, CONNECTICUT**

**GUILFORD LAKES UPPER DAM  
CT. 00412**

**PHASE I INSPECTION REPORT  
NATIONAL DAM INSPECTION PROGRAM**

**JUNE 1981**

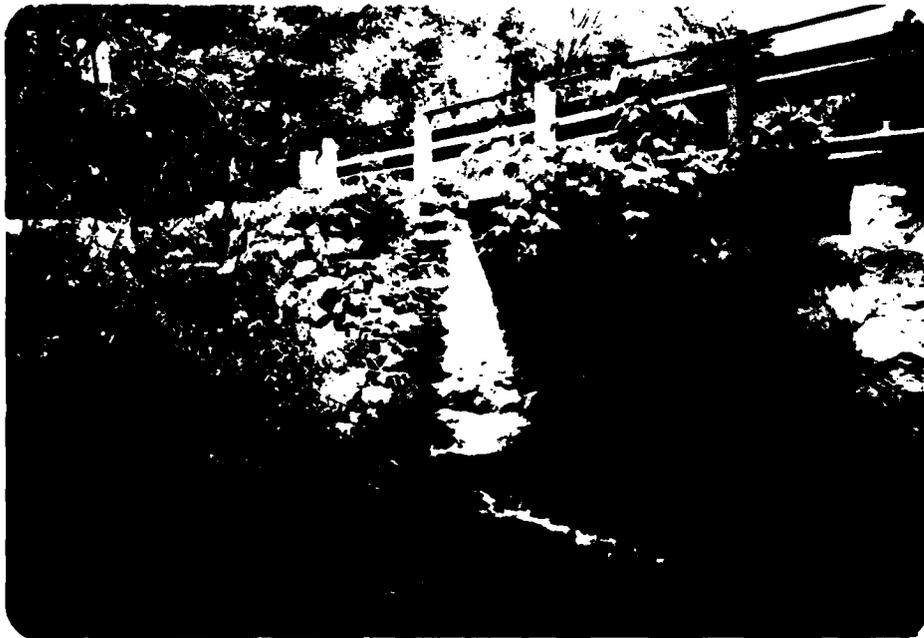
3. Downstream Face and Toe. The downstream face and toe are shown on Photos C-3 and C-4. The downstream face is a dry stone masonry wall in fair to good condition. Brush and trees to 24 inches in diameter are growing immediately downstream from the downstream face. The brush, trees and their roots systems should be removed to a distance of 15 feet downstream to prevent future damage to the wall and to facilitate proper inspection by the downstream area.

PHOTO C-3. Downstream face to right of the right spillway.

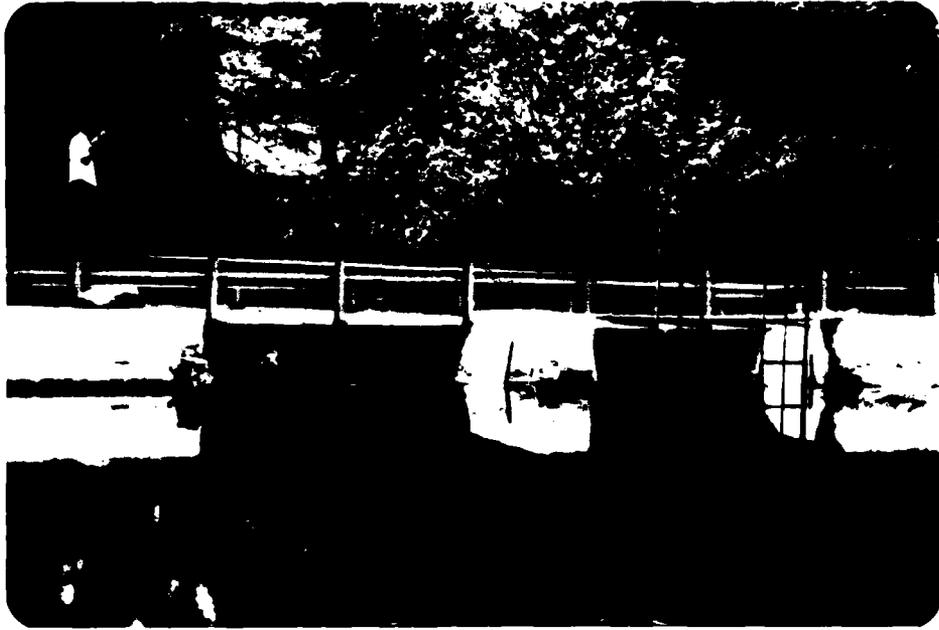
PHOTO C-5. Left and right spillways and outlet gates lifting mechanisms.

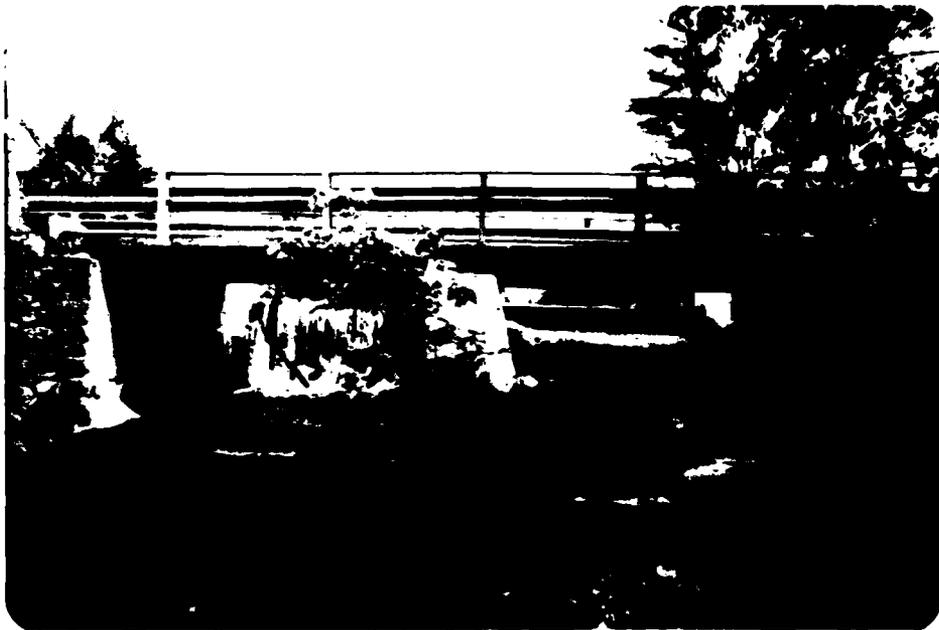
PHOTO C-6. Left and right spillways and spillway discharge channels.

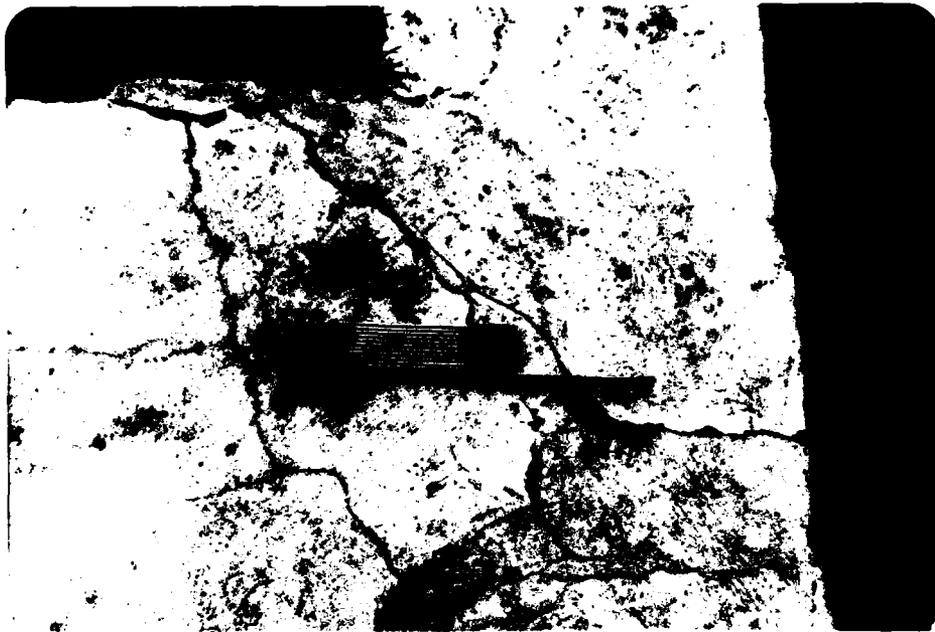
Frost action will continue to open such cracks. The right training wall of the right spillway appears to have moved laterally to the left about 1 inch (into the spillway opening), probably due to frost action. This movement is likely to increase with time. The floor of the left spillway discharge channel is approximately 4 feet higher than the right spillway discharge channel. A floating log was trapped upstream of the right spillway at the low level outlet gate. There are several steel pins set in the crests of the two spillways which were apparently used for stoplogs at one time. These pins should be removed to prevent debris accumulation.

PHOTO C-9. Crack through training wall which divides the spillway discharge channels.

2. Observe movement of right training wall of right spillway and cracks and leaks in center training wall between spillways at least annually. Note condition and take action as needed.

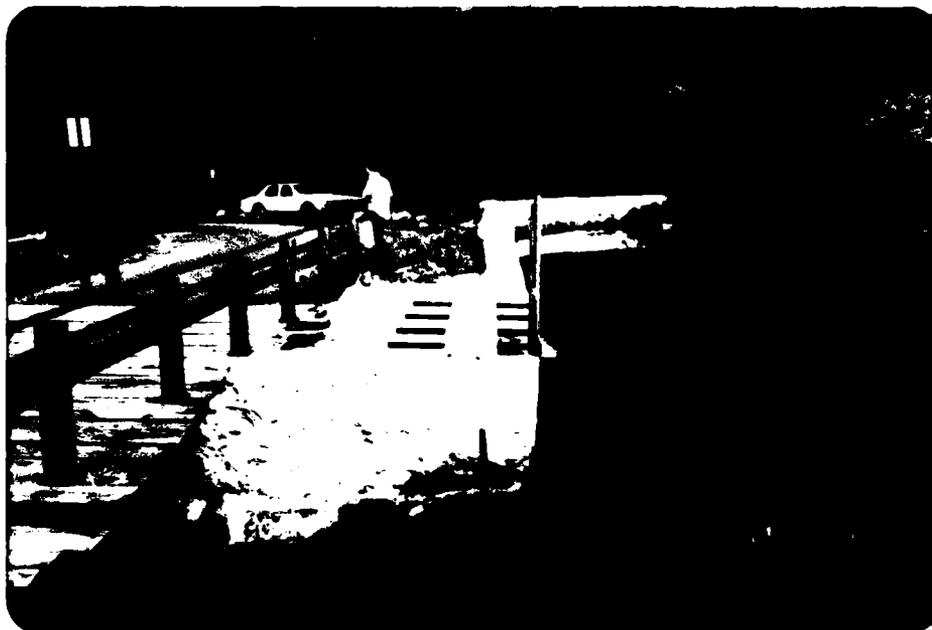
1. Upstream Face. The upstream face is a vertical grouted stone masonry wall which has a slight downstream curvature to the right of the spillways as shown in Photo C-12. It is possible that this curvature is due to ice pressure. The curvature is of no immediate concern, however, it should be observed at least annually to determine if any changes are occurring. The mortared stone masonry has numerous hairline cracks throughout its length.

PHOTO C-12. View along crest from the left of the spillways showing bend in the upstream face.
