NATIONAL PROGRAM FOR INSPECTION OF NON-FEDERAL DAMS
WHITNEY DAM (CT 00477) (U) CORPS OF ENGINEERS WALTHAM
MA NEW ENGLAND DIV DEC 80

THAMES RIVER BASIN
STAFFORD, CONNECTICUT

WHITNEY DAM
CT 00477

PHASE I INSPECTION REPORT NATIONAL DAM INSPECTION REPORT

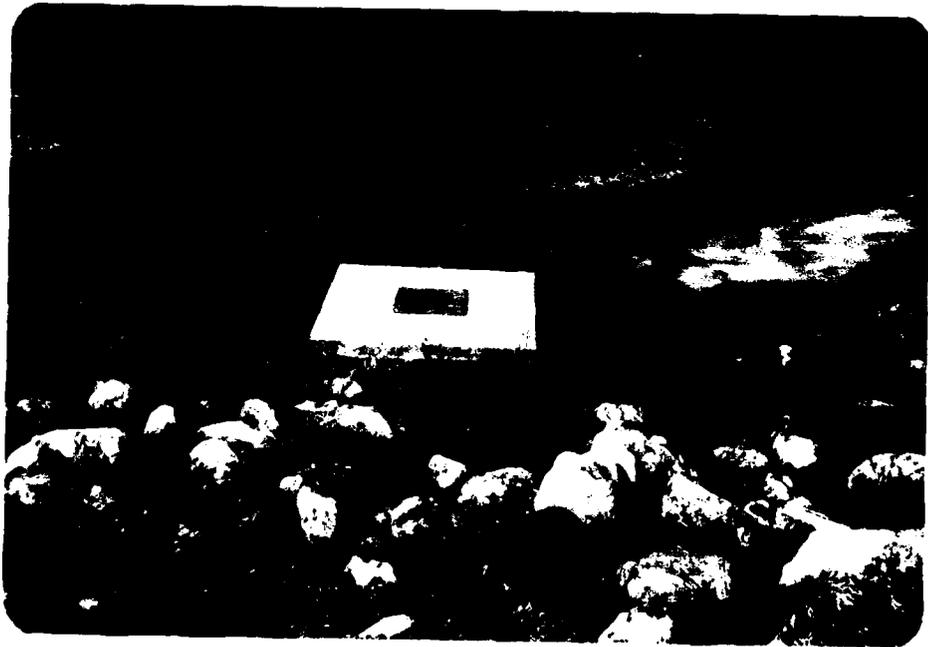
C-8 PRINCIPAL SPILLWAY INLET RISER

operation difficult. The concrete, trash racks and other appurtenances are in good condition. There does not appear to be a significant buildup of sediment in the pool that would require the draining of the pool for cleaning.

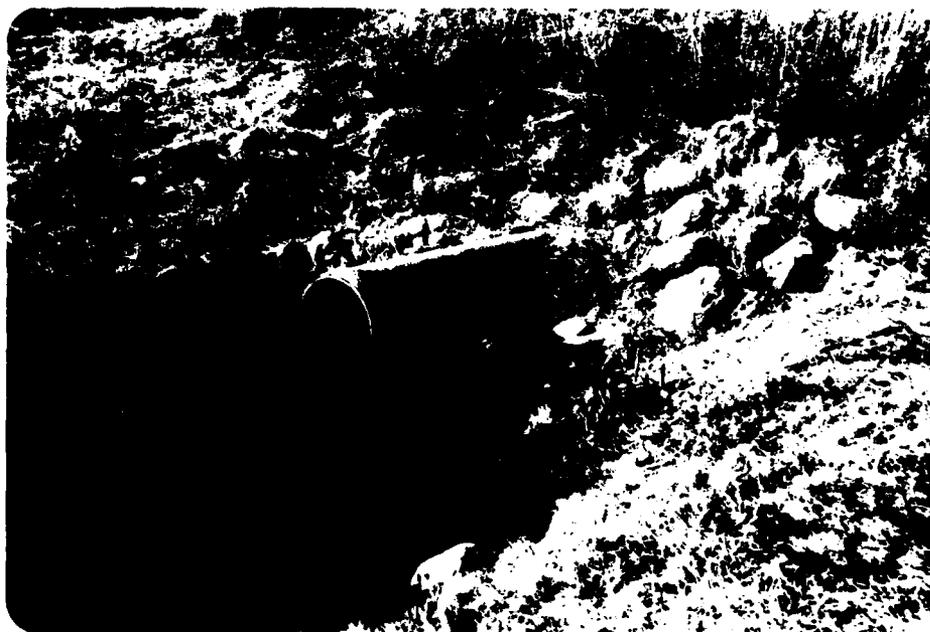
C-10 PRINCIPAL SPILLWAY OUTLET PIPE

There is a 30-inch concrete water pipe from the riser through the embankment to the outlet. The portion of the pipe that is visible is in good condition and is shown in Photo No. C-10. The last pipe at the outlet is 16 feet in length and is supported at mid-point by a reinforced concrete bent 8 feet deep and the remainder of the pipe is supported on a reinforced concrete cradle. A bent and cradle are not visible, but there are no outward signs of any problems. The discharge end of the pipe is in good condition with no erosion in the stream bed.

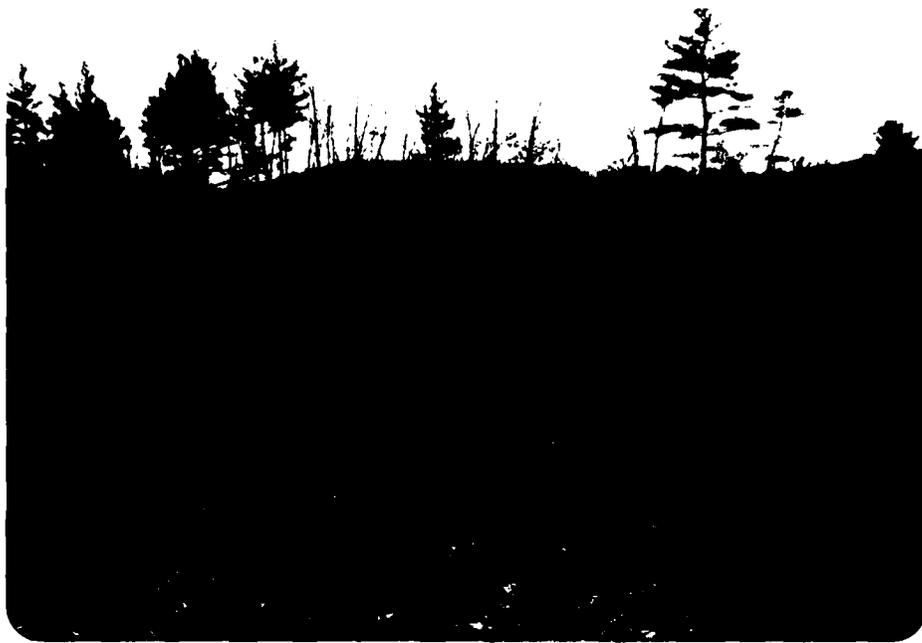
C-11 EMERGENCY SPILLWAY LOOKING DOWNSTREAM

emergency spillway. The spillway is in good condition with very little chance of erosion due to the underlying bedrock.
