QUINNIPIAC RIVER BASIN  
MERIDEN CONNECTICUT

**HANOVER POND DAM  
CT 00134**

**PHASE I INSPECTION REPORT  
NATIONAL DAM INSPECTION PROGRAM**

FEBRUARY 1979

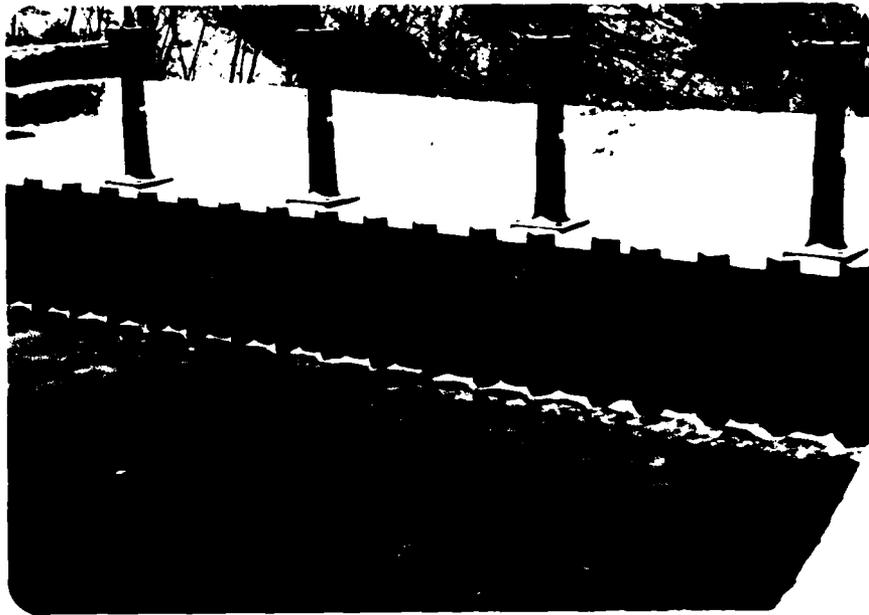
PHOTO NO.3 - Upstream view of gate valves and trash racks at left abutment.
