SIMPSON POND DAM
CT 00630

PHASE I INSPECTION REPORT
NATIONAL DAM INSPECTION PROGRAM

FEBRUARY, 1981

Identification Number:	CT 00630
Name:	Simpson Pond Dam
Town:	Wallingford
County and State:	New Haven County, Connecticut
Stream:	Wharton Brook
Date of Inspection:	October 23, 1980

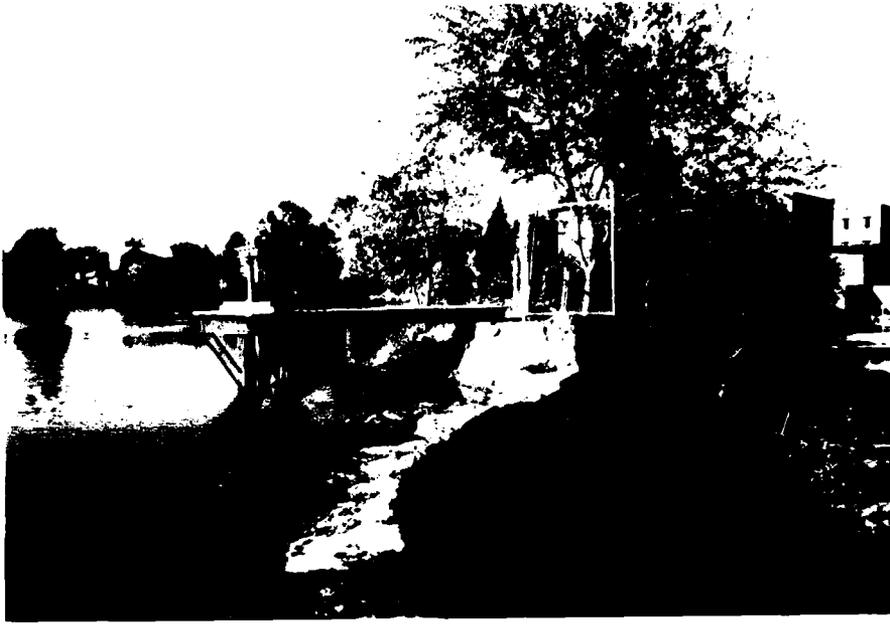
PHOTO 3
SPILLWAY - SOUTH ABUTMENT - CONTROL GATE

A service bridge extends about 20 feet from the south abutment to a low level discharge gate (Photo 3). The bridge, consisting of wooden boards on steel beams and columns, is in good condition. The gate is kept locked to inhibit vandalism. The gate is operable and controls a 27-inch metal low-level discharge pipe that passes through the base of the dam (Photo 6).
