CONNECTICUT COASTAL BASIN  
STONINGTON, CONNECTICUT

MYSTIC RESERVOIR-SOUTH DAM  
CT. 00613

PHASE I INSPECTION REPORT  
NATIONAL DAM INSPECTION PROGRAM

FEBRUARY 1981

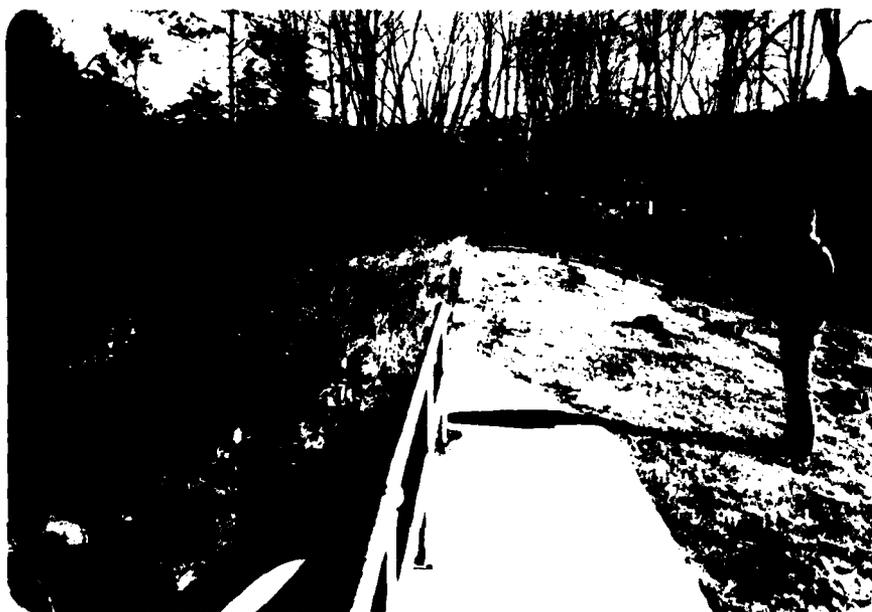
PHOTO C-2: Left abutment and dam crest.

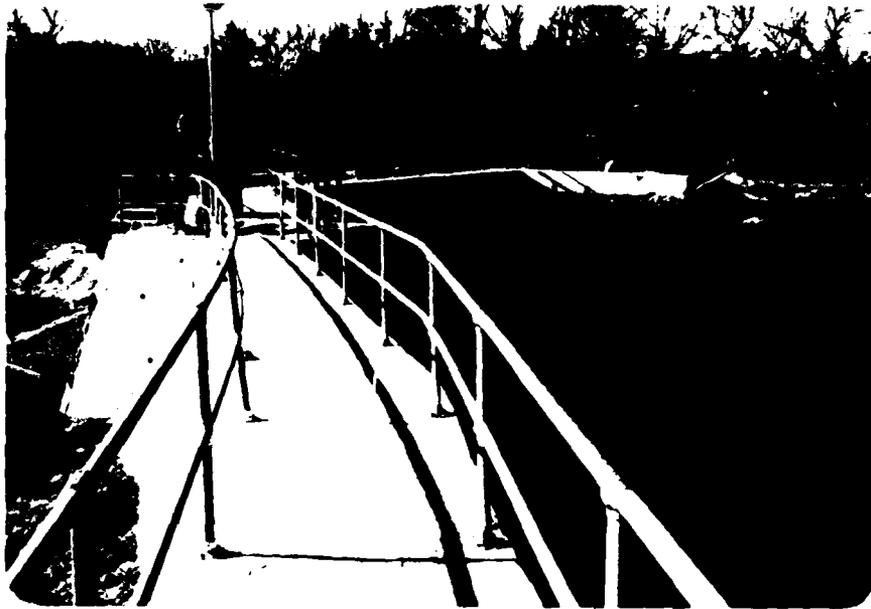
1. Upstream Face. The upstream face of the earth embankment section has 10-20 pound stone riprap protection to within 3 feet of the crest (Photo C-4). Small trees and brush cover the upstream slope from the riprap to the crest of the dam. The upstream face of the gravity section of the dam is vertical and spalling of the concrete in several places in vicinity of the normal pool level was observed (Photo C-3).

PHOTO C-3: Upstream face, crest and intake structure looking towards right abutment.

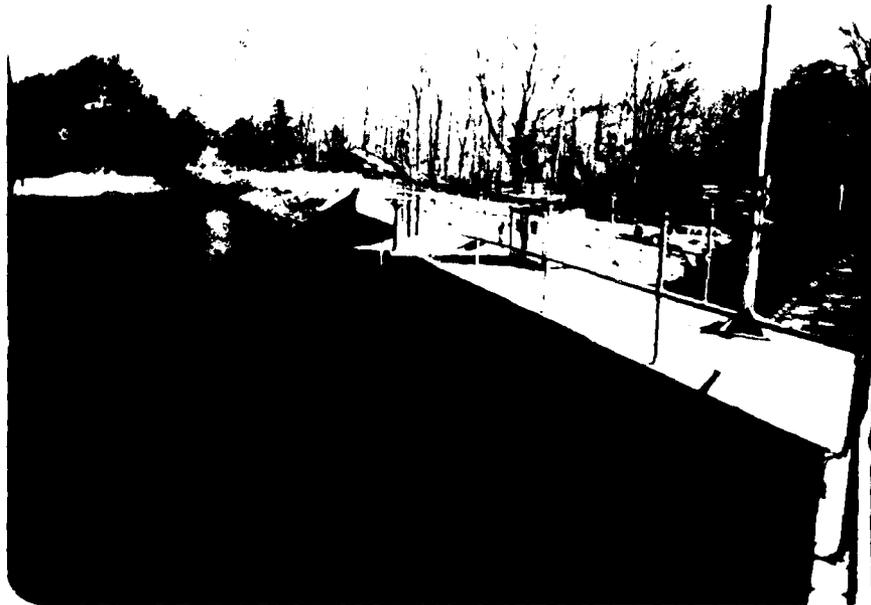
PHOTO C-4: Upstream face and left abutment.

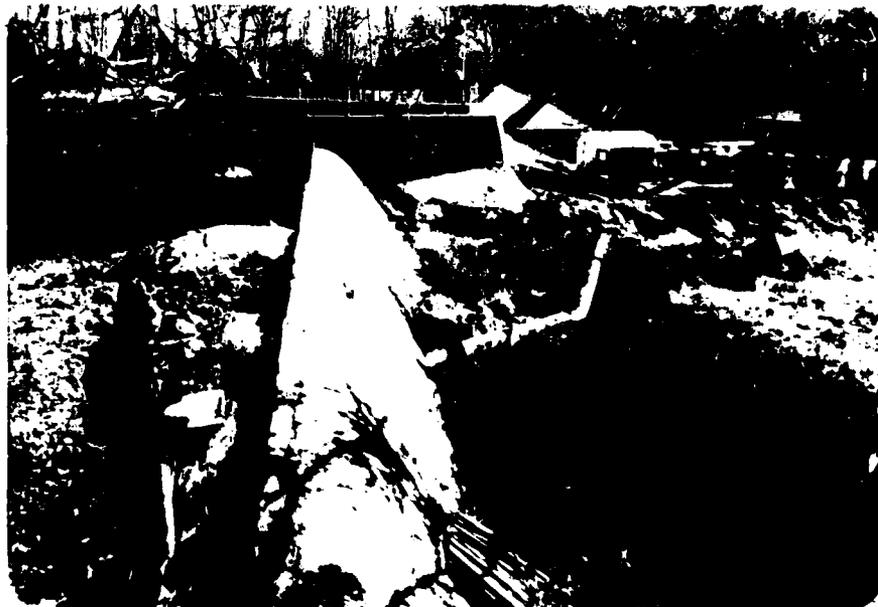
PHOTO C-8: Spillway crest from the right abutment showing constriction of spillway discharge channel by natural ground.

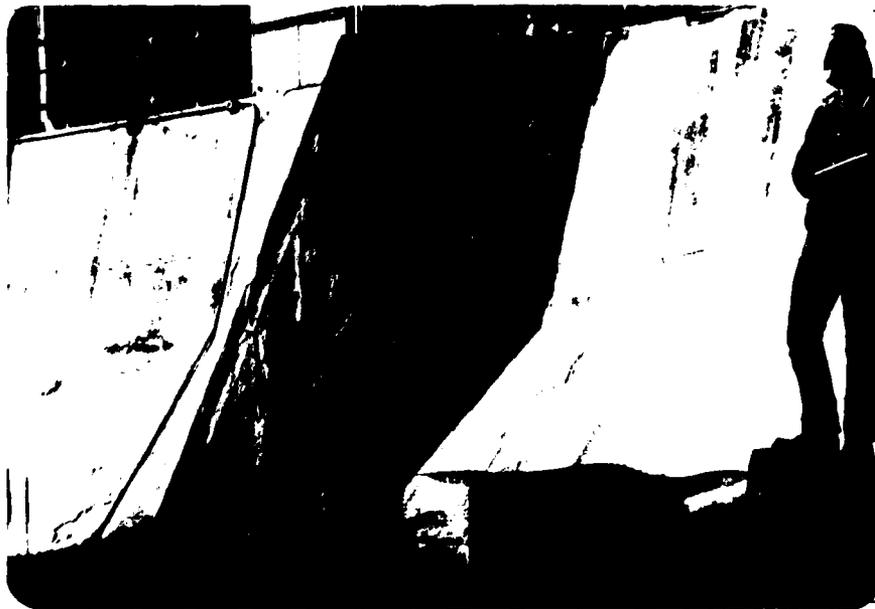
PHOTO C-10: Downstream face of gravity section. Note cracking and efflorescence of concrete.

- d. Investigate and recommend methods to repair cracking and spalling of the concrete along the crest and at the downstream toe of the spillway, at the left spillway abutment on the downstream face of the gravity section of the dam, and at the intake/outlet structure. Investigate and recommend methods to control seepage through and beneath the spillway.
- e. Evaluate the need for increasing the capacity of the spillway discharge channel.
- f. Design and supervise the placement of riprap on the upstream face of the embankment between the normal pool elevation and the crest.
- g. Replace the trash rack.

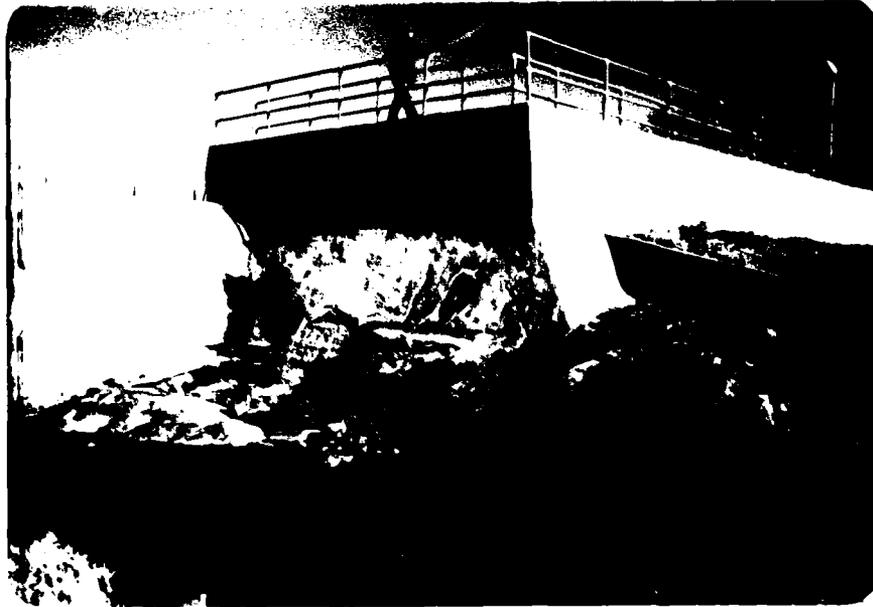
PHOTO C-11: Downstream face of gravity section at the left spillway abutment. Note the seepage and cracking and spalling of concrete near the left spillway abutment.

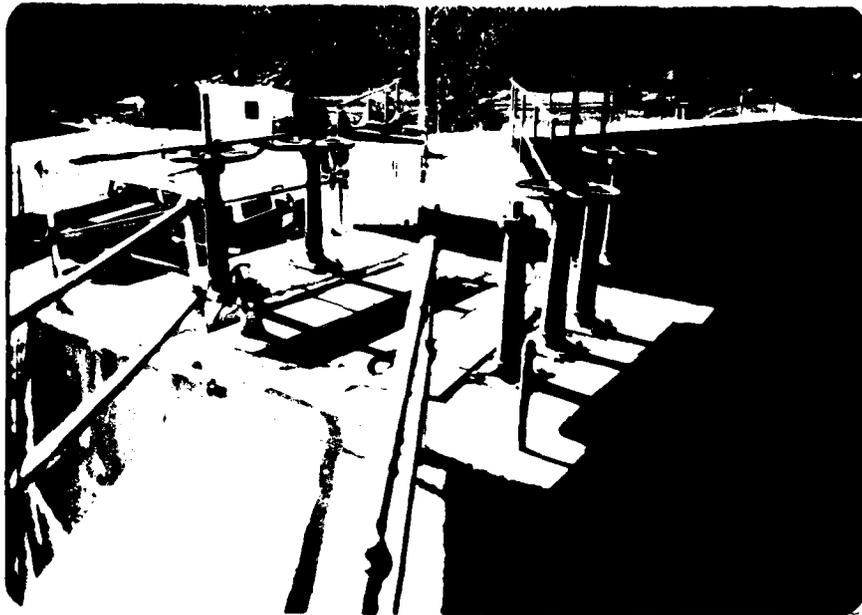
PHOTO C-14: Intake structure and gate mechanisms near the centerline of the dam.
