ASHFORD, CONNECTICUT
ASHFORD LAKE DAM
CT 00462

PHASE I INSPECTION REPORT
NATIONAL DAM INSPECTION PROGRAM

AUGUST 1980

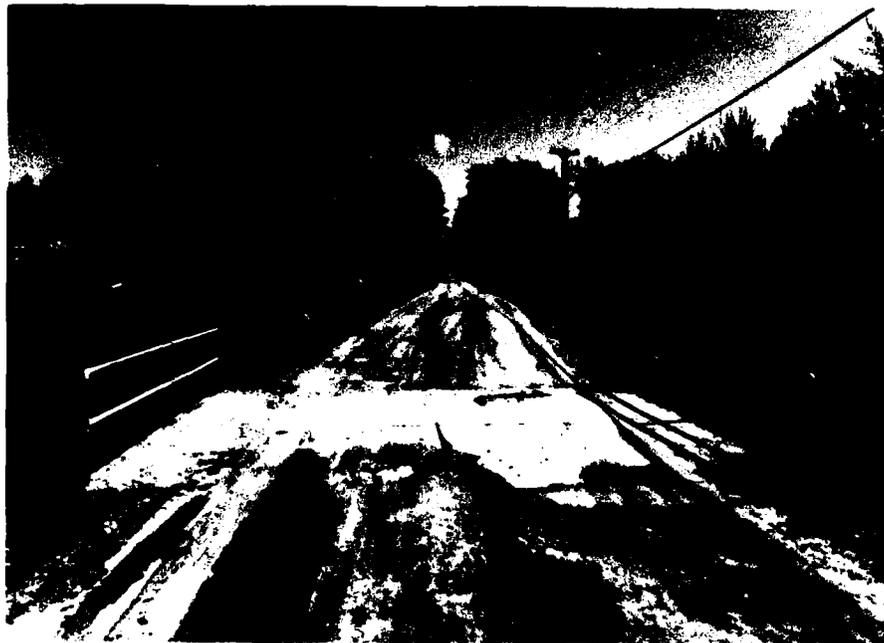
Crest - The top of the dam showed no signs of misalignment or visible cracking. However, there is an unpaved, two lane road which extends the length of the dam. This road had a number of pot holes and ruts (Photo 2).

Photo 2 - Unpaved road and potholes on top of dam taken from right abutment (March 1980).

5. The road on the top of the dam should be regraded and proper protection placed.
6. The spalled concrete of the valve chamber should be repaired.
7. All obstacles, debris, or overhanging trees and brush on the spillway crest, and the floor of the spillway approach, discharge and low-level outlet channels should be removed. The damaged earth dikes along the spillway discharge channel should be restored to prevent spillway discharge along the toe of the dam.

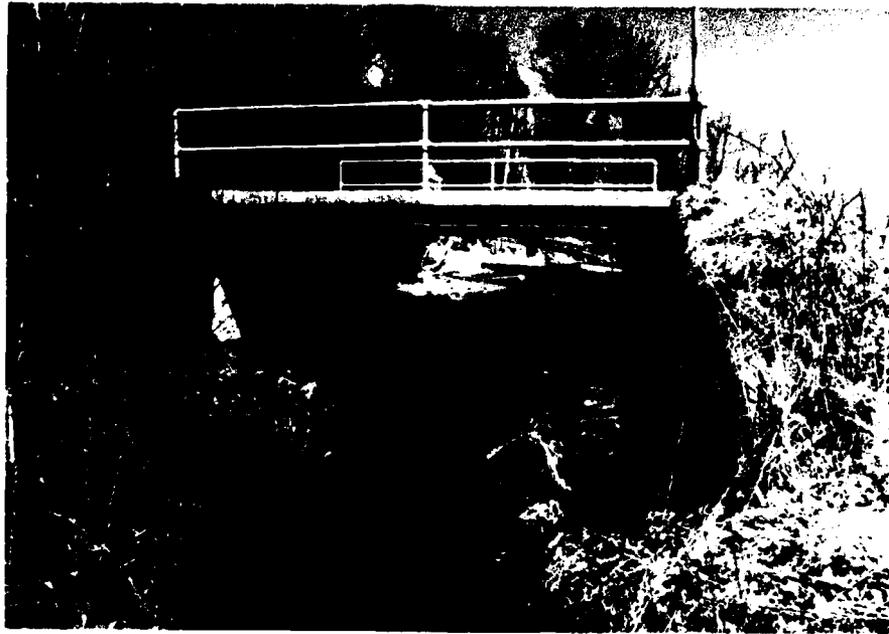
Photo 4 - Spillway channel taken from downstream
(March 1980).
