AVON-BURLINGTON, CONNECTICUT

COLLINS COMPANY LOWER DAM

PHASE I INSPECTION REPORT NATIONAL DAM INSPECTION PROGRAM

JULY 1979

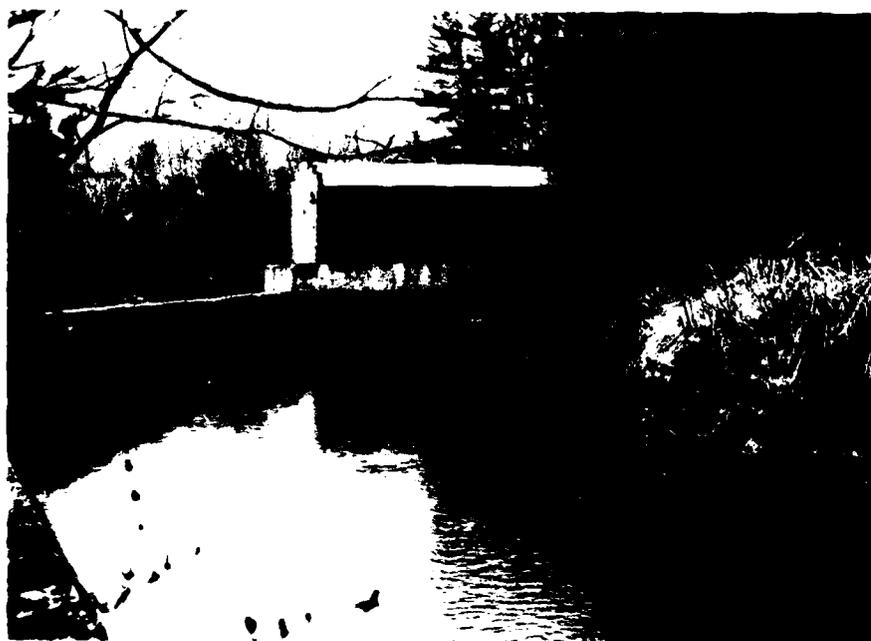
PHOTO 6 - Spalling of downstream face of left abutment at canal inlet. (April, 1979).

4. Deteriorated concrete of the dam abutments, canal walls, canal waste weir, powerhouse bulkhead, and retaining walls upstream of the dam should be repaired. Planking for the steel frame foot bridge over the canal waste weir should be put in place.

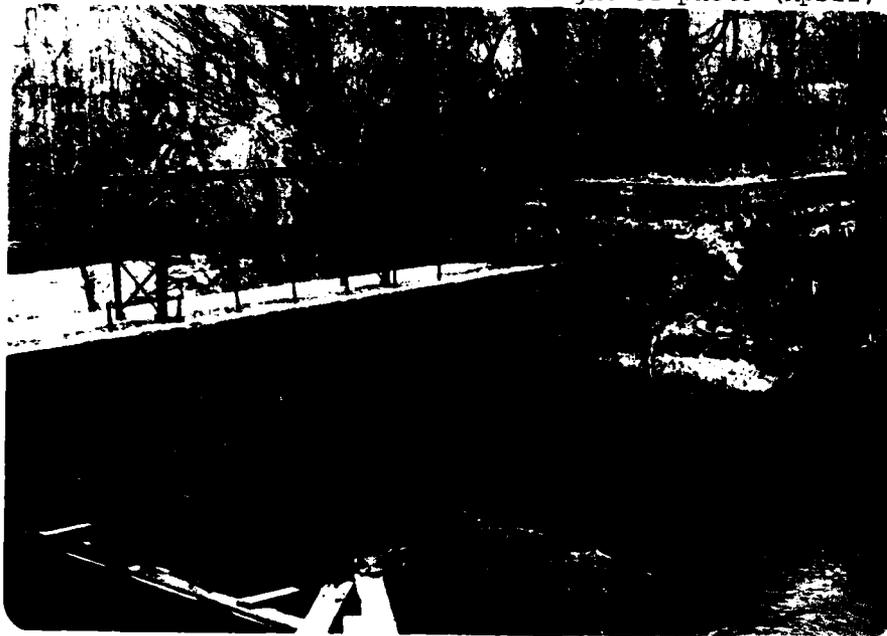
PHOTO 10 - Waste weir at downstream end of canal adjacent to powerhouse. Note spalling of concrete and debris in channel (April, 1979).
