CONNECTICUT COASTAL RIVER BASIN
KILLINGWORTH, CONNECTICUT

KILLINGWORTH RESERVOIR DAM
CT 00401

PHASE I INSPECTION REPORT
NATIONAL DAM INSPECTION PROGRAM

MARCH 1979

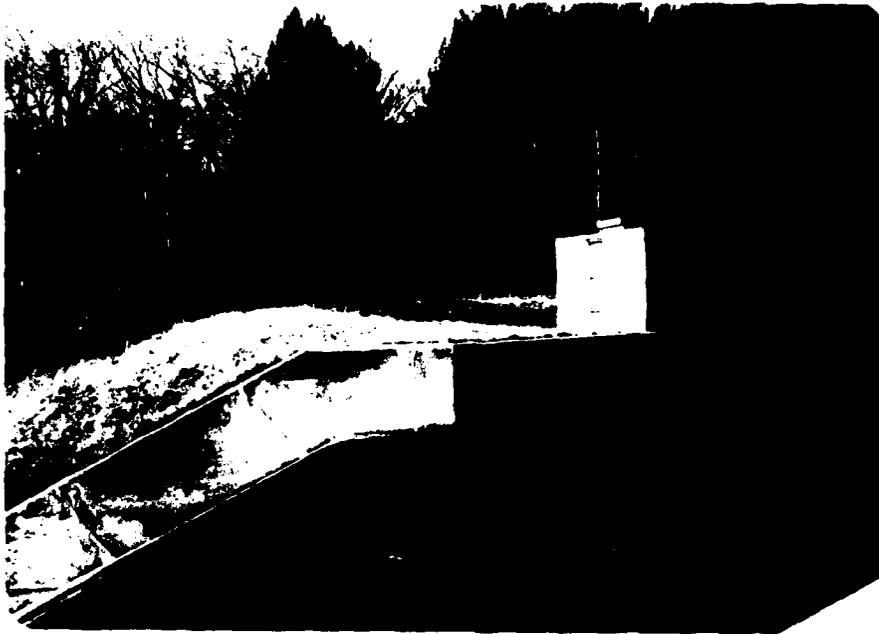
Spillway - The spillway is in good condition as shown in Photo 1. Cracks in the concrete wingwalls have been sealed with silicone caulking as shown in Photo 3. The concrete wingwalls were extended by means of gabions which are presently in good condition although some erosion of the downstream slope behind the gabions has occurred (Photo 2). There is also a slight tilting of the gabions over the left wingwall.

PHOTO 3 - Intake structure and right spillway wingwall. Note cracks which have been sealed.

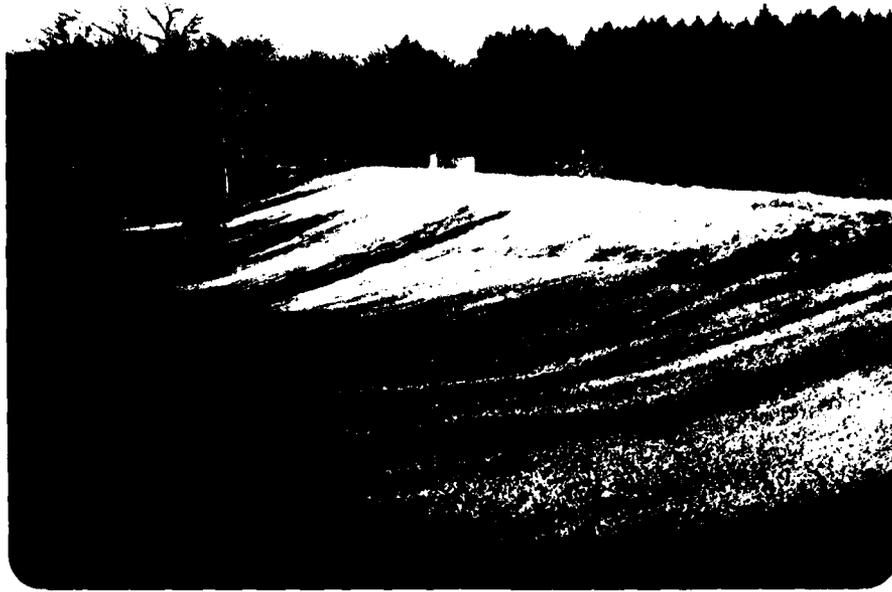
Downstream Slope - The downstream slope is grass covered with a toe drain covered by processed stone running along the length of the dam. There are no signs of sloughing of erosion on the slope, and the toe drain is in good condition and clear of debris and vegetation, as shown in Photo 5. The toe drain outlet pipe exits from the left gabion wall as shown in Photo 6. The owner reported that water has never been observed flowing from the drain pipe.

PHOTO 5 - Downstream face of dam with toe drain.

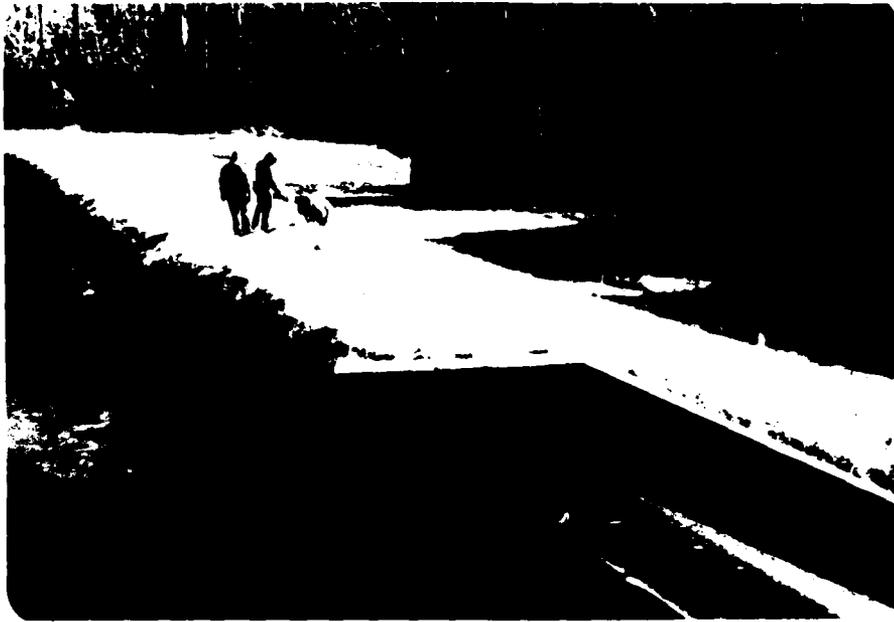
Crest - The crest is grass covered and in good condition with no signs of erosion, as shown in Photo 7.

PHOTO 7 - View of crest and upstream face of dam embankment.
