THAMES RIVER BASIN
BOZRAH, CONNECTICUT

FITCHVILLE POND DAM
CT 00510

PHASE 1 INSPECTION REPORT
NATIONAL DAM INSPECTION PROGRAM

JUNE 1979

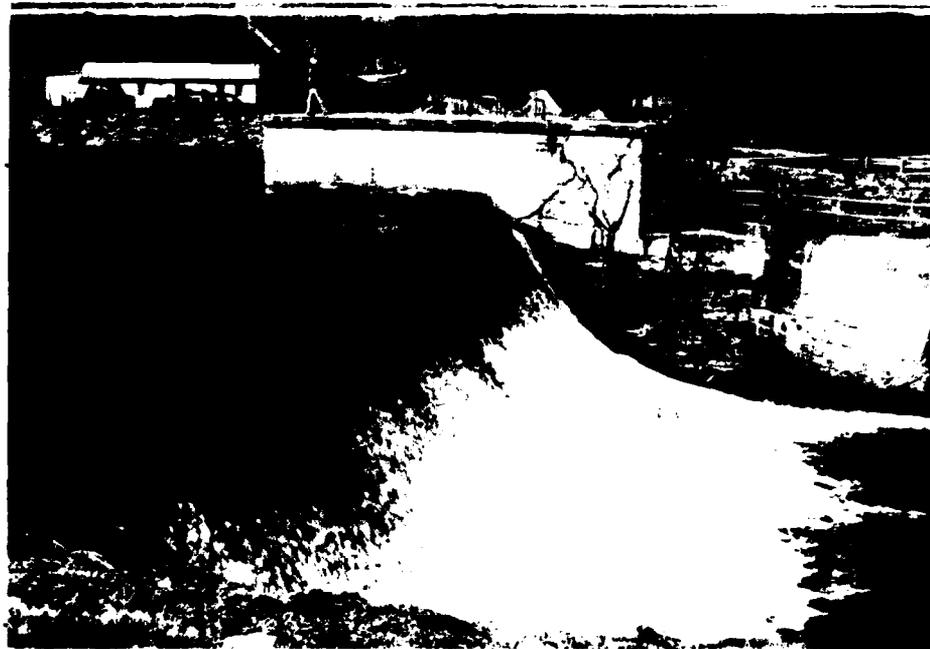
The spillway training walls are in poor condition. As shown in Photo C-2, the concrete facing is missing from the left training wall just downstream from the spillway crest and the underlying open stonework is exposed. Concrete facing is also missing from the left training wall just downstream from the outlet gate raceway and seepage is occurring through the exposed open stonework, as shown in Photo C-10. As shown in Photos C-11 and C-15, the concrete facing on the right training wall is intact, but seepage is occurring through the open stonework in a 25-ft. section starting about 15 ft. downstream from the spillway toe where the concrete facing extends only partway up the training wall. The dry stone masonry wall is damaged with a number of stones missing in a 15-ft. section immediately downstream of the concrete-faced section, as shown in the same photos.

Concrete facing is missing from the left spillway training wall and the underlying open stonework is exposed.

C-2 SPILLWAY - LOOKING FROM RIGHT ABUTMENT (NOTE CRACK IN CONCRETE MONOLITH ON LEFT ABUTMENT)

1. Evaluate the condition of the spillway surfaces and training walls and develop a program for their rehabilitation.
2. Trees and brush on the upstream and downstream slope should be removed. The stumps of the trees should be removed only after a procedure has been developed by a competent engineer for proper backfill and compaction.

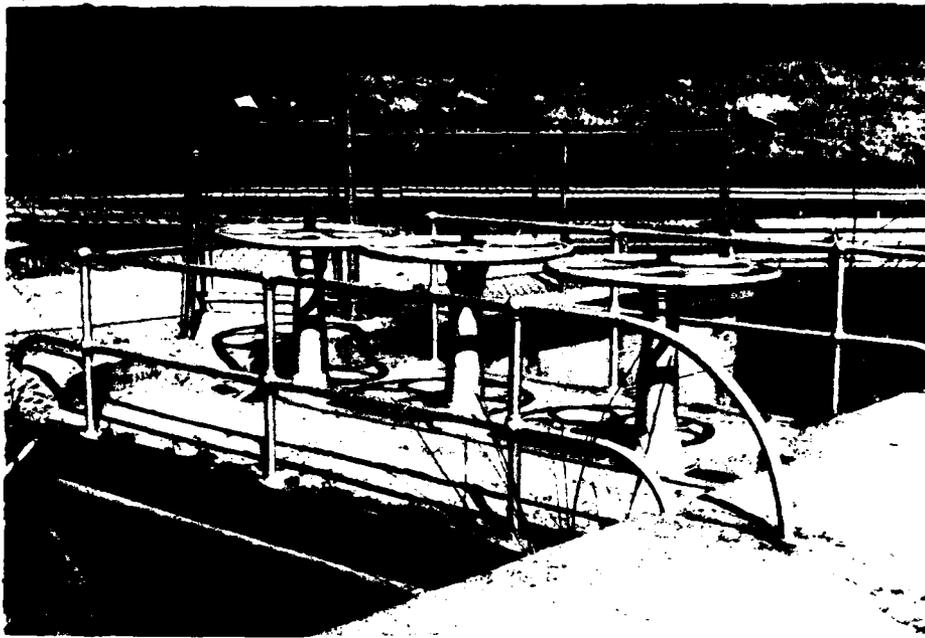
2. Outlet Works. The outlet gate structure is located at the left abutment of the spillway. The general configuration of the outlet gate structure is shown in Photos C-5, C-6 and C-13. Flow from the outlet gate enters the downstream spillway channel through a short raceway section. Large cracks and extensive seepage were noted in the concrete covering of the stone masonry outlet structure, as illustrated in Photo C-5. The outlet works gates were not exercised at the time of the inspection but are reportedly operable according to the Owner of the dam.

C-5 OUTLET WORKS CONTROL GATES

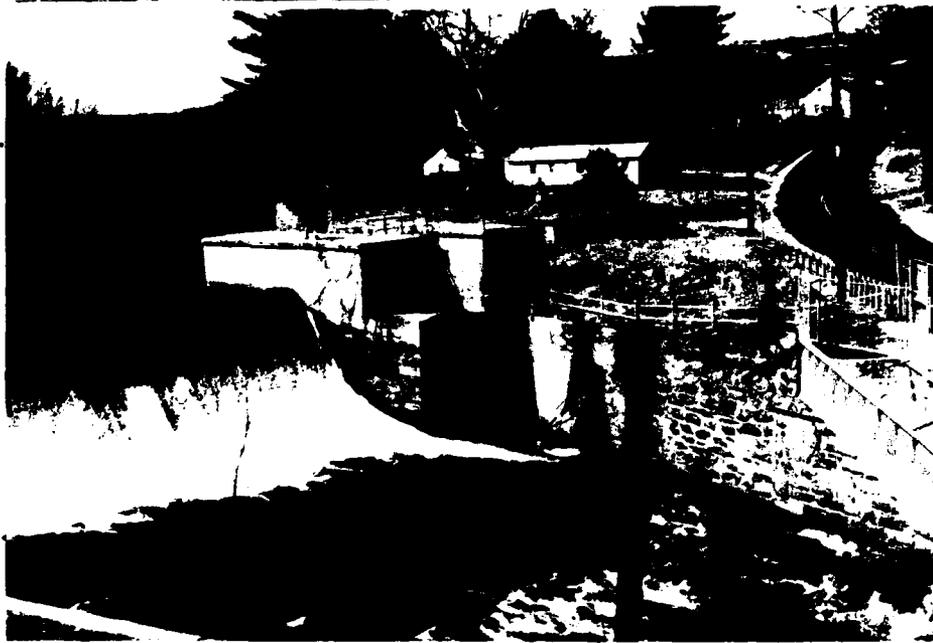
C-13 LEFT ABUTMENT OF DAM AND OUTLET WORKS (HIGHWAY BRIDGE - RIGHT FOREGROUND)
