CONNECTICUT RIVER BASIN
CHESTER, CONNECTICUT

JENNINGS POND DAM
CT 00396

PHASE I INSPECTION REPORT
NATIONAL DAM INSPECTION PROGRAM

FEBRUARY, 1981

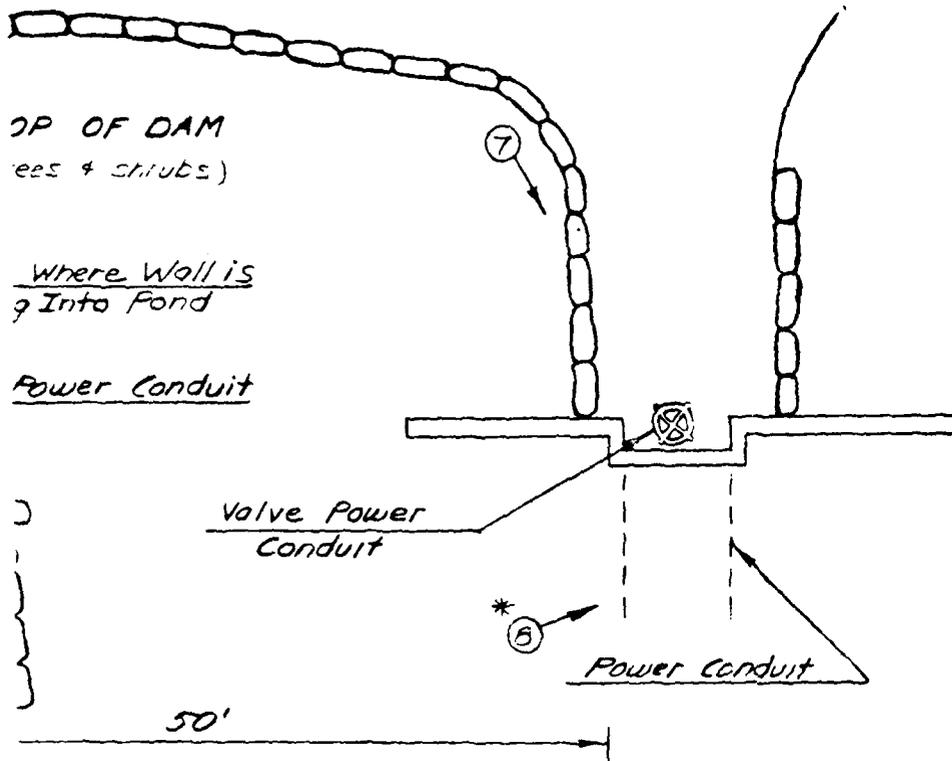
The general structural stability of the dam is fair as evidenced by its vertical, horizontal and lateral alignment. The stone masonry wall on the upstream face of the dam is in fair condition and in one location the wall is falling into the pond. The earth embankment portions of the dam show no evidence of instability. The channel embankment downstream of the dam is sloughing and indicates instability. Also at this location the downstream masonry of the dam embankment is bulging. The cause of the sloughing and bulging should be investigated to determine the structural stability of the dam.

Where Wall is
going into Pond

b. Cracking and movement of the upstream retaining wall should be investigated and means of repair established.
