**WRIGHTS POND DAM**

**CT 00393**

**PHASE 1 INSPECTION REPORT  
NATIONAL DAM INSPECTION PROGRAM**

**AUGUST, 1981**

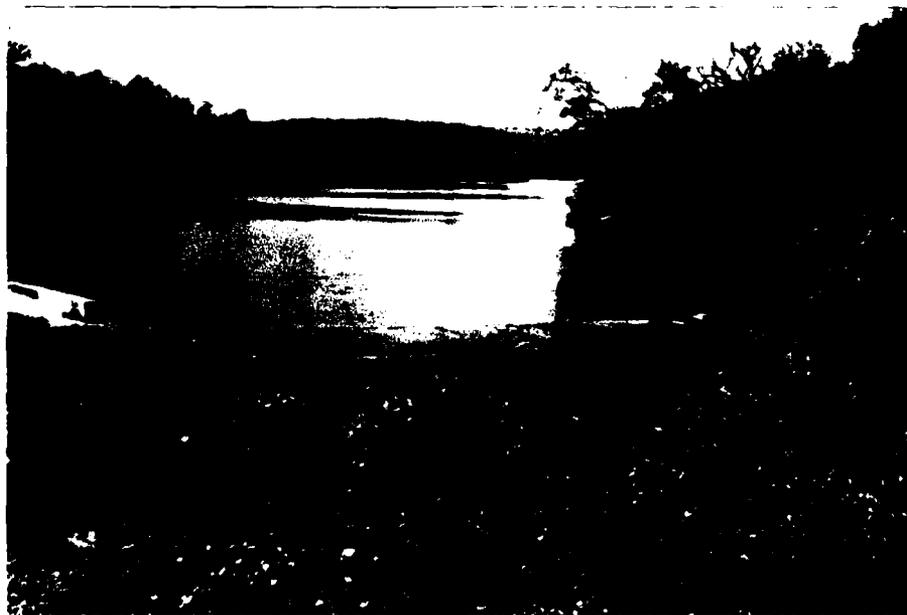
1. **Spillway:** The spillway is a 100 foot long by 11 foot wide stone masonry and concrete structure near the western end of the dam. (Photos C-1, C-2). The eastern half of the spillway is the original spillway for the dam. It is constructed of stone masonry with a concrete covering (Photos C-4, C-8). This covering is spalled but still adequate and there are many missing and loose stones, seepage and brush along the downstream face (Photos C-8, C-9). Because of flow over the spillway, the rate of seepage between the stones in the downstream face could not be determined. No evidence of fines was noted in the seepage. The outlet of the 18 inch pipe is at the base of this spillway section (Photo C-11). A concrete wingwall was added in 1972 and is in good condition (Photo C-4). There is a void under the

C-2 SPILLWAY LOOKING NORTH
