**THAMES RIVER BASIN  
GRISWOLD, CONNECTICUT**

**PACHAUG POND DAM  
CT 00663**

**PHASE 1 INSPECTION REPORT  
NATIONAL DAM INSPECTION PROGRAM**

**SEPTEMBER 1978**

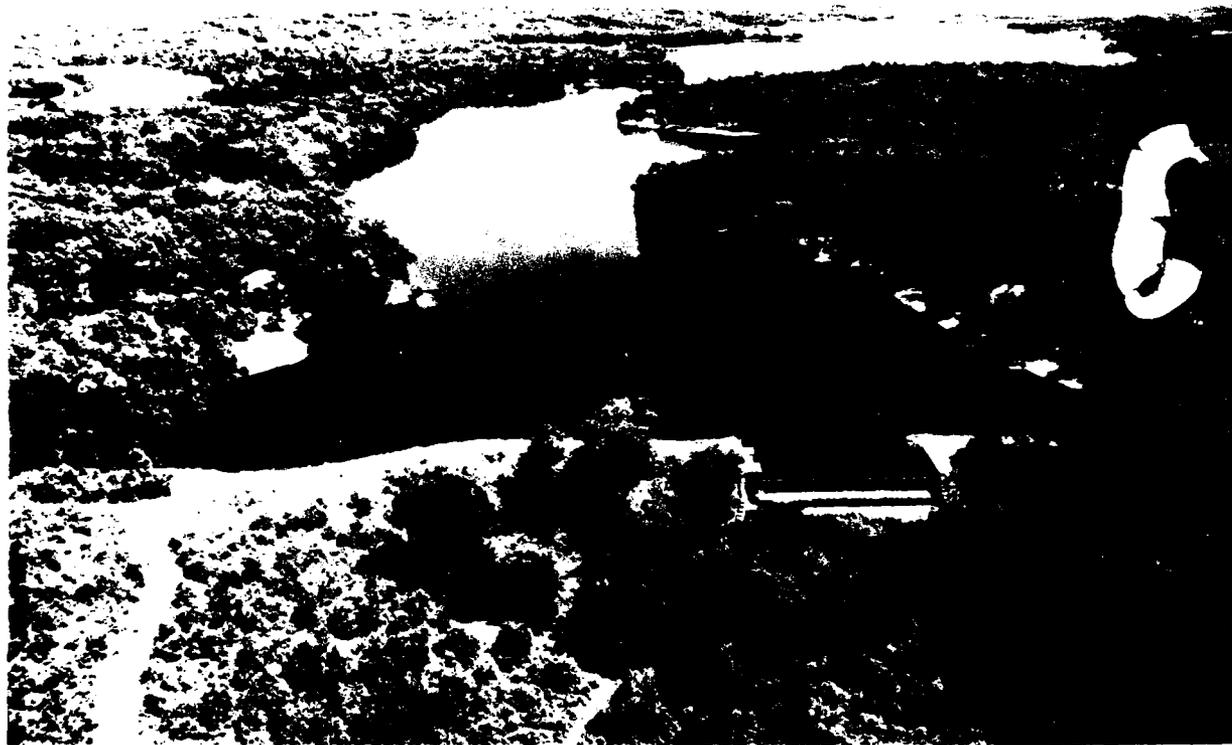
C-1 PACHAUG POND & DAM - LOOKING UPSTREAM

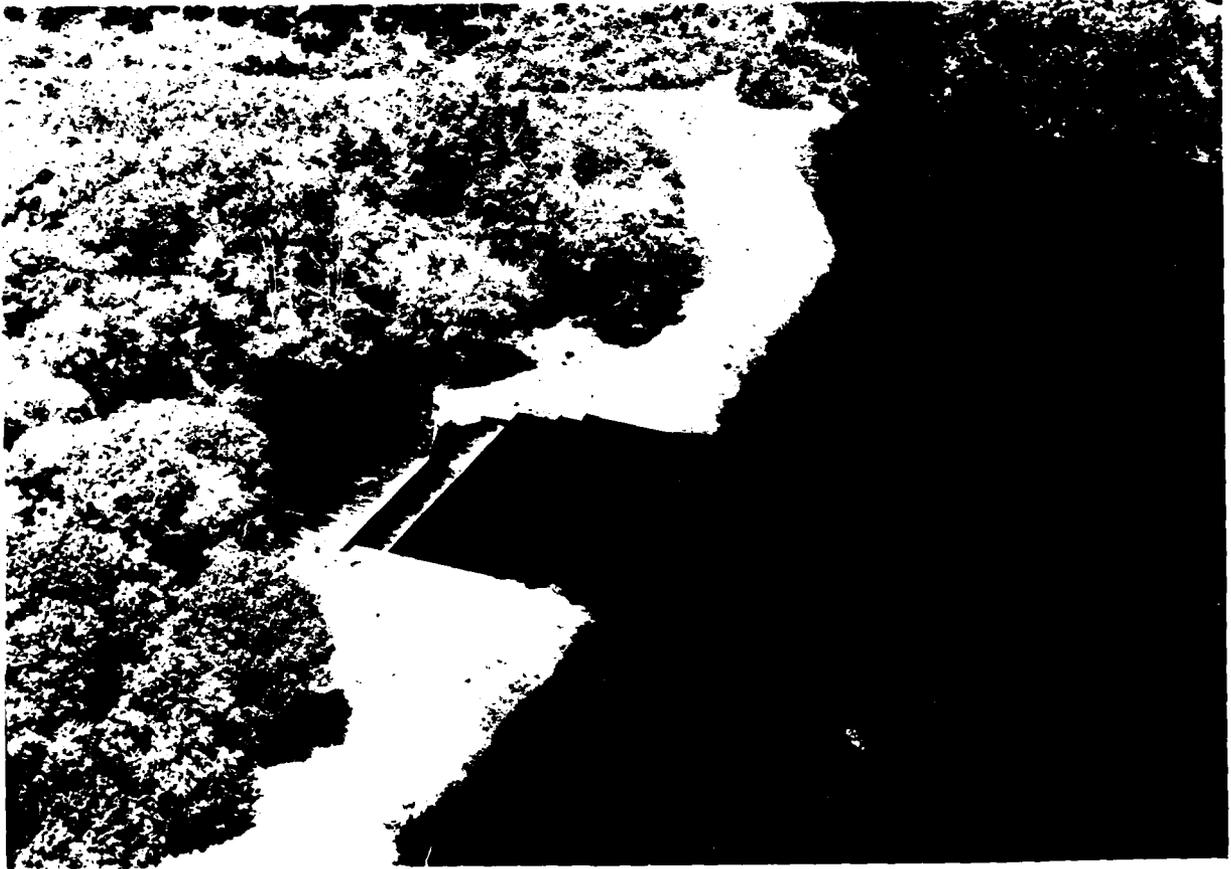
C-2 PACHAUG POND DAM - LOOKING NORTH

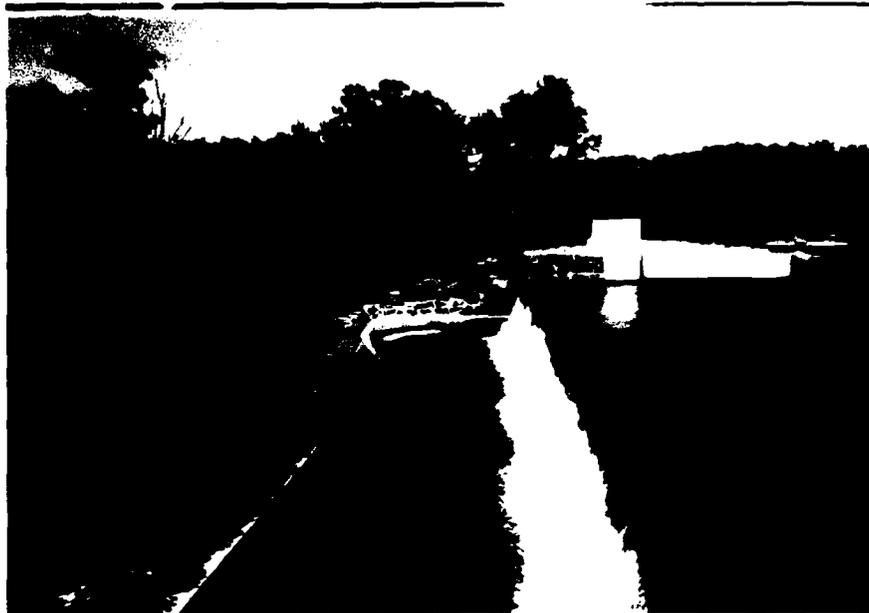
C-3 SPILLWAY CREST, RIGHT TRAINING WALL, GATEHOUSE  
AND DOWNSTREAM STILLING BASIN

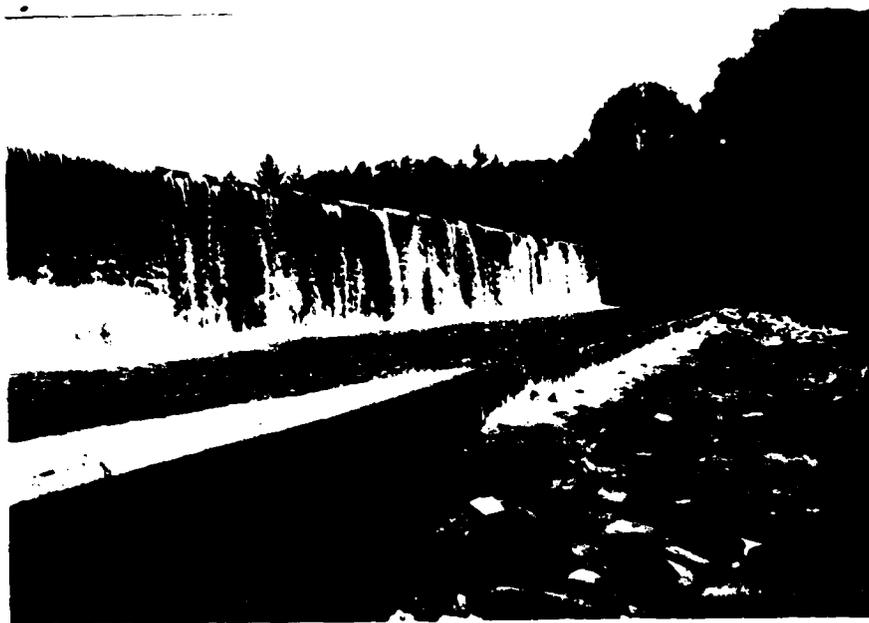
C-4 SPILLWAY CREST, DOWNSTREAM CHANNEL BED AND  
LEFT TRAINING WALL

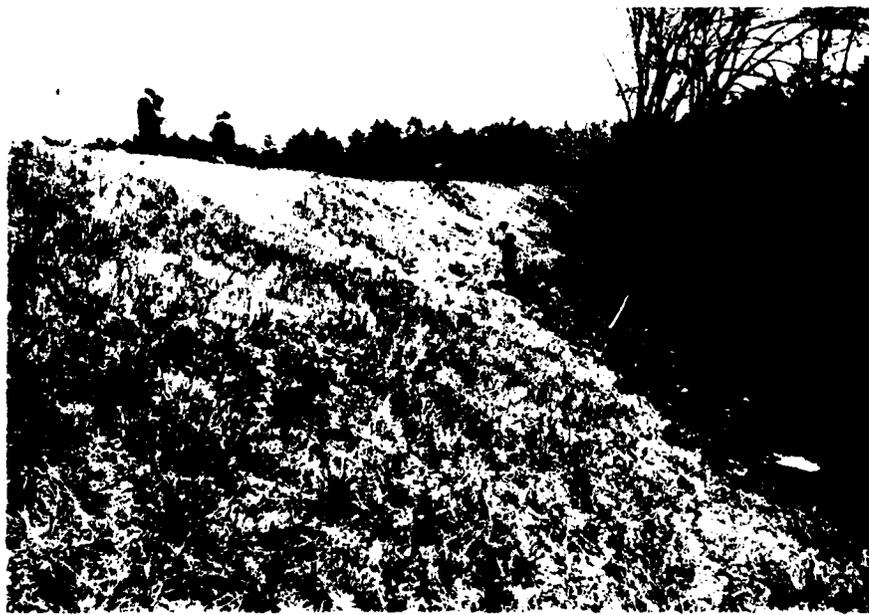
Based on the approximate observed cross section, the seepage appears to exit on the downstream side of the right embankment at a level higher than would be expected if this dam were homogeneous in cross section and permeability. The exit point at one location is shown on a cross-section sketch in Appendix B, and the seepage pond it creates may be seen in Photo C-11. The person standing on the downstream slope (See Photo C-12) is approximately at the top exit point of the seepage.

1. Seepage was observed emerging from the downstream slope of the dam embankment at levels higher than usual for a dam of this type. High water levels in the pond could lead to internal erosion and eventual failure, because the seepage is not controlled. The presence of decaying roots on both the upstream and downstream sides increases the probability of failure by internal erosion. There is no evidence of any wing wall or cutoff from the spillway walls into the embankment. Internal erosion could occur at this location, although no leakage was observed at the time of inspection.

C-12 DOWNSTREAM FACE OF EARTH EMBANKMENT. (note: seepage area to right below level of inspector standing on slope.)

It is recommended that the owner obtain the services of an engineer experienced in the design of earth dams to evaluate and design a seepage monitoring system to effectively collect and monitor these flows; develop a program for the procedure and timely removal of rotting tree stumps and roots along both upstream and downstream slopes of the dam; further, to analyze the embankments with regard to the spillway test flood for slope protection and freeboard allowances. A more detailed investigation should be made of the hydraulic and hydrologic aspects of the site to determine the impact of upstream dam failures and storage at Pachaug Pond because of the large contributing drainage area.
