US Army Corps
of Engineers
Construction Engineering
Research Laboratory

TECHNICAL REPORT M-347
June 1984

INVESTIGATION OF TRI-SERVICE HEAT DISTRIBUTION SYSTEMS

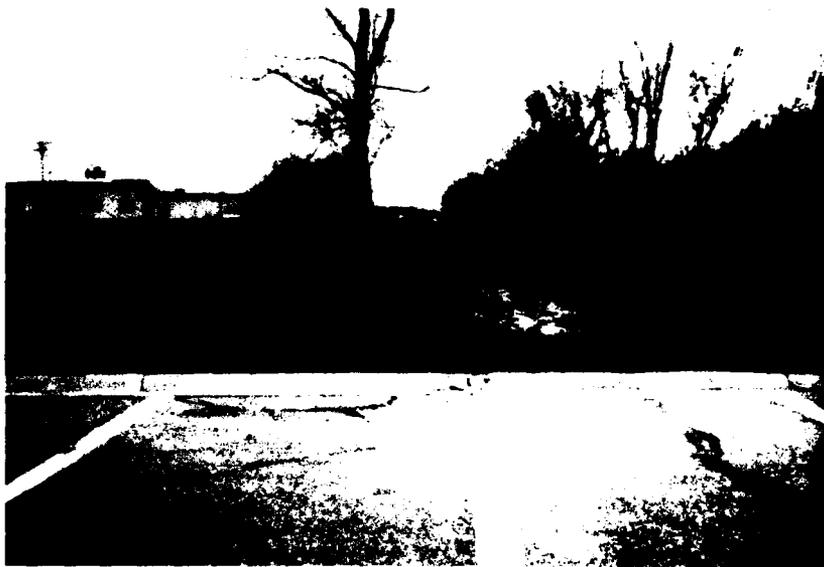
Figure 7. Missing grass above line (L7-7).

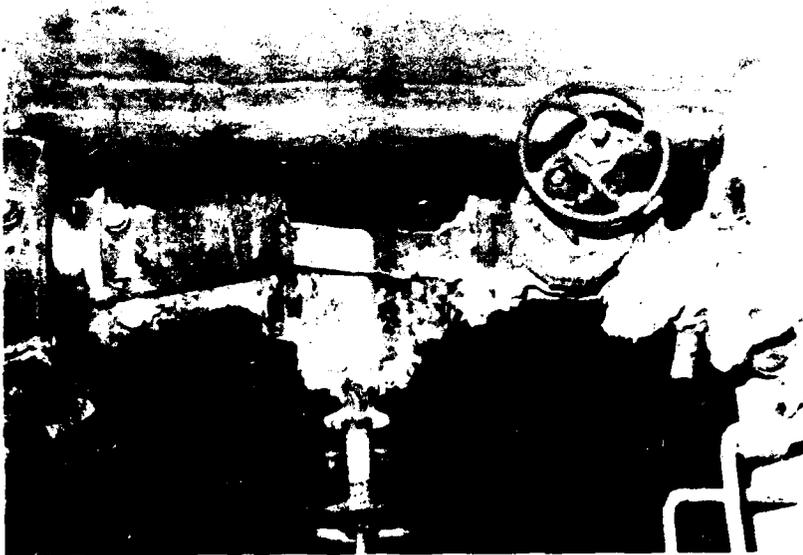
Piping and Components. Piping and components in manholes were often observed in poor condition (Table 5). Problems included corrosion, damaged or missing insulation, and leaking valves. Figure 10 shows rusted piping in a partially flooded manhole. Figure 11 shows seriously damaged insulation, piping, and end plates in a manhole which had been repeatedly flooded. Poor manhole design leads to insulation damage during maintenance operations, since maintenance personnel must often stand on the pipes to do their work. Inadequate drainage and ventilation of manholes causes corrosion of piping and components. Several leaking valve stems were observed; valves were often allowed

Figure 11. Corroded manhole piping and components (L3-10).

to leak for long periods of time. Using higher-quality valves, which would leak less frequently, should be investigated.

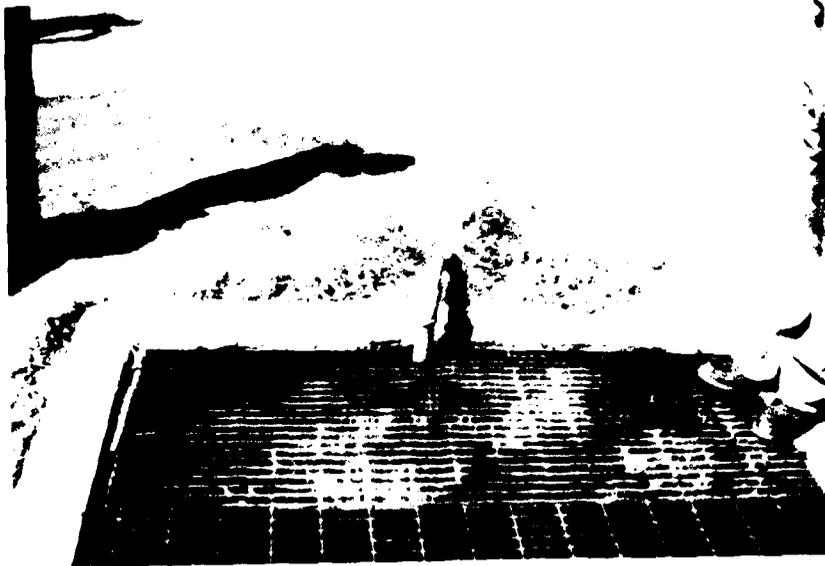
Figure 12. Drainage of surface water into manhole (L3-10).

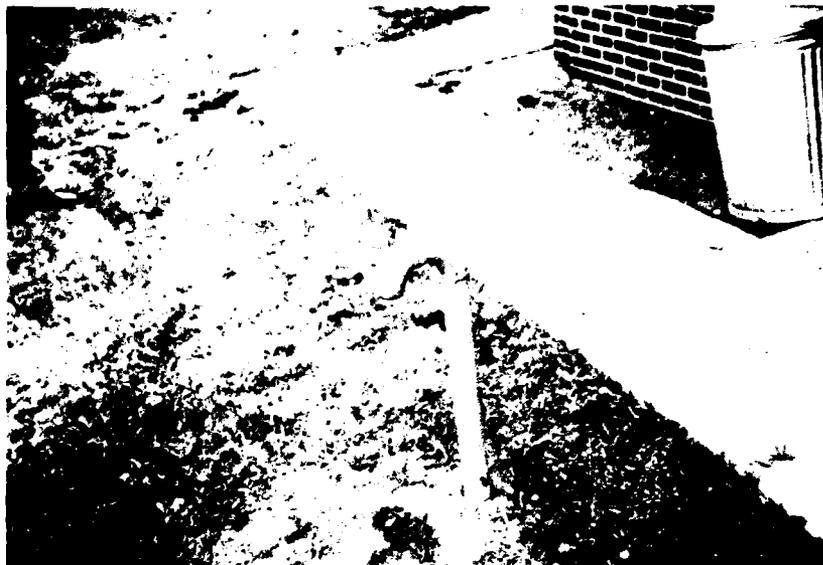
Figure 14. Vent pipe for conduit interior installed outside manhole (L7-8).

Vent Pipe. Conduit ventilation was found to be inadequate in many instances because of vent pipe problems. Failure to incorporate existing design guidance into design and construction resulted in the vent pipes being placed at the bottom or sides of conduits, failure to install vent pipes, and failure to open vents (Table 5). At several sites, vent pipes did not extend out of the manhole. Although this is a satisfactory arrangement for grate-top manholes, it is not acceptable for concrete- or steel-top manholes, because the vents must be easily observed for evidence of conduit flooding. In one case, check valves were installed in vent lines, which is not allowed by current guidance, since it prevents the vent from steaming if the conduit floods.
