WESTFIELD RIVER BASIN
WEST SPRINGFIELD, MASSACHUSETTS

**BEARHOLE RESERVOIR
MA 00073**

**PHASE I INSPECTION REPORT
NATIONAL DAM INSPECTION PROGRAM**

JUNE 1981

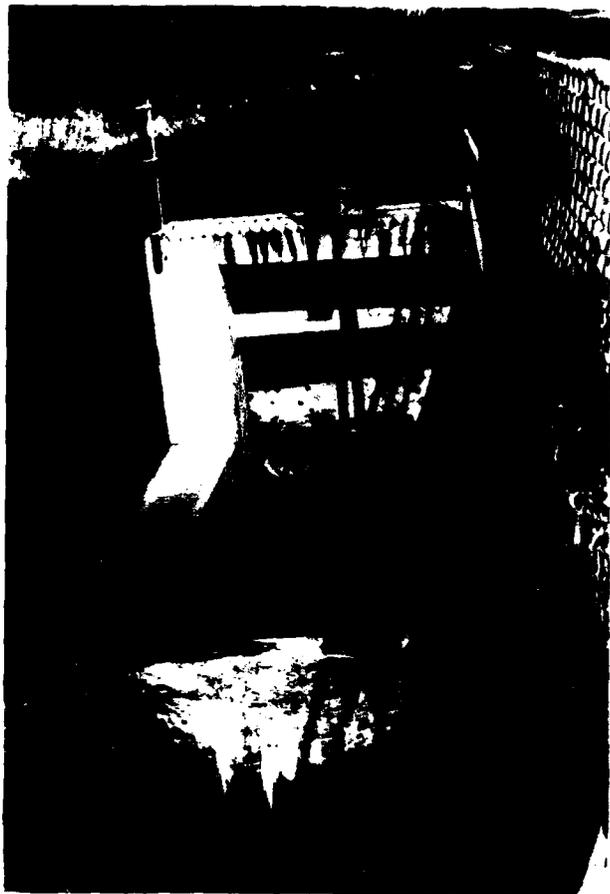
(b) Operating Facilities. A flashboard consisting of 3/4 inch plywood and approximately 24 inches in height can be installed at the 6 foot long spillway. Considerable seepage is flowing around this flashboard. The bench stands and hand crank operators for the control valves are well maintained and operable (see Photos No's. 5, 6, and 7). It is reported that all sluice gates, except the 30-inch by 36-inch sluiceway, are operated at least once a year. The 30-inch by 36-inch sluice gate for draining the reservoir has reportedly never been opened. Spalling and surface erosion have occurred on the spillway structure (see Photos No's. 5, 6 and 7). The footbridge, railing, and chain link fence are in good condition.

PHOTO NO. 5
 VIEW OF END WEIR ON SPILLWAY
 AND OPERATOR FOR GATE ON
 RESERVOIR DRAIN

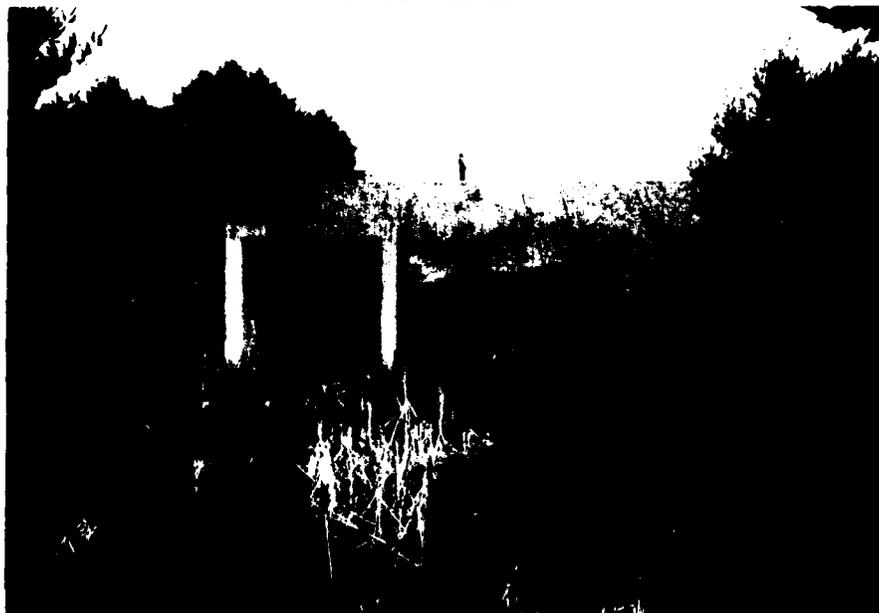
The outlet structure consists of a 127 foot long, 12 x 12 foot reinforced concrete conduit with an 18-inch thick roof and sidewalls. The concrete encasement for the 24-inch raw water supply line is located on the left side of this structure, terminating approximately 10-feet from the outlet end of the culvert. With the exception of minor surface erosion on the invert slab, the culvert is in good condition. A 24-inch diameter access manhole is bolted in place at the terminating end of the concrete encasement.

PHOTO NO. 8
 VIEW OF SLUICWAY OUTLET LOOKING UPSTREAM.
 NOTE CONCRETE ENCASEMENT FOR RAW WATER SUPPLY
 LINE IN LOWER RIGHT CORNER OF SLUICWAY.
