NATIONAL PROGRAM FOR INSPECTION OF NON-FEDERAL DAMS  
LOWER MERINO POND DAM. (U) CORPS OF ENGINEERS WALTHAM  
MA NEW ENGLAND DIV OCT 78

LOWER MERINO POND DAM  
MA 00109

PHASE I INSPECTION REPORT  
NATIONAL DAM INSPECTION PROGRAM

OCTOBER 1978

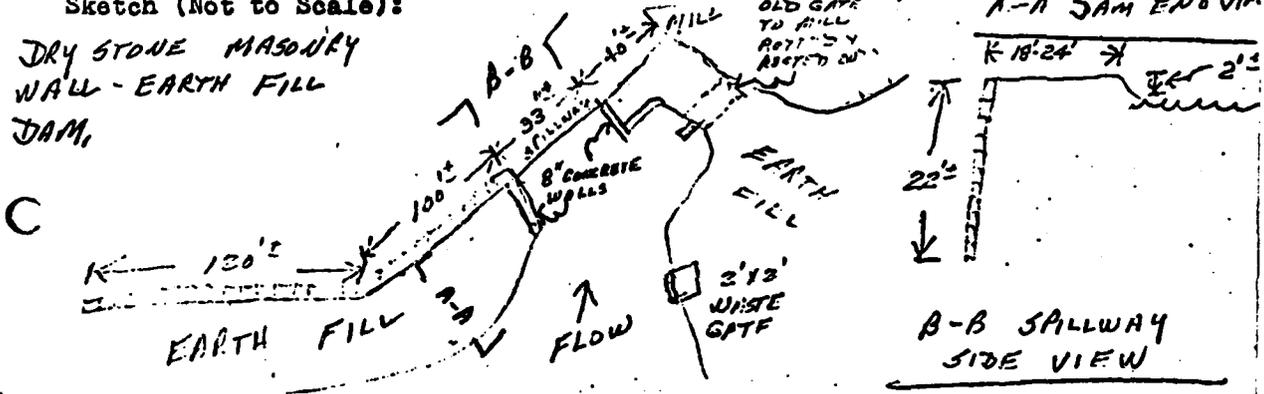
General Description of Dam and Discharge Control: 1/2:1 DRY WALL - EARTH -  
SIPRAD SPILLWAY LEN. = 23' ± ... WASTE GATE 2'x2'.  
NUMEROUS MEDIUM LEAKS AT BASE OF DAM. NO APPARENT DANGER  
SPUSH TO 18" TREES GROWING ON TOP OF DAM. ONE 4" MAPLE  
GROWING OUT OF FACE OF ABUTMENT WALL  
 Sketch (Not to Scale):

Remarks and Recommendations:  
 WASHOUT BEHIND WESTERLY WALL AT SPILLWAY, SHOULD BE WATCHED.

6.5' LONG  
 1.5' WIDE  
 3.0' DEEP
