MERRIMACK RIVER BASIN  
TOWNSEND, MASSACHUSETTS

TOWNSEND HARBOR DAM  
MA 00138

PHASE I INSPECTION REPORT  
NATIONAL DAM INSPECTION PROGRAM

JUNE 1979

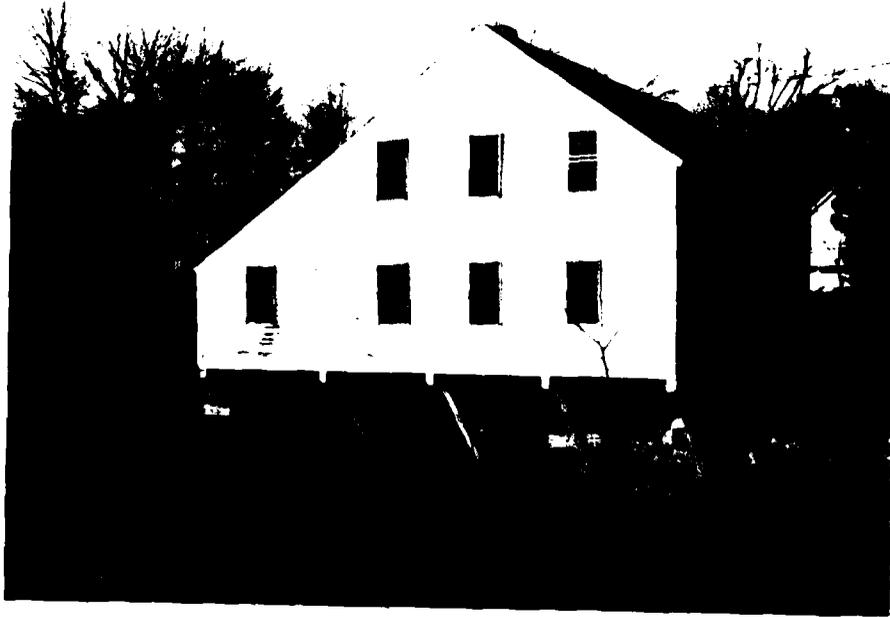
4. VIEW OF THE "COOPERAGE" FROM DOWNSTREAM RIGHT BANK OF SQUANNACOOK RIVER.

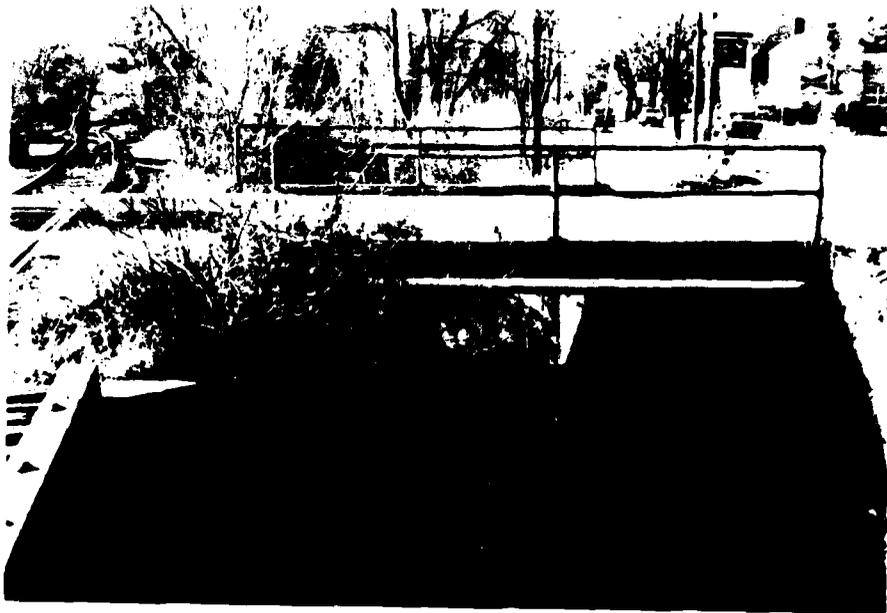
8. DOWNSTREAM FACE OF SOUTH HARBOR ROAD OVER MILLRACE.
