HASKELL POND DAM
MA 00155

PHASE I INSPECTION REPORT
NATIONAL DAM INSPECTION PROGRAM

DEPARTMENT OF THE ARMY
NEW ENGLAND DIVISION, CORPS OF ENGINEERS
WALTHAM, MASS. 02154

SEPTEMBER 1979

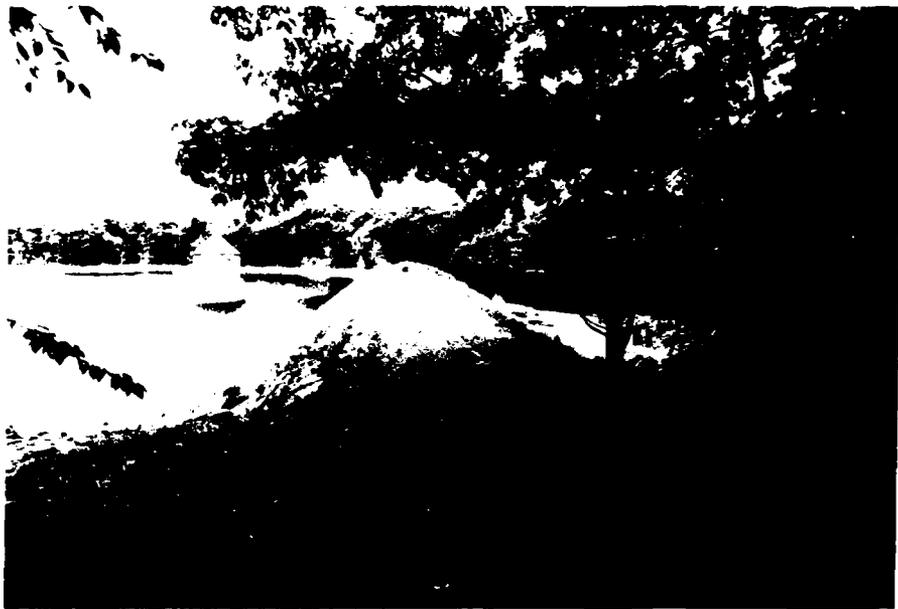
1. Overview of Haskell Pond Dam

On the top of the dam there is a one-lane gravel roadway with a thin layer of broken rock as a surface, Photo No. 1. The top of the dam measured about 17 ft. in width at the right end. The gravel roadway itself, which is about 3 to 6 in. higher than the shoulder areas, is about 10 ft. in width. The crest of the dam has been cleared of brush over about two-thirds of its length at the right end. At the left end, at the location of an abandoned cast iron emergency supply pipe which crosses the crest of the dam and the spillway, brush has not yet been cleared.

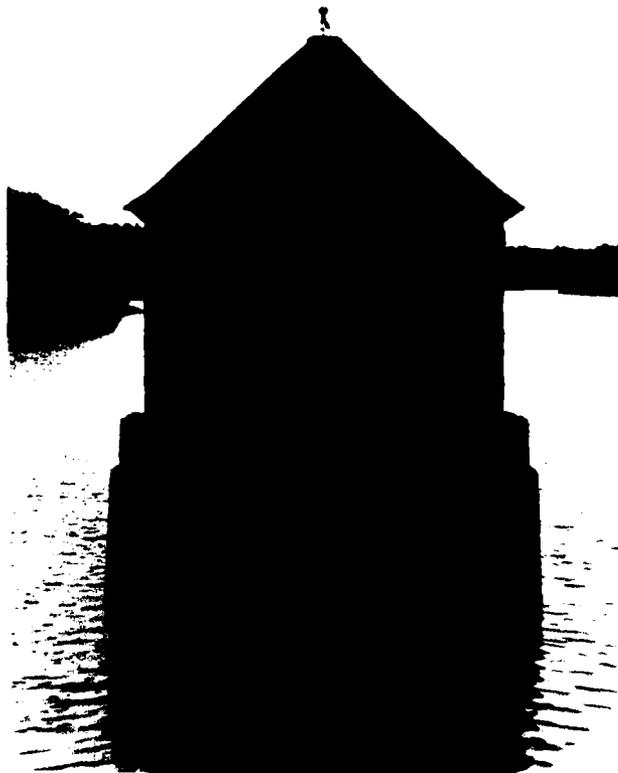
The roof of the outlet gatehouse has many bullet marks and a few missing slates. The portion of the roof facing the dam needs to have the major portion of the slates replaced. The brickwork is in good condition. There are some bullet marks and some minor loss of mortar in the joints. Traces of efflorescence were observed on the brickwork. The concrete base is sound, but there is some surface deterioration. The exterior of the outlet gatehouse is shown on Photos No. 4, 5, 6 and 11.

4. Circular intake structure with reservoir level guage

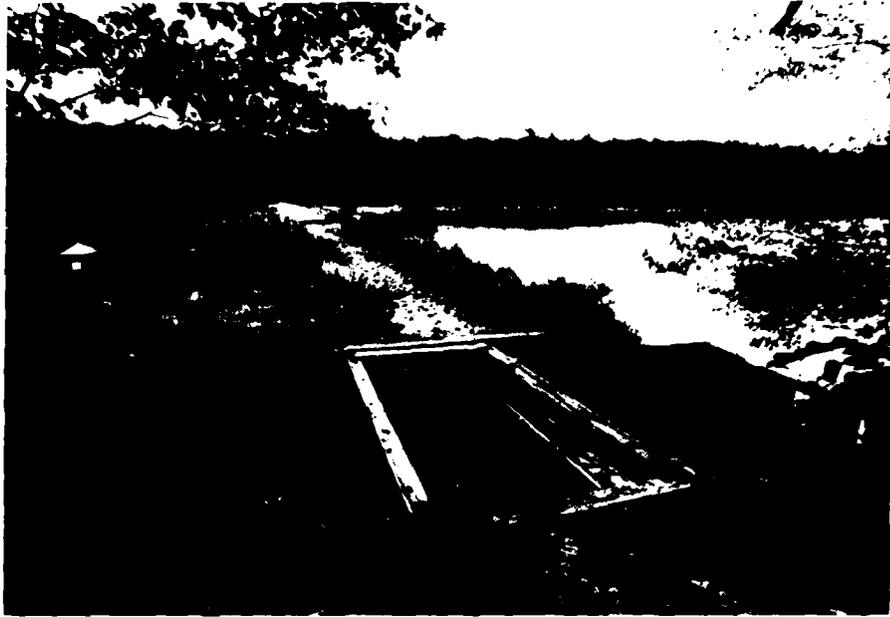
The chute discharge channel from the spillway appears to be in good condition. The invert of the chute is stone masonry, Photos No. 8, 9 and 10. Vegetation is very heavy on the left side and somewhat lighter on the right side of the chute, Photo No. 10. Many trees overhang the channel from the left side. It appears that there has been a buildup of earth at the transition between the spillway and the chute on the right side of the discharge channel, Photos No. 8 and 9. A small amount of loose overhanging rock is present at the upstream end of the chute on the left side.

8. Spillway weir and approach channel

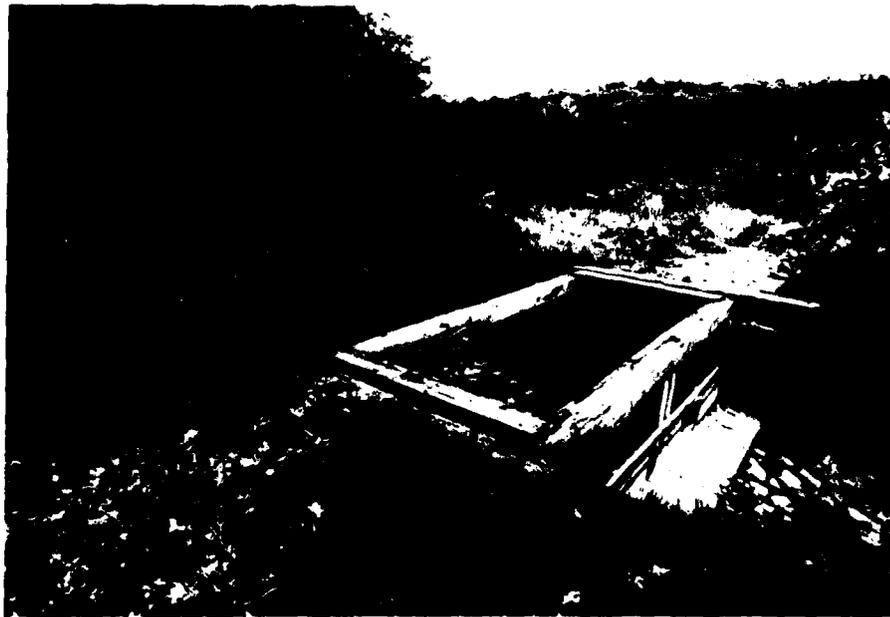
It appears that the remains of an old timber bridge across the spillway are present just downstream of the flashboards. The timbers are in poor condition. The upstream timber forms an additional support for the flashboards. Vegetation is present in the area just downstream of the flashboards at the invert of the spillway, Photo No. 9. Only slight efflorescence was observed on the concrete side walls.

9. Spillway weir and discharge channel

Remedial measures, including supplying access to the intake gatehouse, making sure gate valves for pipes through the embankment can be closed at the upstream end, removing flashboards and timber beams from across the spillway, completing brush removal, monitoring seepage near the toe on the right side, clearing vegetation along the spillway discharge channel and repairing the gatehouses and reservoir drain gate valves, as outlined in Section 7.3, should be implemented by the Owner within one year after receipt of this report. The Owner should also prepare a formal operations and maintenance manual for the dam and update the emergency preparedness plan.
