PARKER MILLS POND DAM

MA 00150

PHASE I INSPECTION REPORT
NATIONAL DAM INSPECTION PROGRAM

JULY 1981

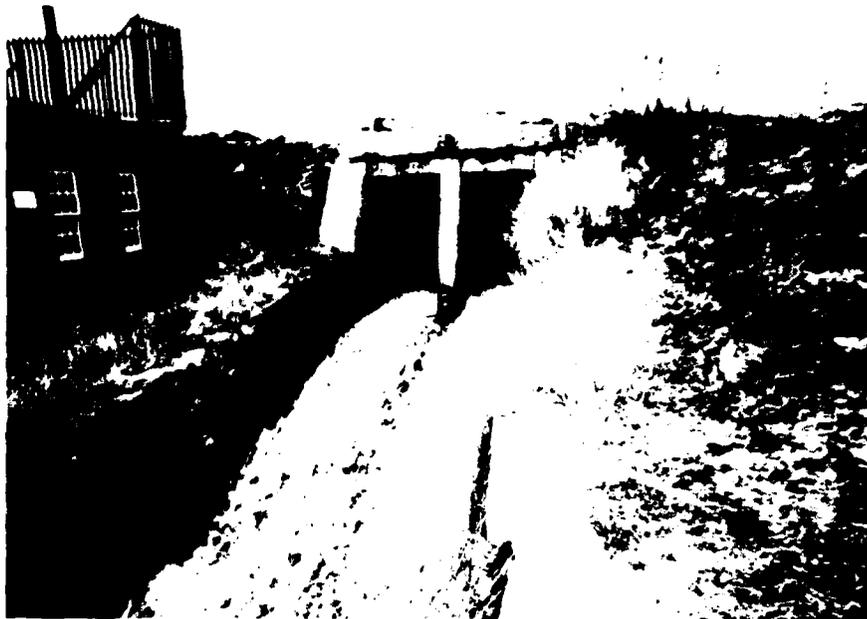
The right spillway structure (referred to as the "Main Spillway" in inspection reports) is also a concrete structure with a stone and mortar upstream face wall and a weathered concrete roof. The culvert under the roadway could not be observed. The concrete at the structure's roof was in generally poor condition with much spalling and exposed reinforcing evident (Photo # 5 &

6). The concrete for the observable portions of the walls and floor of the structure appeared in fair condition with no visible reinforcing or major spalling evident. Maximum stoplog height is 11.8 ft. , the stoplogs were in good condition.

Photo # 5 Right spillway structure

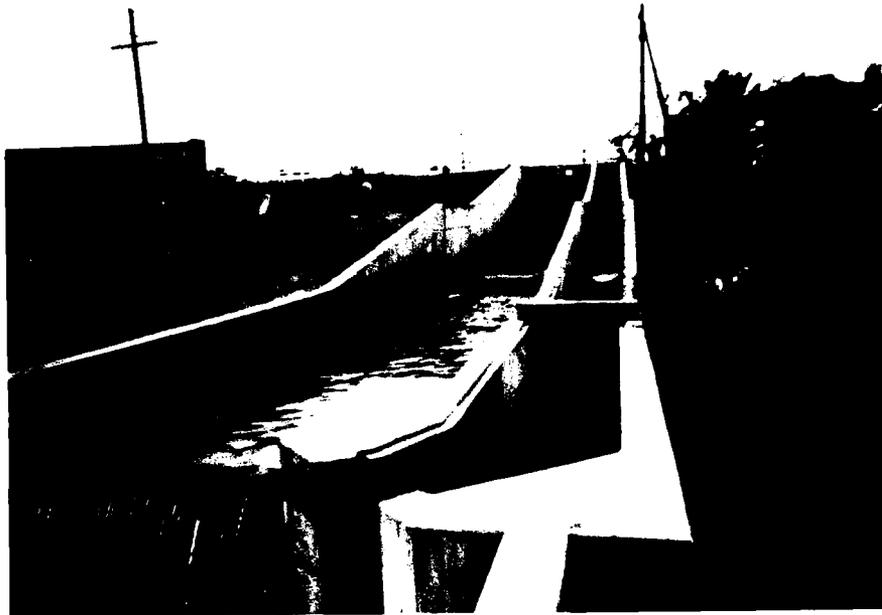
The left spillway discharge channel is generally clear of obstructions with some rocks, cans and litter scattered across the channel. The concrete channel floor and walls are intact, the concrete is in good condition (Photo # 7). The stone wall adjacent to the left side of the channel is also generally intact although several blocks have fallen out of one small section of the wall.

Photo # 7 Discharge channel, stilling basin, and fish ladder
left spillway
