NATIONAL PROGRAM FOR INSPECTION OF NON-FEDERAL DAMS
MERRIMACK RIVER BASIN.. (U) CORPS OF ENGINEERS WALTHAM
MA NEW ENGLAND DIV SEP 79

LAWRENCE RESERVOIR

**OVERVIEW
LAWRENCE RESERVOIR**

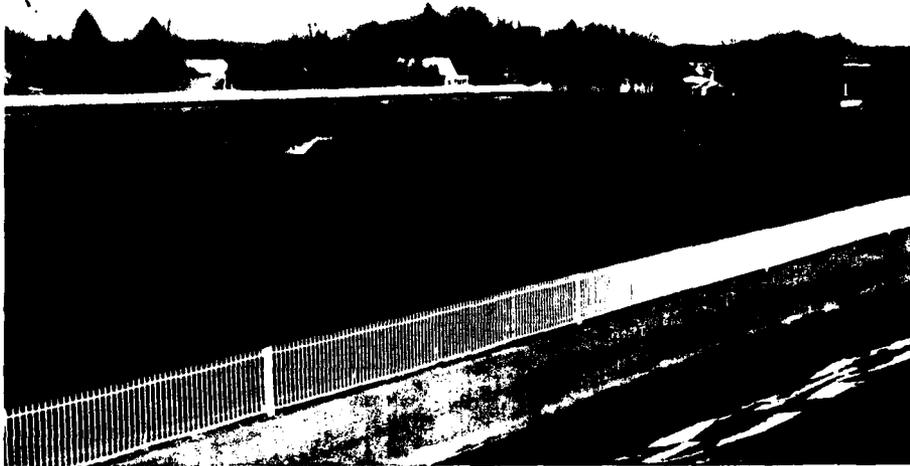
**NO. 1 VIEW OF INFLOW CONDUIT AND DIKE
SEPARATING NORTH & SOUTH BASINS**

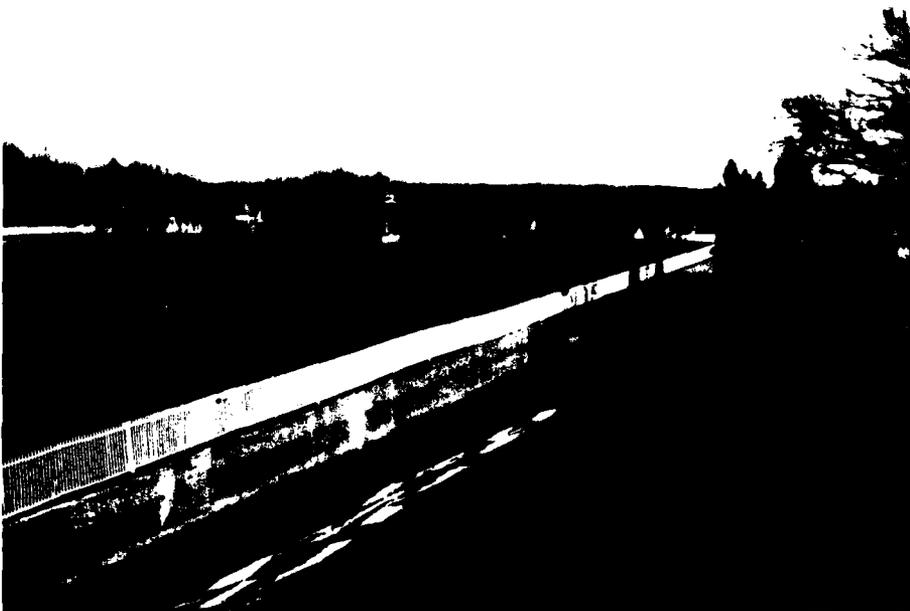
NO. 2 VIEW OF WEST SIDE OF RESERVOIR AND GATE HOUSE

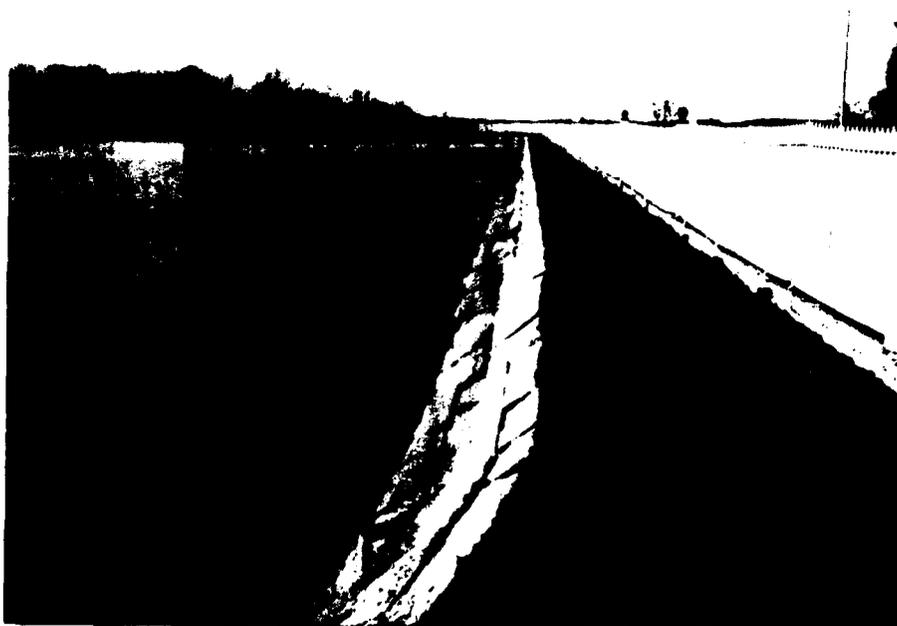
NO. 4 LINER ON INSIDE SLOPE OF RESERVOIR

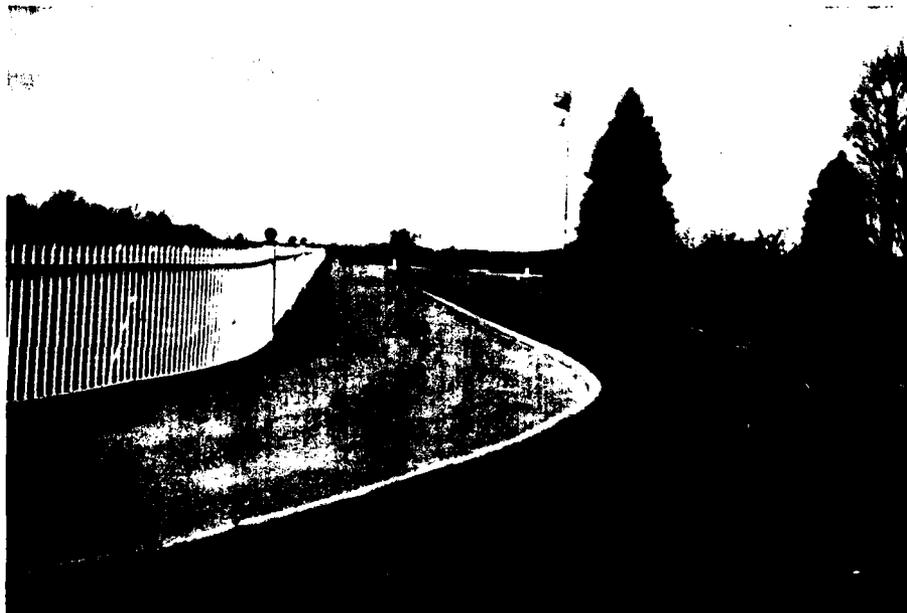
NO. 7 CREST OF EMBANKMENT ON EAST SIDE OF RESERVOIR
