Ludlow and Cherry Valley Dams, which impound Springfield Reservoir, are in good condition. Based upon visual inspections, the reservoir dams are maintained in good operating condition with a continual maintenance program.

PHASE I INSPECTION REPORT
LUDLOW & CHERRY VALLEY DAMS
MA 000547 & MA 000548

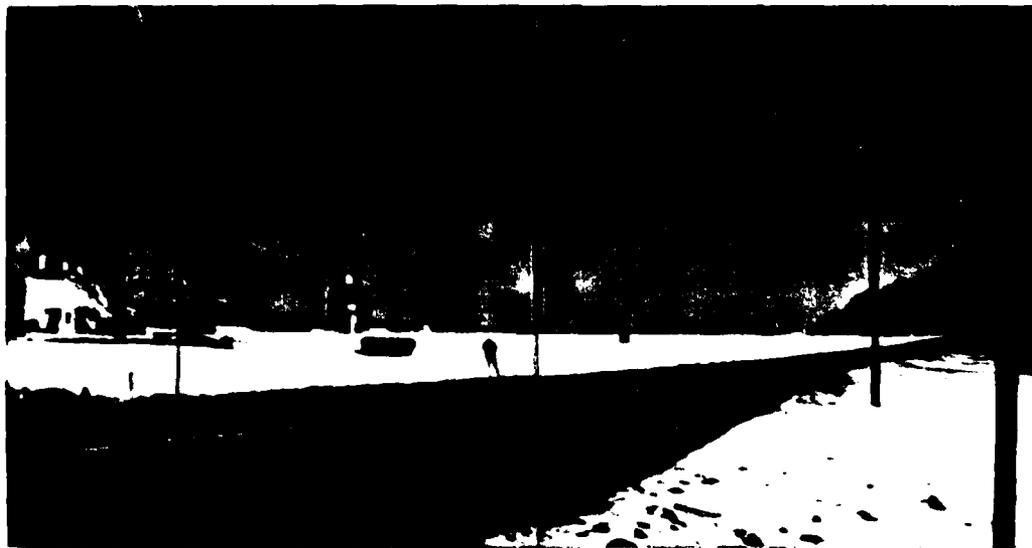
Photograph #3

Ludlow Dam - Downstream
View on Southerly Side
of Route 21

b. Ludlow Dam. There was no evidence of problems with Ludlow Dam or the two upstream dams that separate the filter and settling pools. A minor amount of seepage with soft ground was noted between the dam and the highway located approximately 300 feet below the dam. Water was found bubbling up near a culvert passing under Route 21, downstream of the dam. Further investigation by the superintendent and others revealed the source to be an old catch basin for the drainage layout of old Rte. 21, that had not been plugged with reconstruction of the road. There was no evidence of problems with the two upstream dams that separate the filter and settling pools.

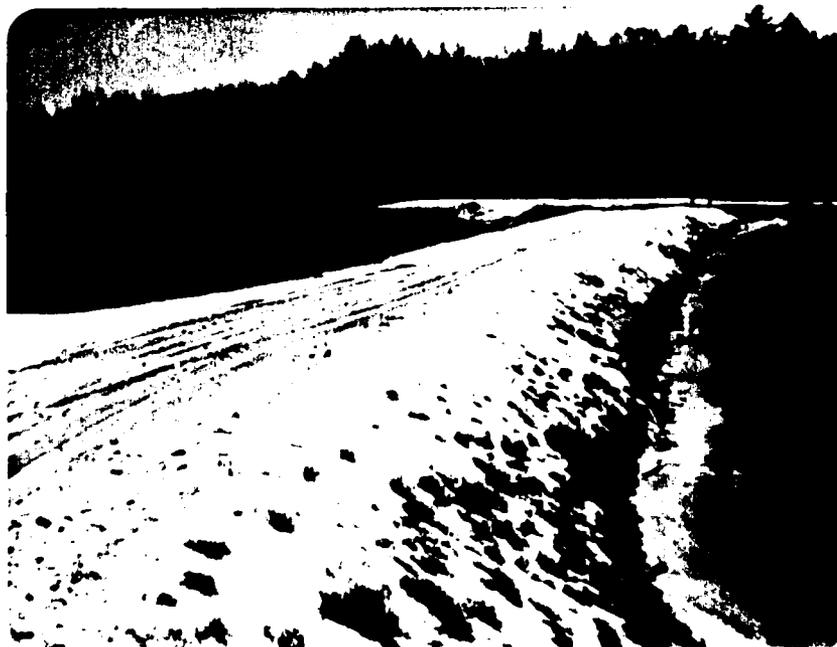
Photograph #5

Dams Upstream of Ludlow Dam
Separating Filter & Settling Basins

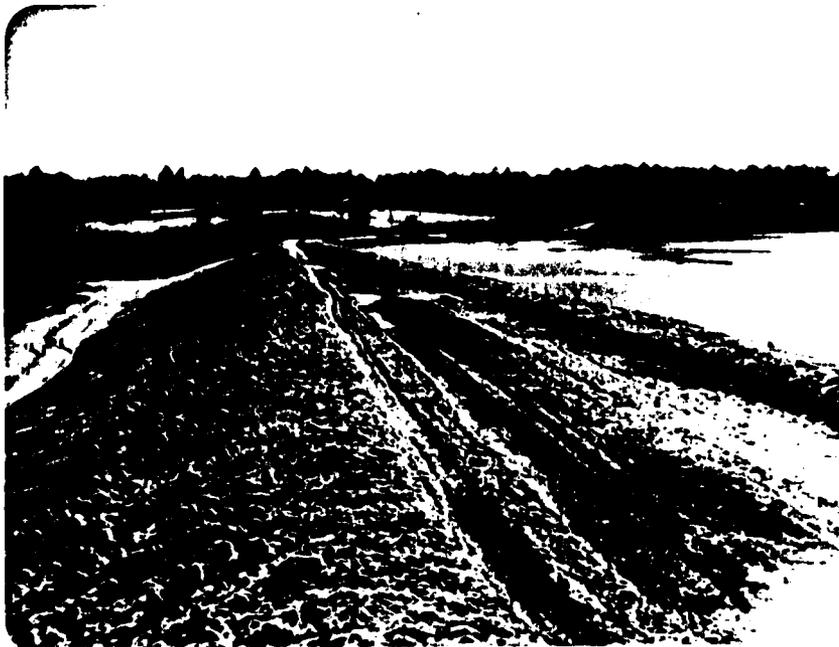
Photograph #14

Downstream View of Cherry
Valley Dam - Left Abutment

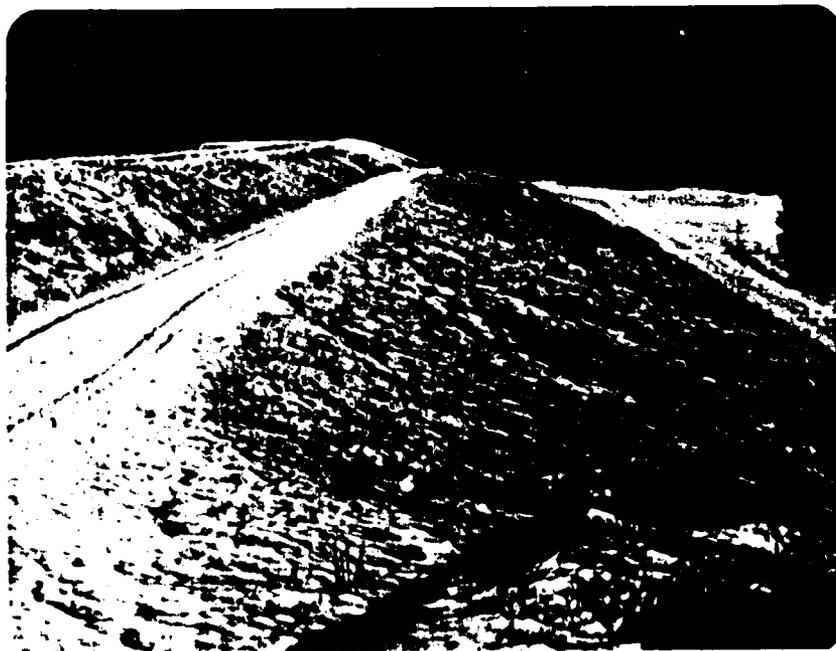
Photograph #15

Downstream View of Cherry
Valley Dam - Right Abutment
