TAUNTON RIVER BASIN  
BROCKTON, MASSACHUSETTS

WALDO LAKE DAM  
MA 00426

PHASE I INSPECTION REPORT  
NATIONAL DAM INSPECTION PROGRAM

MAY 1979

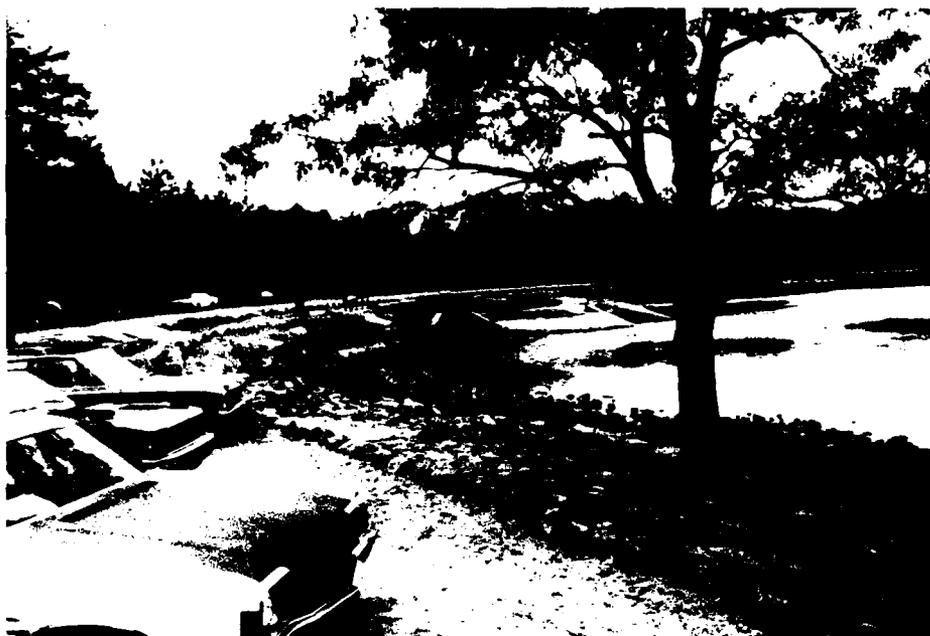
1. Overview of upstream face of dam and spillway from dike.

1. The upstream slope of the roadway embankment is relatively flat and generally protected by broken rock, cobbles and boulders to a level approximately 4 to 5 ft above the spillway crest. The slope protection has been locally displaced in some areas at and below the apparent high water line, as shown in Photos Nos. 1 and 2.

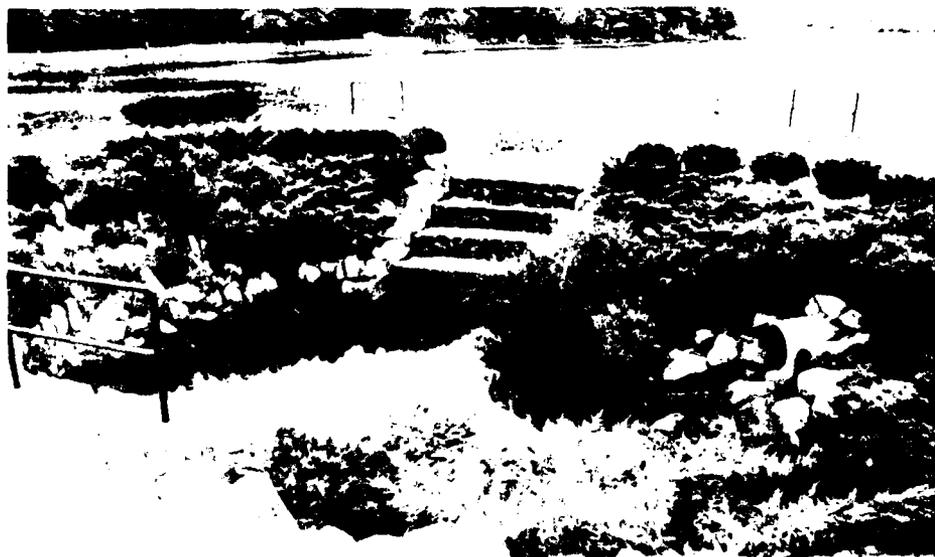
2. The upstream slope and crest of the dam embankments above the slope protection are generally mowed and clear of brush and trees. However, foot traffic has caused many bare areas to develop, especially near the spillway embankment, as shown in Photos 2 and 4.

1. The upstream slope protection has been locally displaced in some areas at or below the apparent high water line as shown in Photos 4 through 8.
2. Foot traffic has caused many bare areas to develop as shown in Photos 4 through 8.

4. The downstream slope of the embankment is heavily planted with junipers and other shrubs that hinder visual examination, as shown in Photo 4. In some areas, the boulders retain the terraces which have been dislodged and have rolled down the slope. A small portion of the overall downstream slope is bare and eroding. No seepage was noted around the perimeter of the pool at the toe, although prior inspection reports indicate that minor seepage has been observed on the slope in the past.

9. Undercutting is present at the pipe outlets of the principal spillway and the ornamental bushes interfere with the discharge of the left reservoir drain as indicated in Photo 4.
10. Trees are present in the center of the discharge channel immediately downstream of the culvert through the dam as shown in Photo 10. It should be noted that the photograph distorts the stones present in the channel.

4. Overview of spillway from dam.

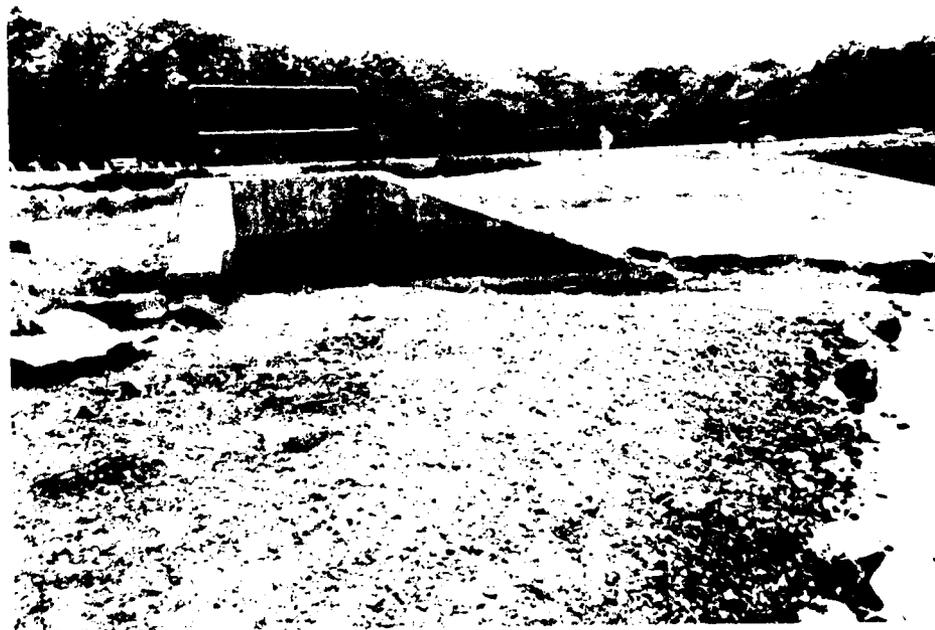
5. The headwalls of the principal spillway had some erosion of concrete present as shown in Photo 5.
6. The headwalls of the left reservoir drain and the right reservoir drain have significant deterioration especially at the elevation of normal water level as shown in Photos 6 and 8.

5. Upstream headwall of left spillway (principle spillway).

5. Remove silted materials, cobbles and debris from the principal spillway inlet.
  6. Patch eroded concrete areas at the principal spillway inlet and repair the upstream end of the overflow spillway sidewall.

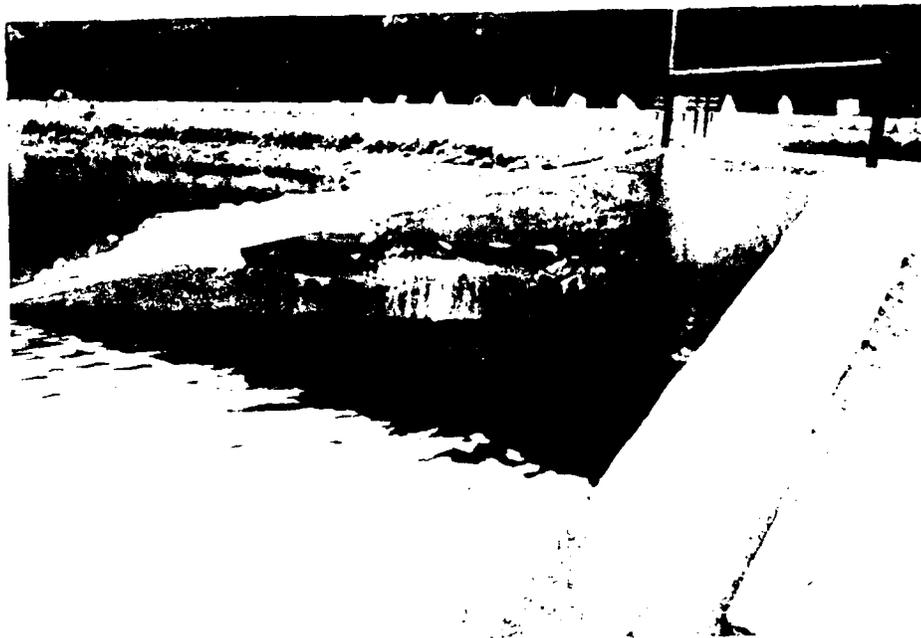
6. Upstream left wingwall of left reservoir drain.

1. An engineering investigation for the reconstruction or replacement of the deteriorated concrete entrance structures at the left and right reservoir drains. The work should include an investigation of the condition of the inlet valves, due to their prolonged period of inactivity and the valve being buried by debris.
2. An engineering investigation of the seismic stability of the dam and dike embankments.
3. A detailed hydrologic-hydraulic investigation to determine the adequacy of the spillway and discharge culvert and any necessary modifications to provide adequate capacity.

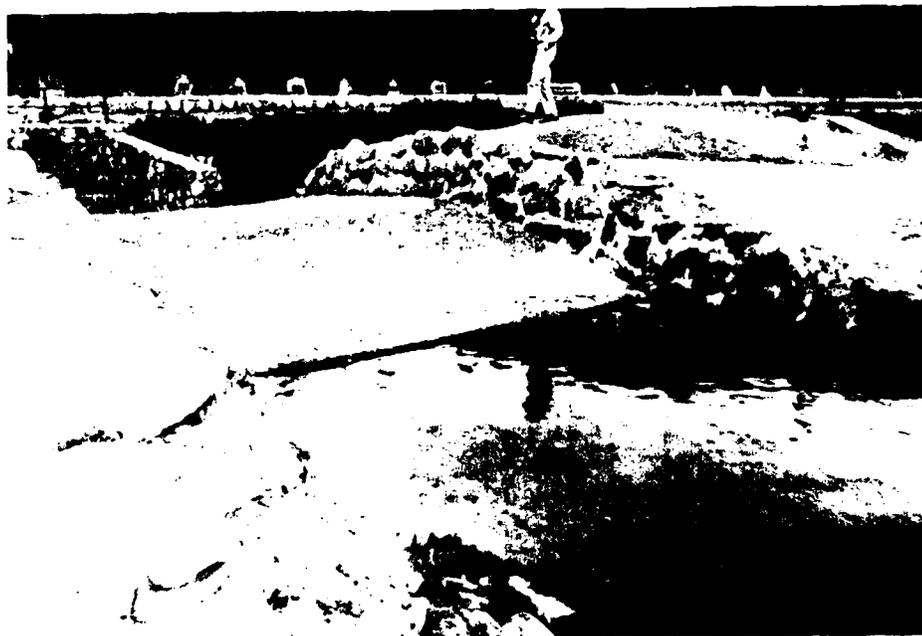
8. The upstream ends of the overflow spillway sidewalls have deteriorated.

7. Upstream right sidewall of emergency spillway.

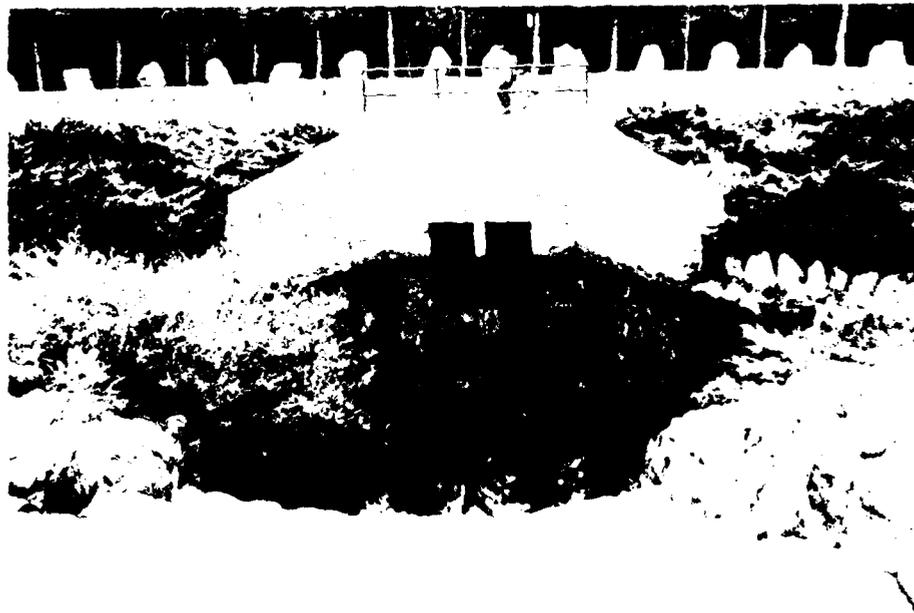
9. Spillway stilling pool and upstream face of culvert through dam.
