Due to the extent of downstream development that would be affected in the event the dam were to fail, Mill Pond Dam is classified as having a "high" hazard potential in accordance with Corps of Engineers guidelines.

The dam is in poor condition, based on a visual examination of the structure. Several major deficiencies were noted, although there was no evidence of major settlement, overall lateral movement or other signs of impending structural failure, or other conditions which would warrant urgent remedial action.

1. Overview of Mill Pond (Myrtle Street) Dam

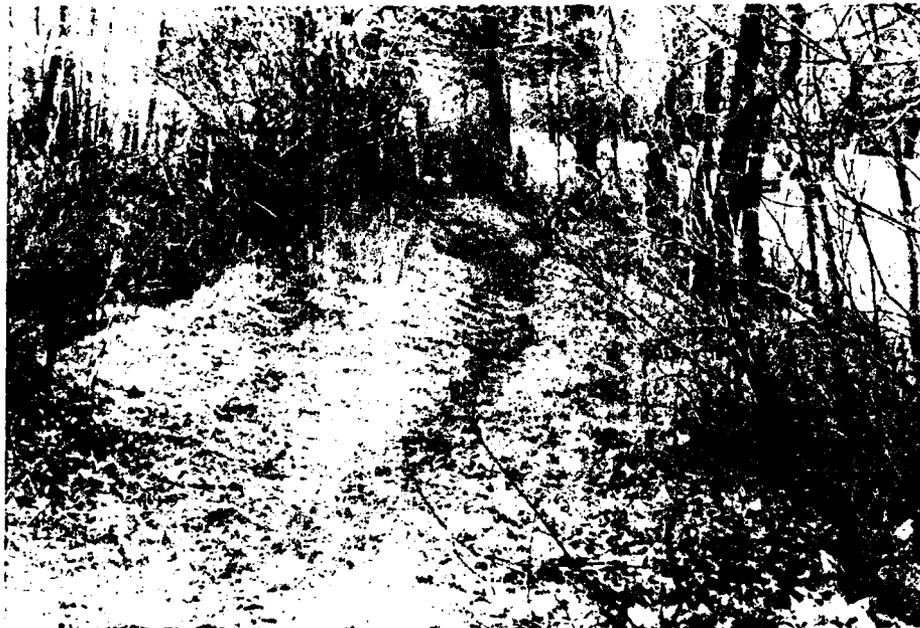
1. The upstream slope, crest and downstream toe are overgrown with brush, saplings and large trees up to 1 ft. in diameter, Photos No. 2 through 7. Tree roots have grown throughout the embankment and are exposed in eroded areas, Photo No. 5.
2. The stone wall on the upstream side has several stones dislodged, resulting in an unprotected shoreline in local areas, Photo No. 2. Soil loss and erosion is evident where the stone slope protection is missing.
3. The sloping top of the embankment is eroded and rutted by runoff and unrestricted foot traffic, Photo No. 3. As can be seen on Photo No. 8, taken when the water level was about 0.3 ft. below the top of dam following a storm in January 1979, the dam was being overtopped to the left of the blocked sluice gate outlet and sandbags were resisting further overtopping

3. Eroded path on top of earth embankment

1. Clear the earth embankment of trees and brush, remove stumps and major roots and place fill to restore the embankment cross-section or add additional fill to increase the existing embankment cross-section as determined by the results of the studies recommended in Section 7.2.1. Grass cover should then be established on the embankment and mowed several times each year.
2. Replace displaced stones and repair collapsed sections of the stone masonry walls on the upstream and downstream sides of the embankment and in the left spillway discharge channel.

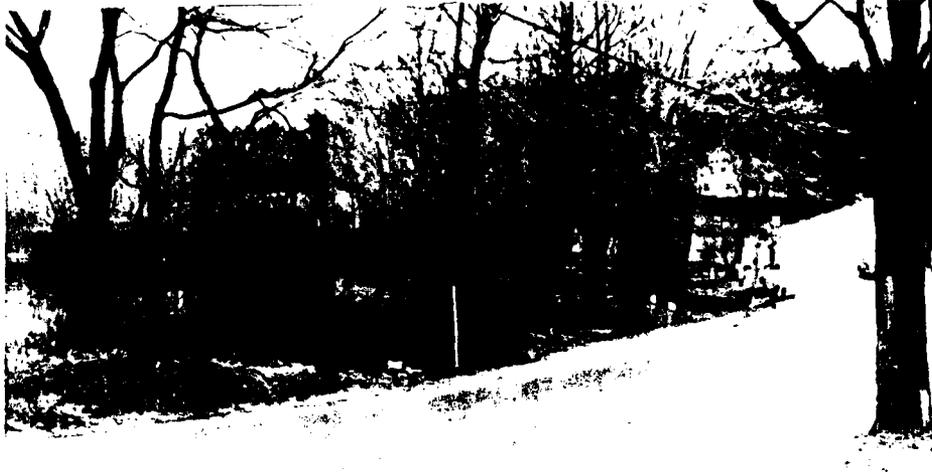
4. Overview of downstream side of earth embankment

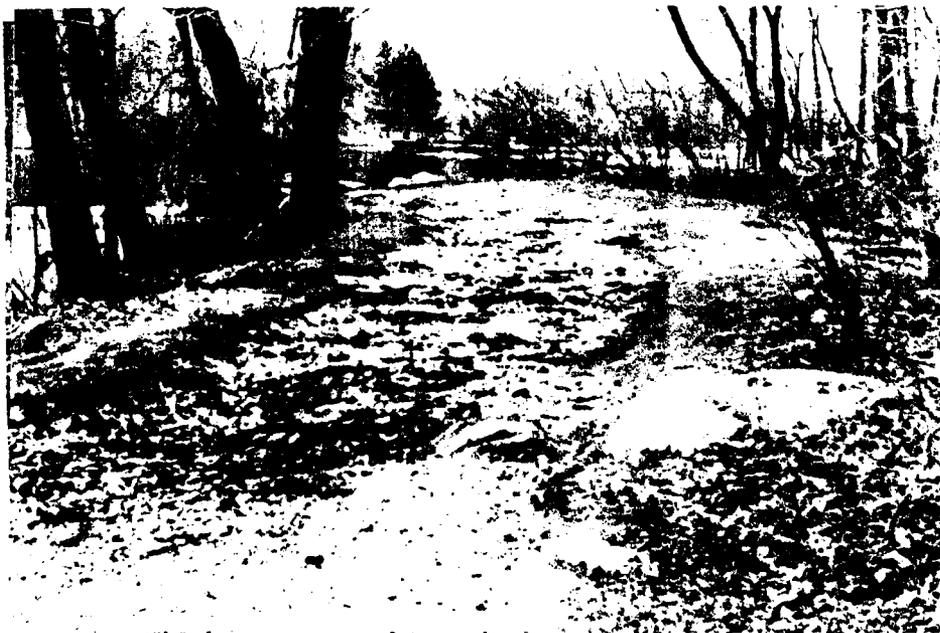
10. Badly eroded unpaved road at left abutment of dam

3. Repair upstream riprap protection and restore grade to top of dam at the left abutment.
4. Remove the flashboard supports on the spillway weirs, since they only serve to trap debris and further reduce the already grossly inadequate spillway capacity. This would also eliminate the possibility of anyone installing flashboards at the spillways.

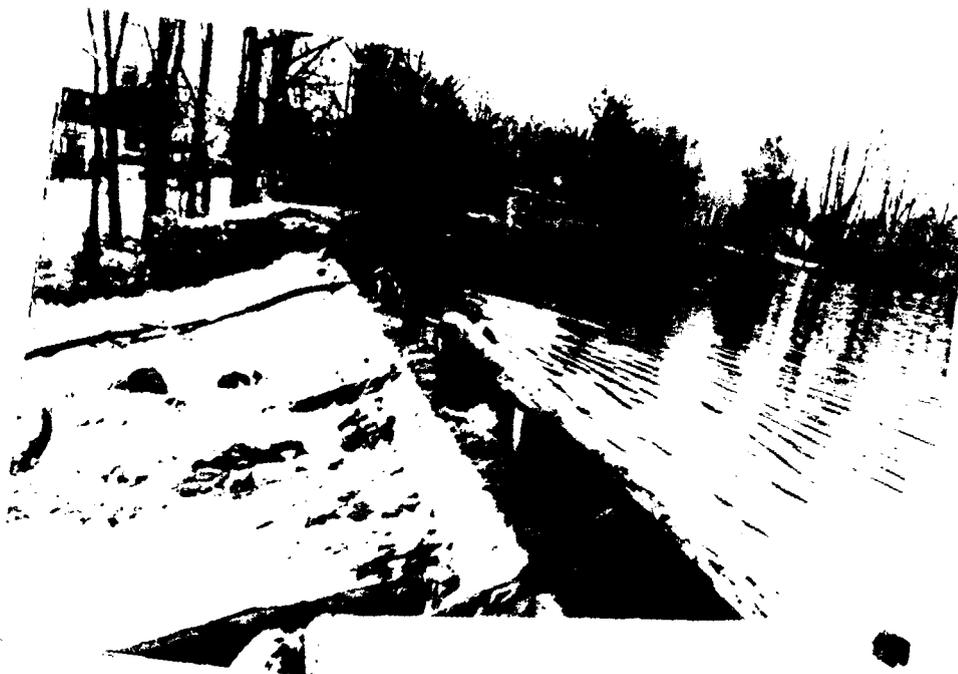
11. Weir and trapped debris at right (southerly)
spillway

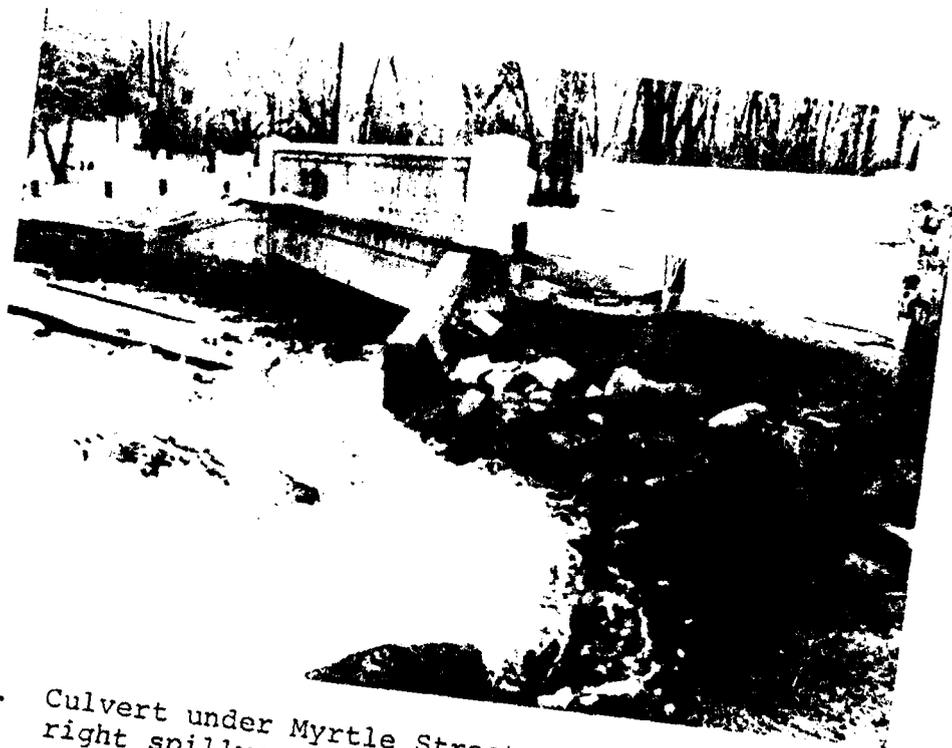
The remains of stone masonry walls can be seen on both sides of the cascades and discharge channels. Except for the left wall of the right spillway discharge channel, Photos No. 12 and 13, those portions of the stone walls which are still intact are in poor condition. Water could be seen flowing from the joints at the bottom of the remains of the right wall at the right spillway cascade, Photo No. 7. The left wall of the left spillway discharge channel is partially washed out, and part of the bank is undercut by about 4 ft., Photo No. 16.

12. Culvert under Myrtle Street downstream of
right spillway

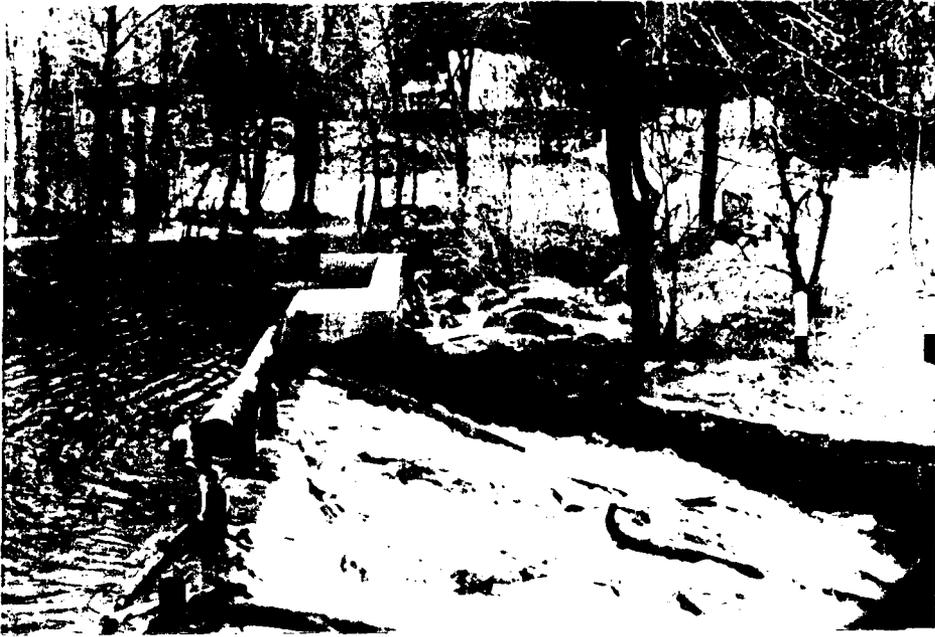
The general condition of the "L" shaped concrete wall, Photos No. 13 and 14, is good with some minor staining observed. The earth backfill on the downstream side has been washed out to about 3 ft. below the top of the wall, apparently most recently by overtopping of the wall in January 1979.

13. Concrete wall separating two spillways

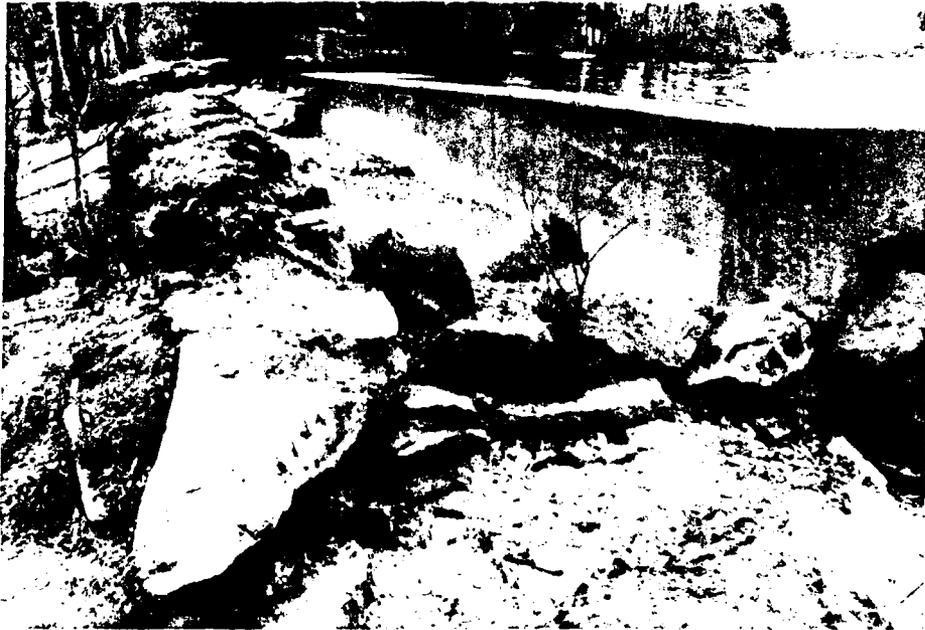
14. Eroded earth berm on downstream side of
concrete wall

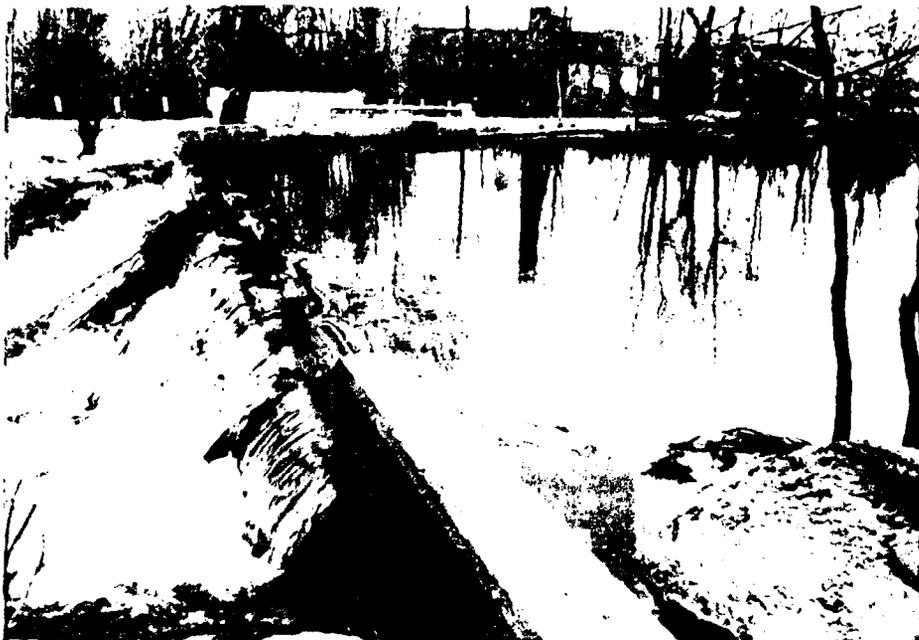
15. Weir and trapped debris at left (northerly) spillway

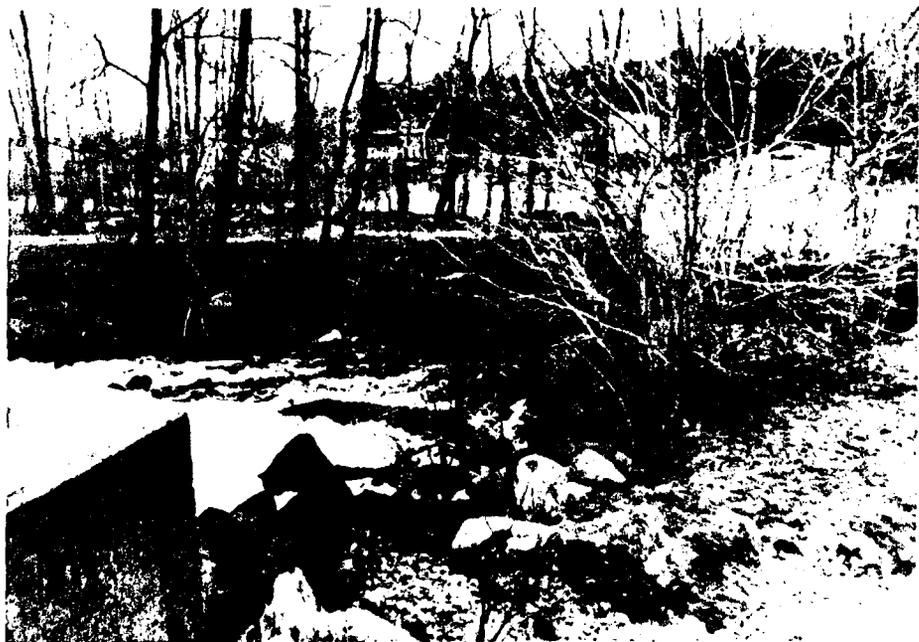
16. Bank undercut along left spillway discharge channel

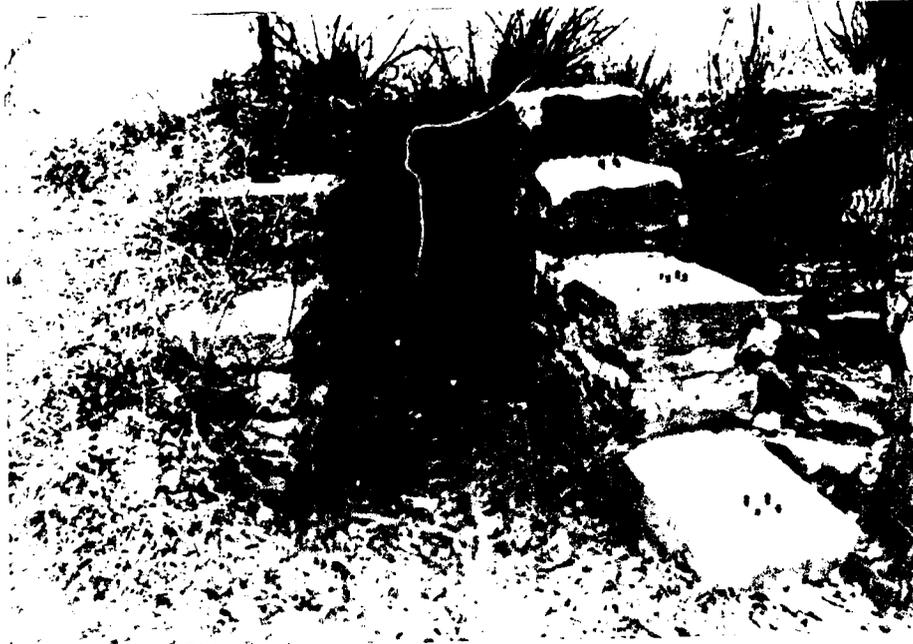
k. Regulating Outlets. There are no regulating outlets presently operational at this dam. There are provisions for flashboards at both spillways, but none were observed during the visual examination. About 25 ft. to the right of the southern spillway is an abandoned sluice gate outlet which is blocked up with concrete.

17. Sluice gate outlet in earth embankment blocked by concrete

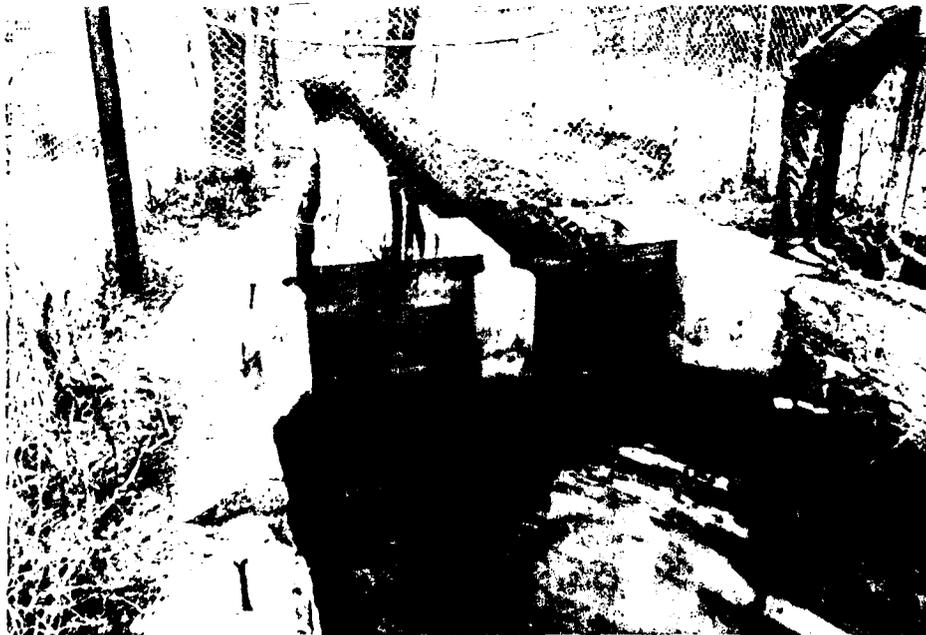
A water supply outlet channel with two 3 ft. wide by 8 ft. high slide gates at the entrance is located at the right abutment of the dam. The invert of the gates is about 5 ft. below spillway crest. The poor condition, configuration and nature of the controls in the drop structure and the outlets downstream of Myrtle Street would make the use of the water supply channel as a regulating outlet impractical. Furthermore, the outlet conduit passes beneath the floor of the industrial property downstream of the drop structure in a configuration which is not understood by the owner of the property and could not be visually determined during the site visit.

18. Steel gates at entrance of air conditioning water supply outlet channel

5. Replace trash rack at entrance to water supply outlet channel.
6. Provide a more positive seal than the existing gates at the entrance to the water supply outlet channel. Stoplogs could be used as a control weir for this outlet from which Gordon-Mindick Properties draws air conditioning water.

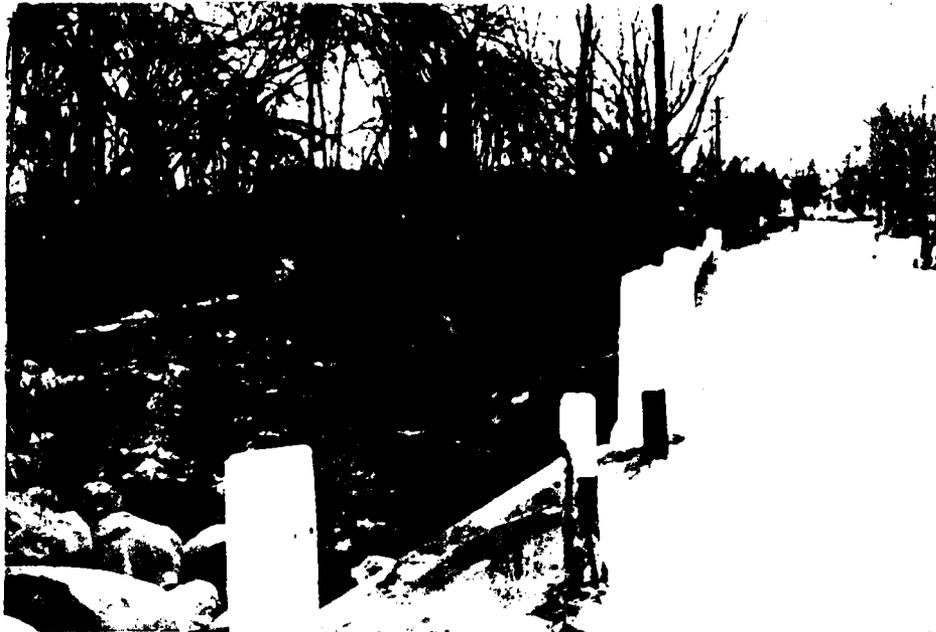
Myrtle Street bridges. The two channels join at a point about 80 ft. downstream of Myrtle Street. Various size trees and boulders were observed on both banks of the river downstream of Myrtle Street, Photo No. 23. The left bank rises at a very steep slope to a height of about 20 ft. The right bank borders the Gordon-Mindick Properties parking area.

23. Downstream channel from left spillway culvert under Myrtle Street

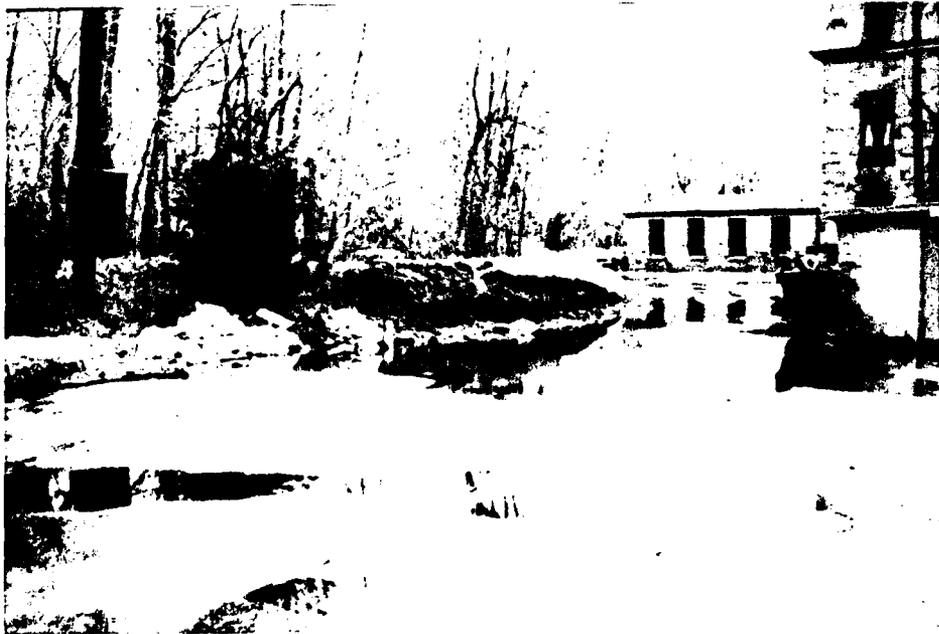
24. Earth flood-control dike along Gordon-Mindick Properties complex (January 1979)
