WHITIN RESERVOIR DAM

MA. 00200

PHASE I INSPECTION REPORT
NATIONAL DAM INSPECTION PROGRAM

JULY 1980

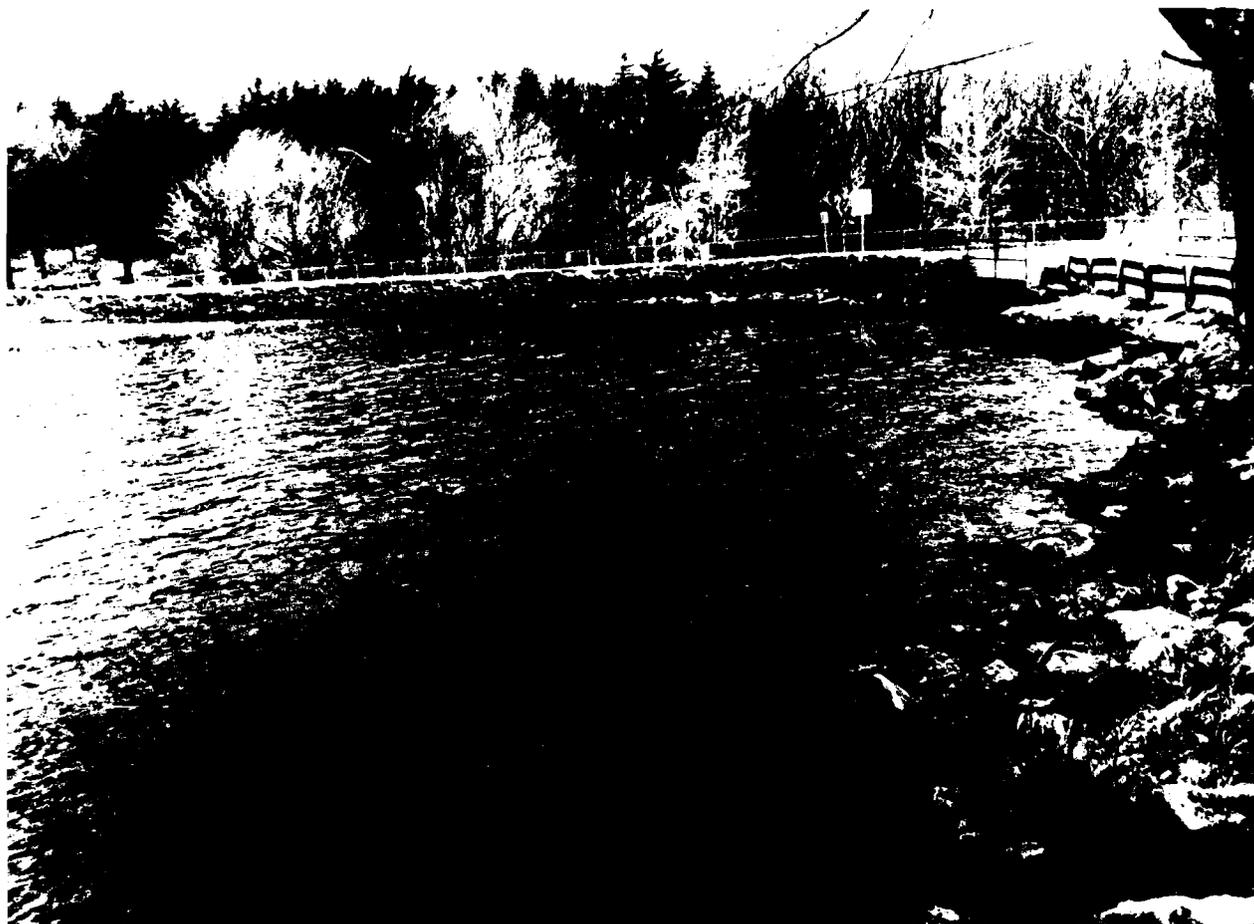
OVERVIEW FROM RIGHT ABUTMENT

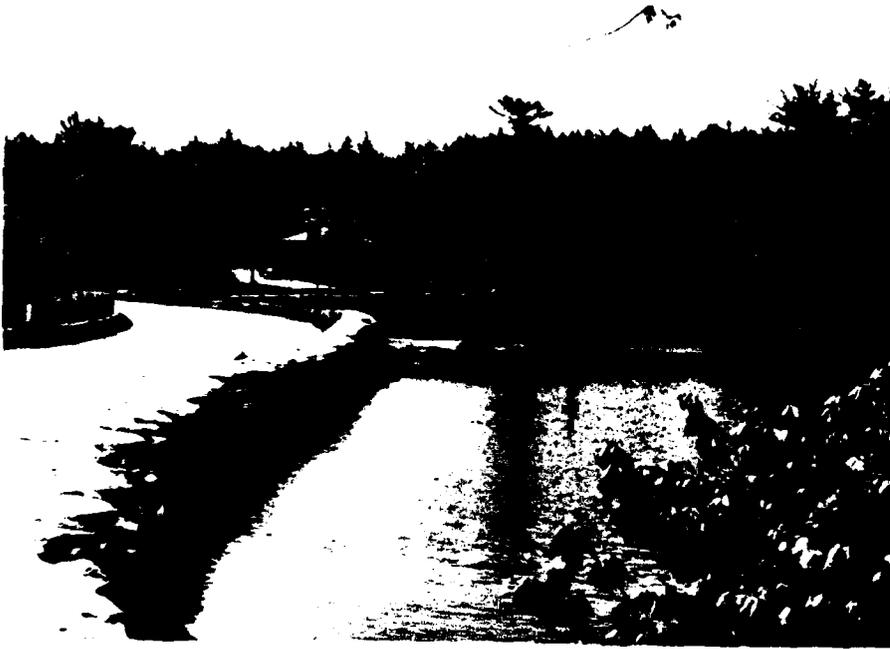
9. Gate structure on upstream face of dam

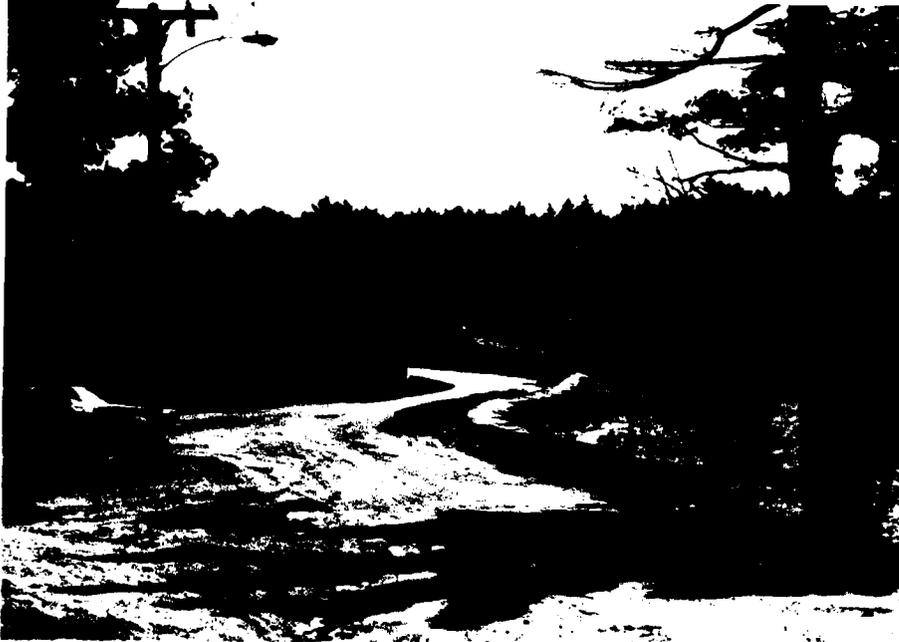
3. View along crest of dam

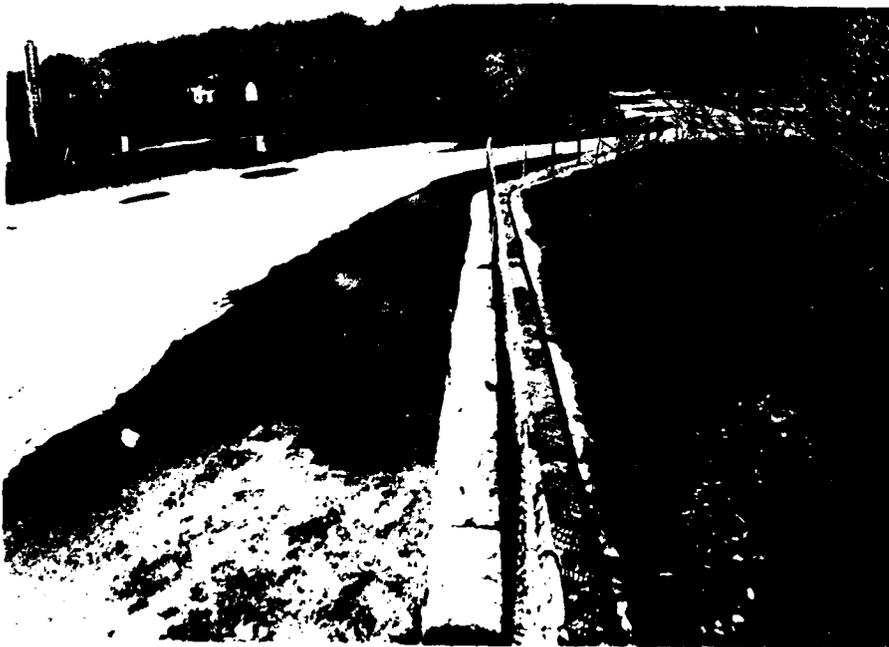
4. Crest of dam and downstream face
