NORTH RIVER BASIN
PEABODY, MASSACHUSETTS

BROWNS POND DAM
MA 00192

PHASE 1 INSPECTION REPORT
NATIONAL DAM INSPECTION PROGRAM

DECEMBER 1978

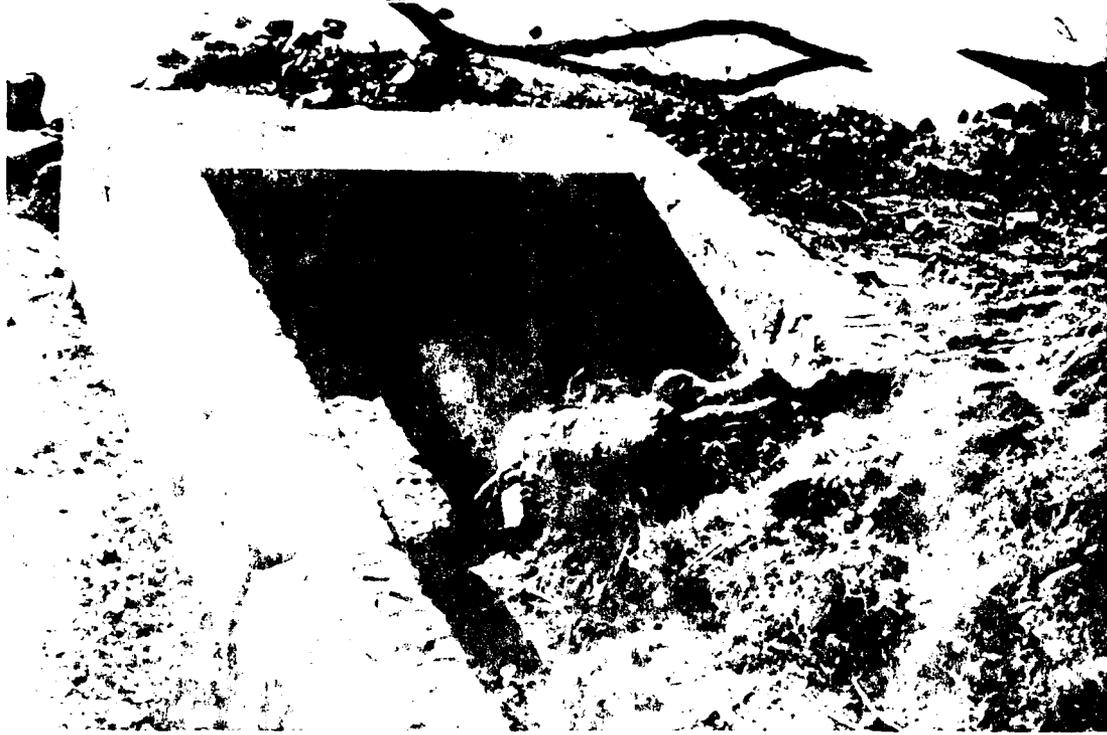
The concrete outlet structure and the 20-inch diameter cast iron outlet pipe which is protected by a steel trash rack are in good condition. The pipe shows minimal rusting and the condition of the concrete is good. (See Photograph No. 4). It is reported that the gate valve for the outlet pipe is in operating condition.

4. VIEW OF OUTLET STRUCTURE AND OUTLET PIPE. NOTE NOTCH RECENTLY CONCRETE FILLED.

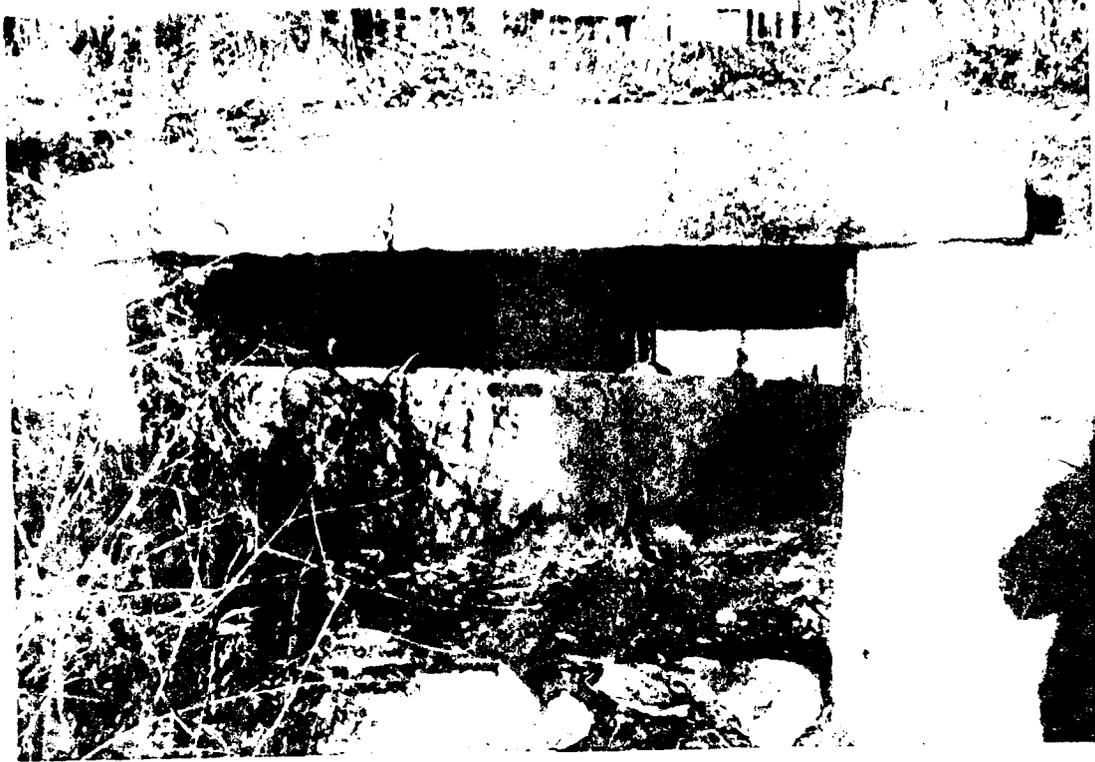
have fallen into the spillway approach channel. In addition, minor debris has accumulated in the channel. At several locations along the walls, mortar in the joints is loose and missing. At the time of inspection, there was a steel plate flashboard at the entrance to the spillway. (See Photograph No. 6).

6. VIEW OF SPILLWAY LOOKING DOWNSTREAM.
NOTE STEEL PLATE FLASHBOARD AND IN BACKGROUND HEADWALL
WITH ENTRANCE TO OUTLET PIPE COVERED WITH TRASH RACK.

6. The gullies and sloughed areas of the upstream slope should be filled with suitable material and compacted.
7. Stone blocks at the entrance and exit of the spillway should be removed.
8. Remove debris from spillway approach channel.
9. Missing stones should be replaced along the spillway training walls and all joints should be repointed.
10. The extent of the spillway outlet pipe should be determined and the broken portion of the pipe repaired.
11. The gate valve which controls discharges through the outlet pipe should be maintained in operable condition.

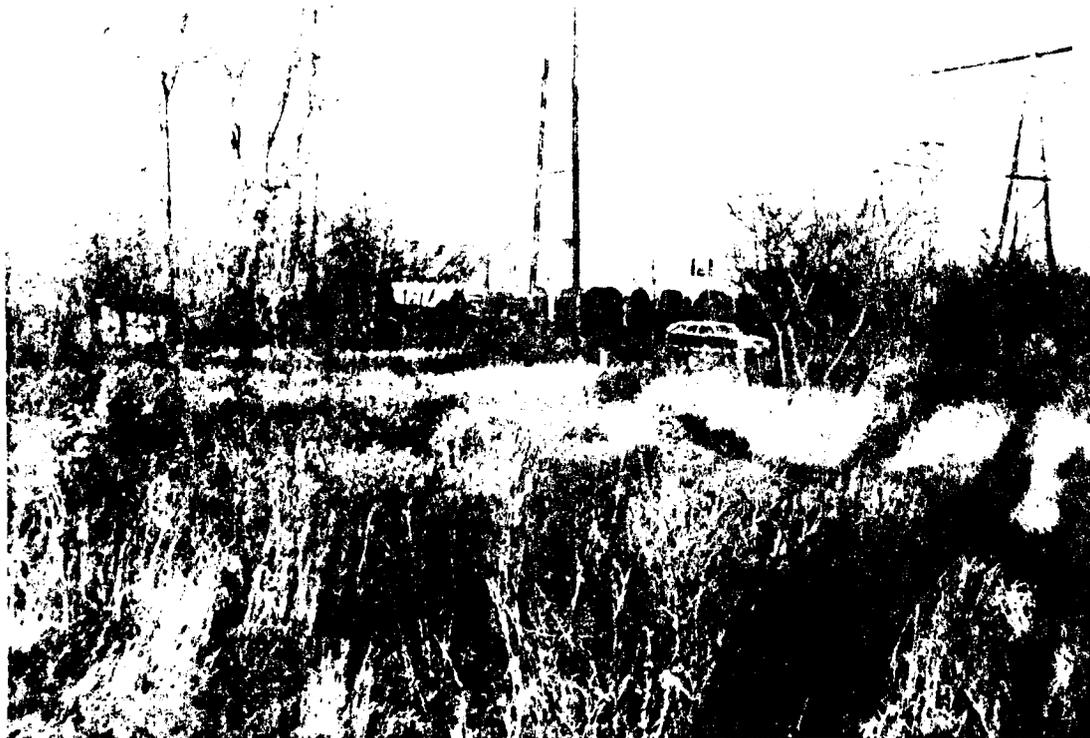
7. VIEW OF DOWNSTREAM CHANNEL. NOTE VEGETATION.
