HOUSATONIC RIVER BASIN
MONTEREY, MASSACHUSETTS

LAKE GARFIELD DAM
MA 00249

PHASE I INSPECTION REPORT
NATIONAL DAM INSPECTION PROGRAM

MARCH 1980

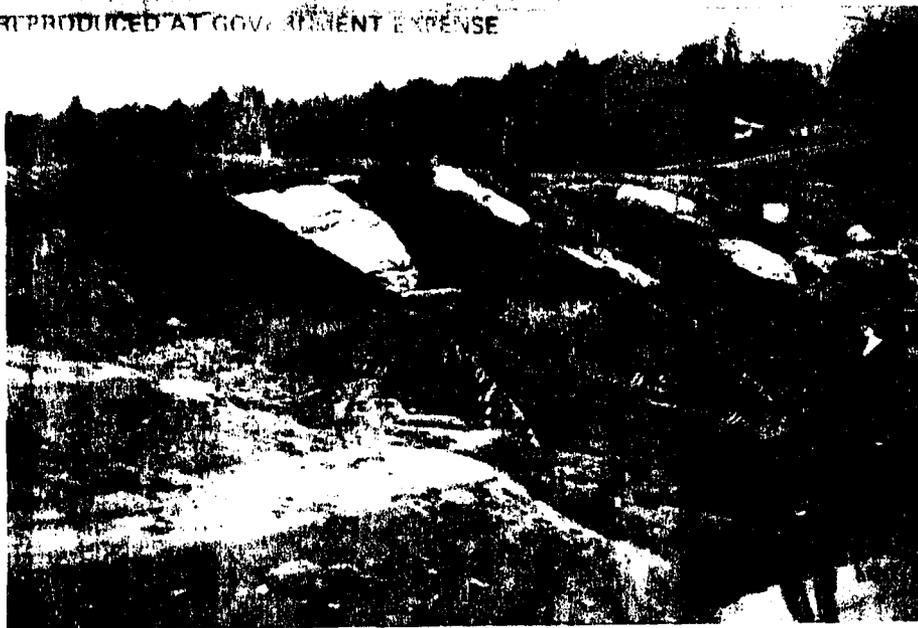
215

Side of triple barrel
cut under Tyringham
which crosses impound-
ment area.

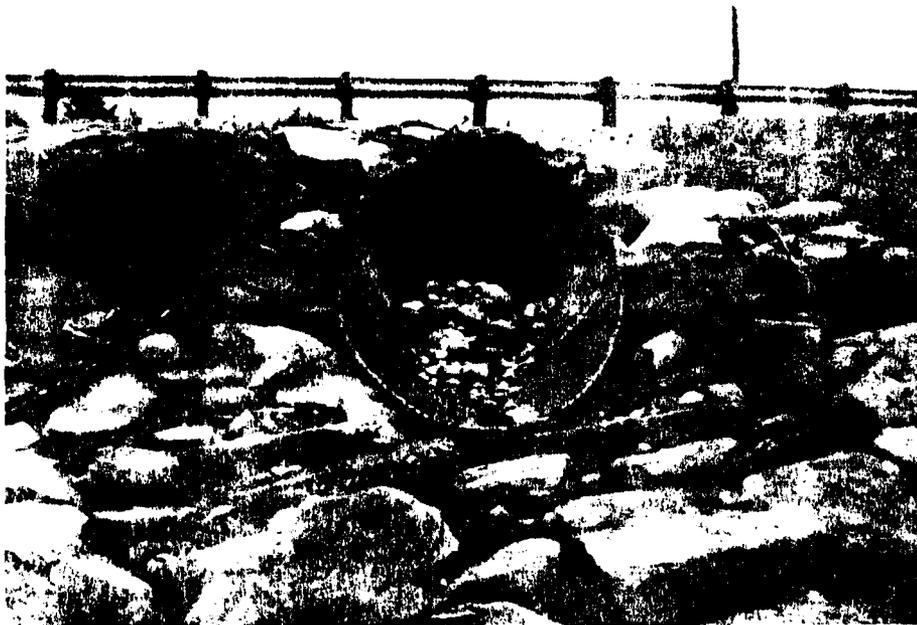
216

Side of triple barrel
cut showing typical
sedimentation.

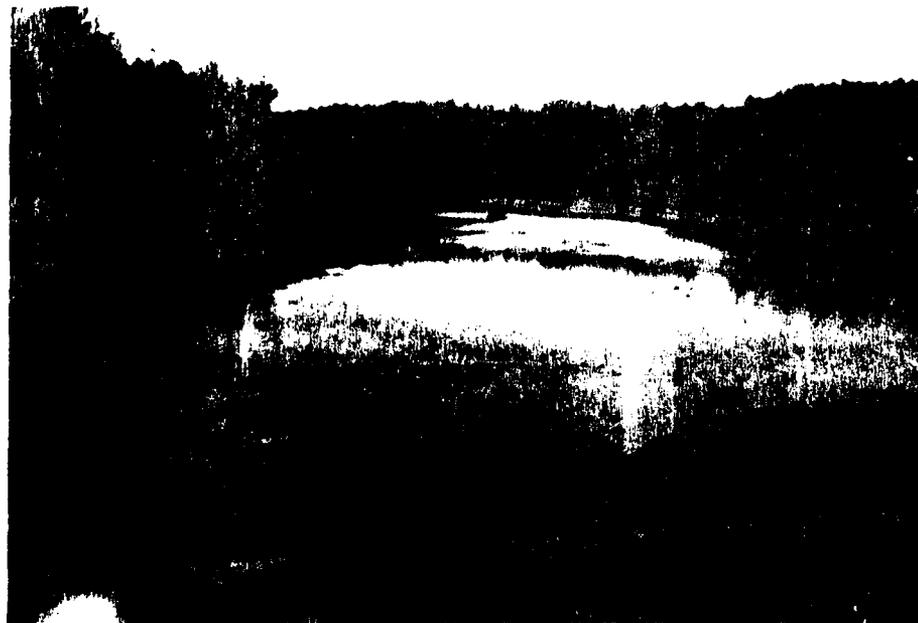
217

Adjacent area looking
down of Tyringham Road
cuts towards dam
tion. (dam not in photo)

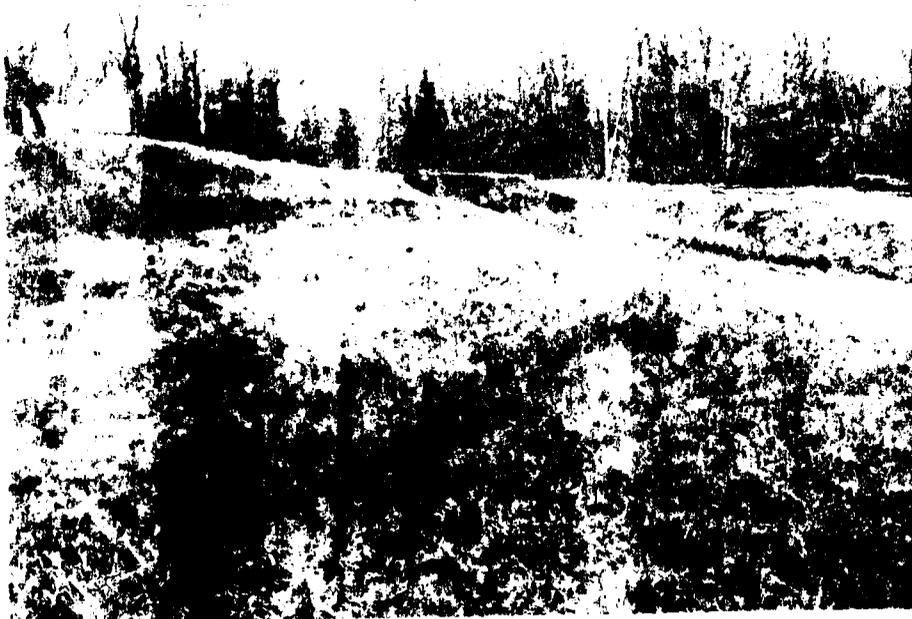
Photo 13

Emergency spillway right
side training embankment
and left side of dam.

The recommended remedial measures as listed in Section 7 including the additional erosion protection along the right training embankment of the emergency spillway, maintenance of the downstream embankment, and clearing of vegetation from the downstream channel, should be implemented within two years of receipt of this report by the Owner.

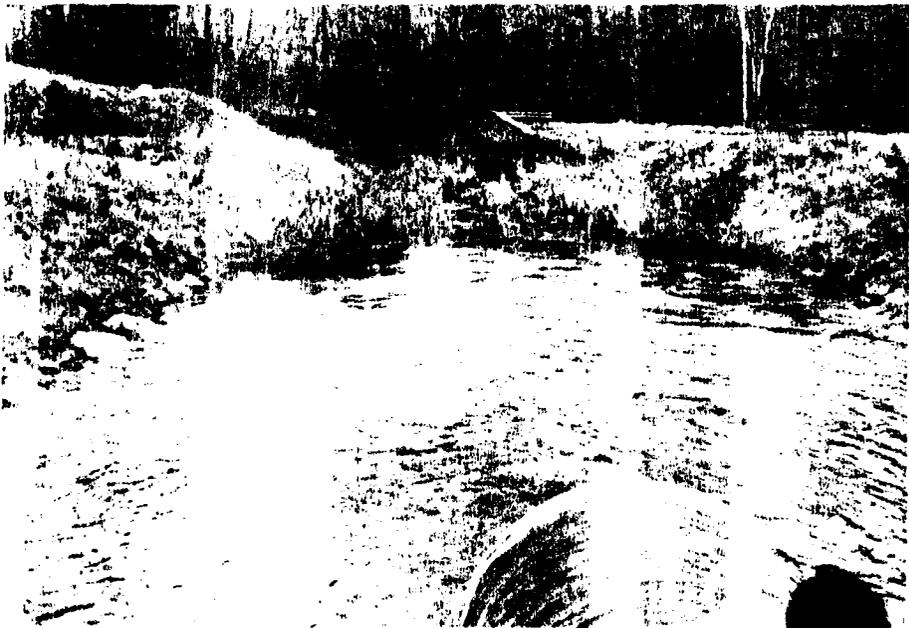
FIG. 9
Principal spillway outlet
conduit at stilling basin.

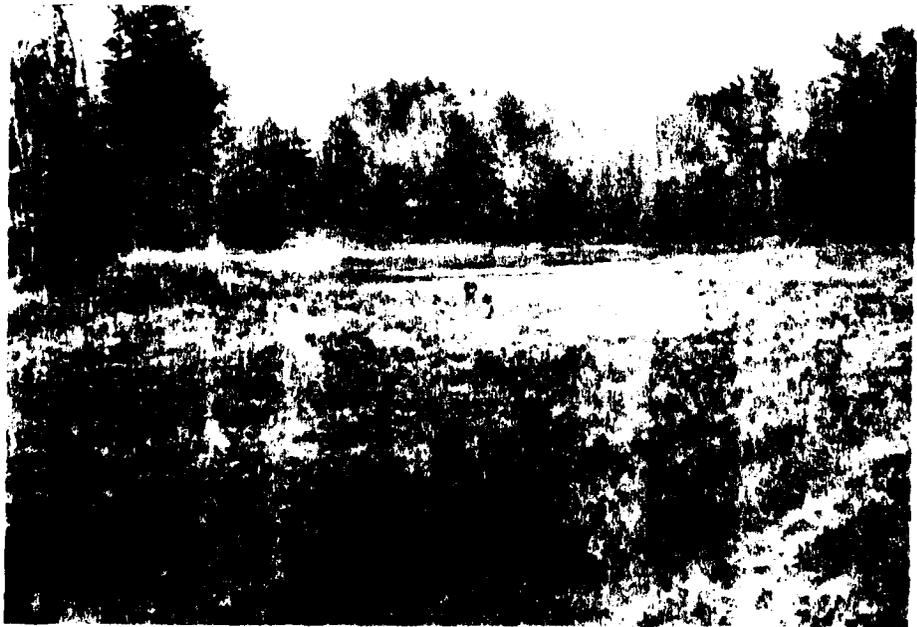
FIG. 10
Stilling basin and discharge
channel looking downstream
from outlet conduit.

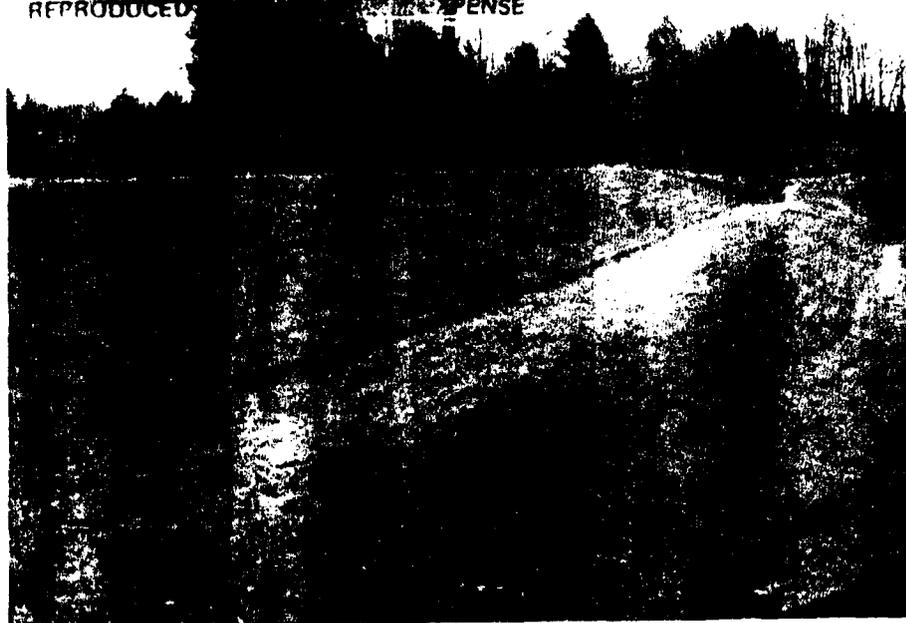
photo 4

downstream embankment
sloping towards left
settlement from right
etc.

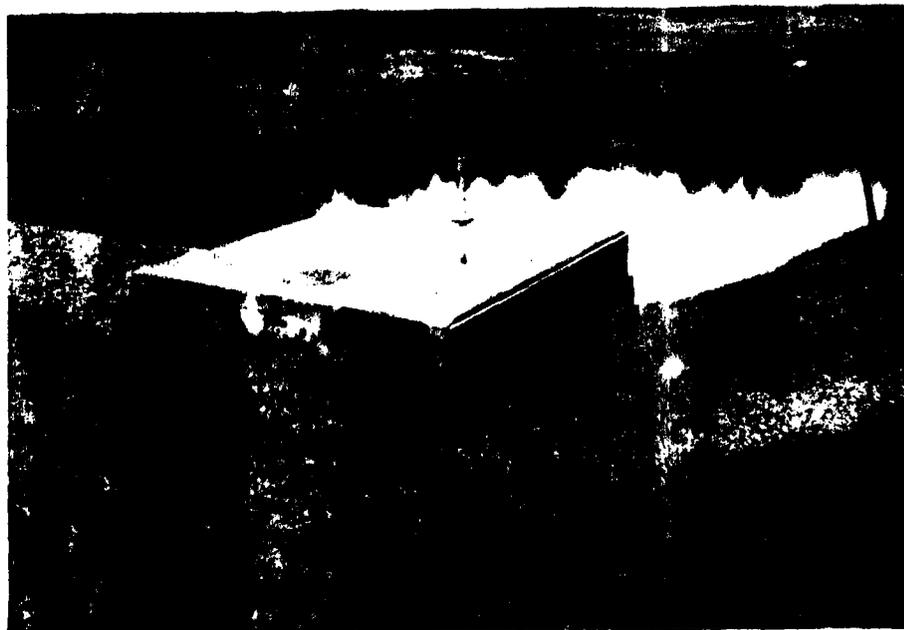
photo 5

principal spillway drop
structure.
