20. ABSTRACT (Continue on reverse side if necessary and identify by block number) The dam is an zoned earthfill dam that is about 1560 ft. long and 20 ft. high. The dam is in fair condition. Regular monitoring programs of the groundwater levels should be instituted to monitor the performance of the dam. It is intermediate in size with a hazard potential of high.

ASSABET RIVER DAM

**OVERVIEW
ASSABET RIVER DAM
WESTBOROUGH, MASSACHUSETTS**

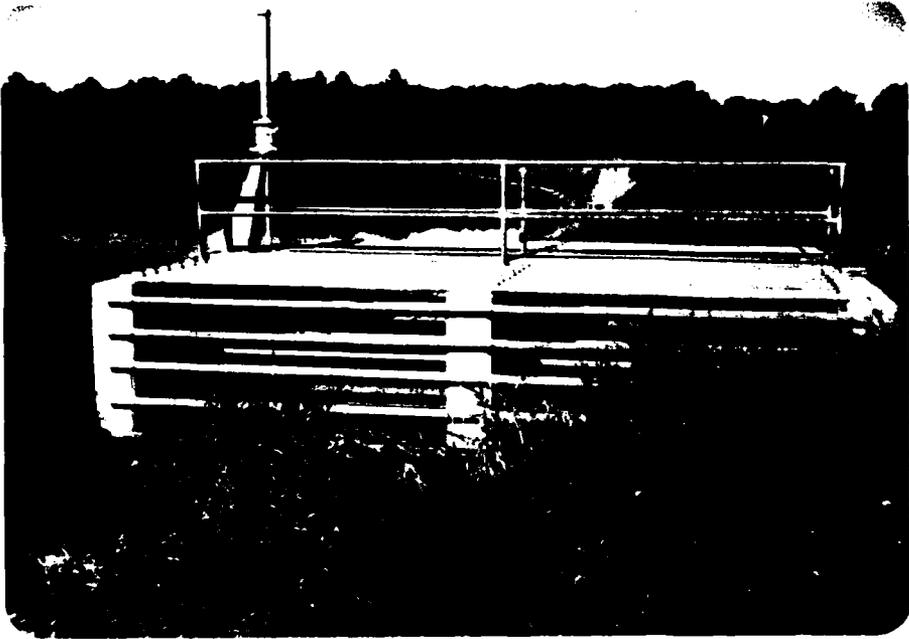
NO. 1 OUTLET WITH TRASH RACKS AT SPILLWAY

- 4.3 Maintenance of Operating Facility. The operating mechanism at the dam is the sluice gate on the low-level outlet. This gate is operated by the SCS personnel during their annual inspection. The condition of the trash racks around the outlet structure (see Photo No. 1 in Appendix C) is also reported and maintenance performed as required.
