MERRIMACK RIVER BASIN  
ASHLAND, MASSACHUSETTS

HOPKINTON RESERVOIR DAM

MA. 00437

PHASE I INSPECTION REPORT  
NATIONAL DAM INSPECTION PROGRAM

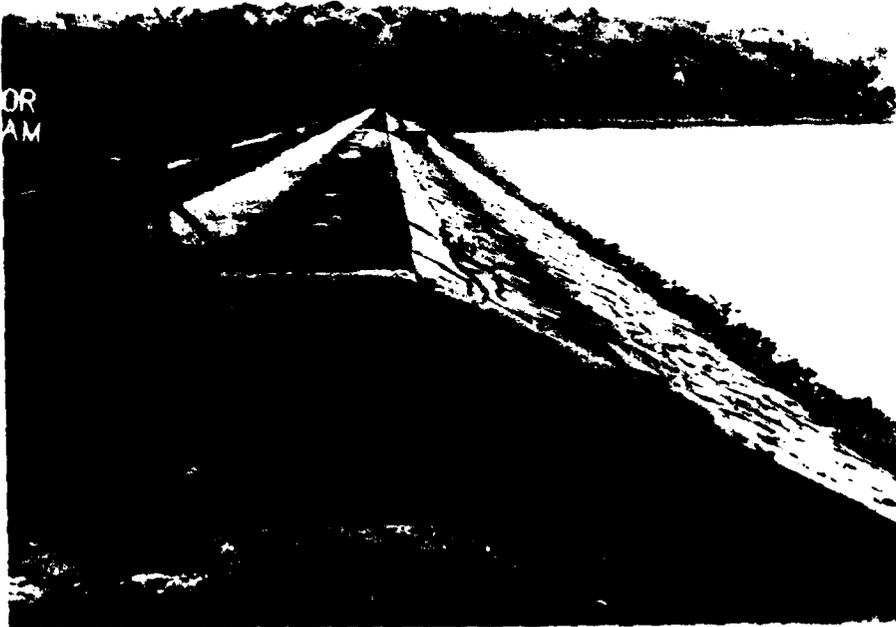
1. Upstream slope of dam covered with hand placed granite block.

(1) Repair voids in the riprap on the upstream slope of embankment.

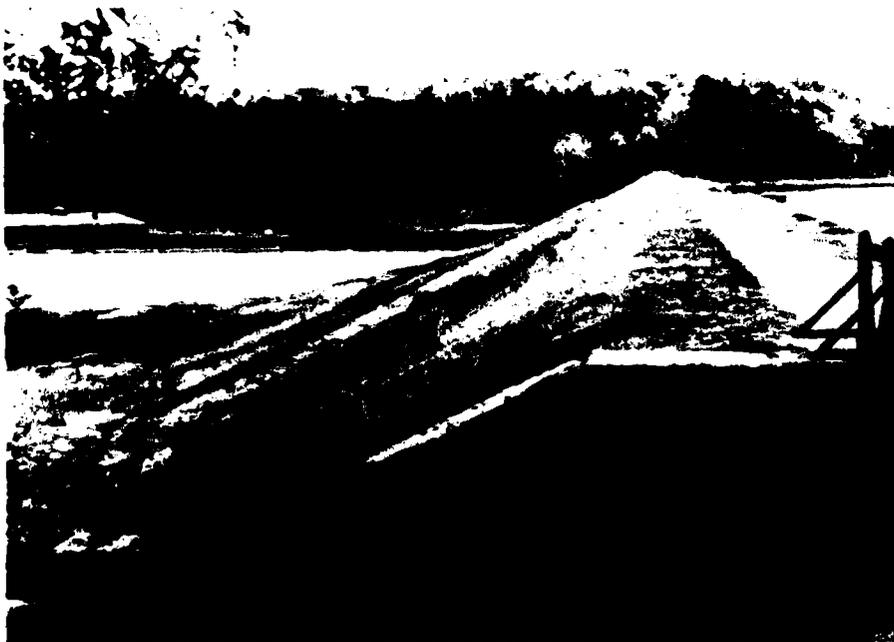
2. Downstream slope of dam

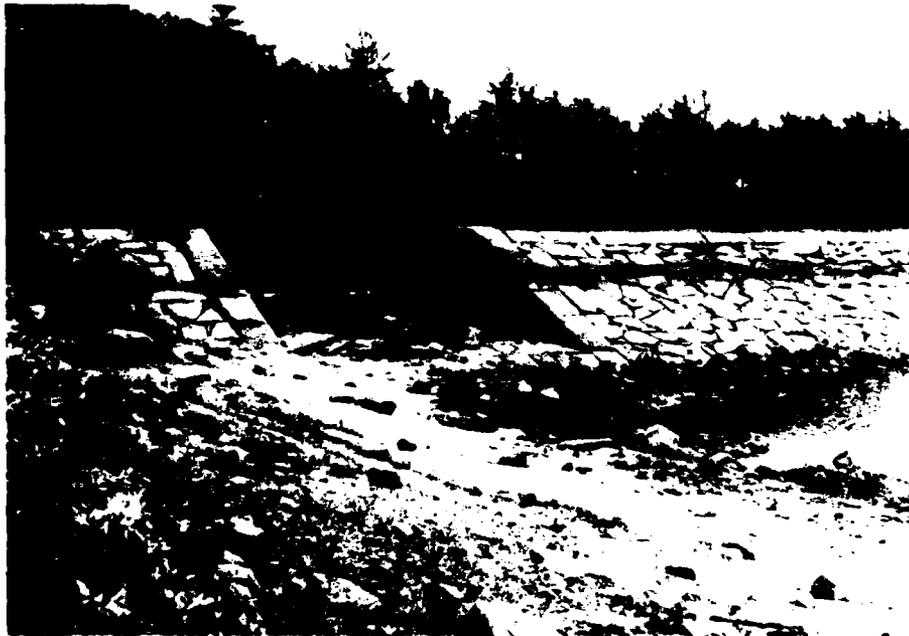
6. Spillway approach channel.

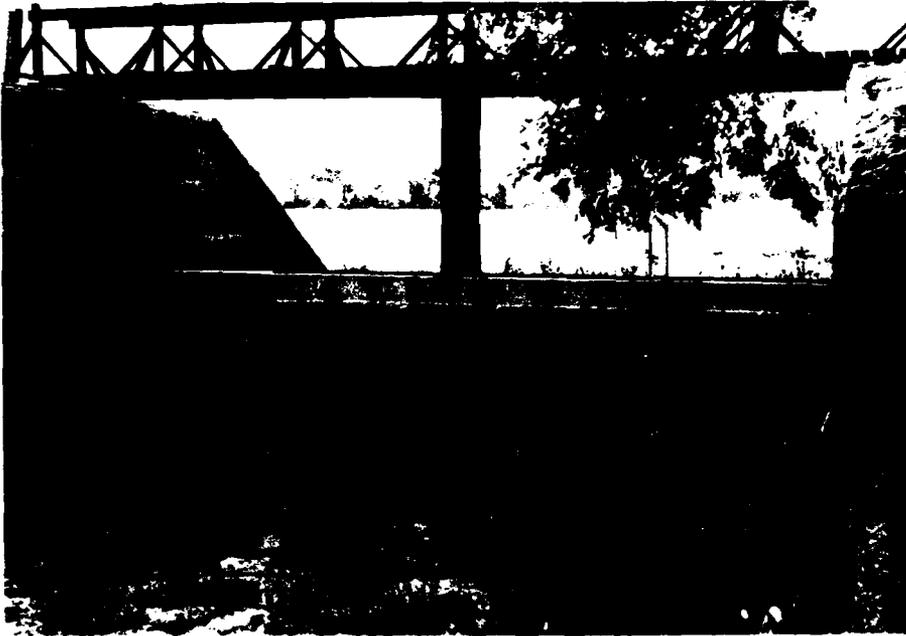
7. View of spillway from downstream channel.

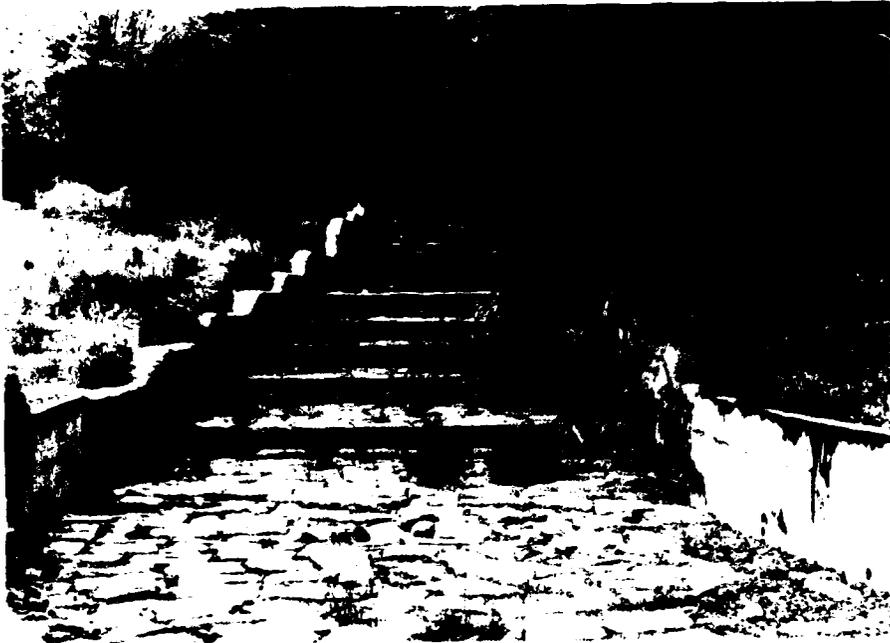
. View of spillway channel from downstream toe.

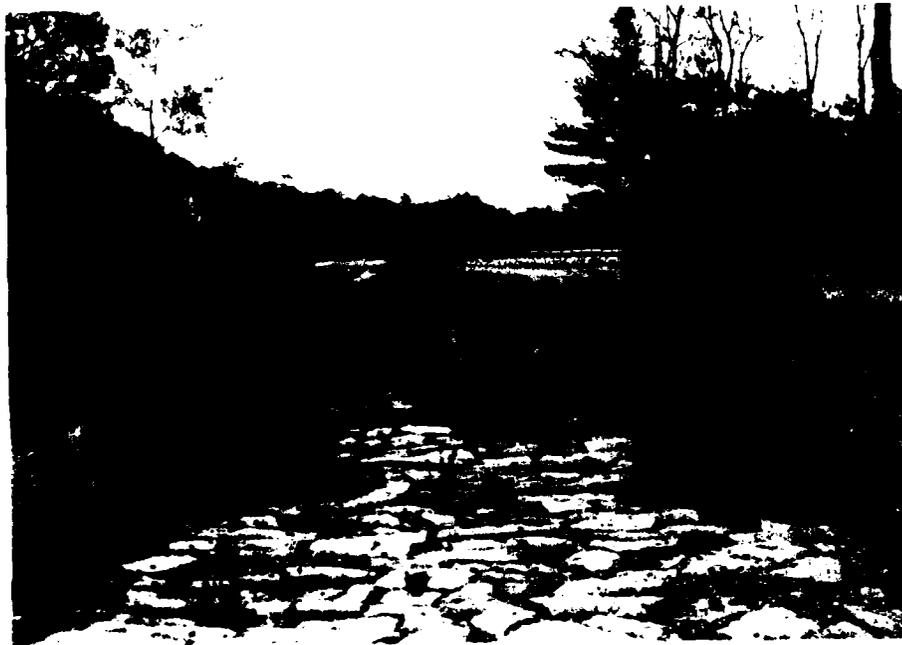
.0. Granite block and concrete channel and earth embankment channel beyond downstream toe of spillway channel.

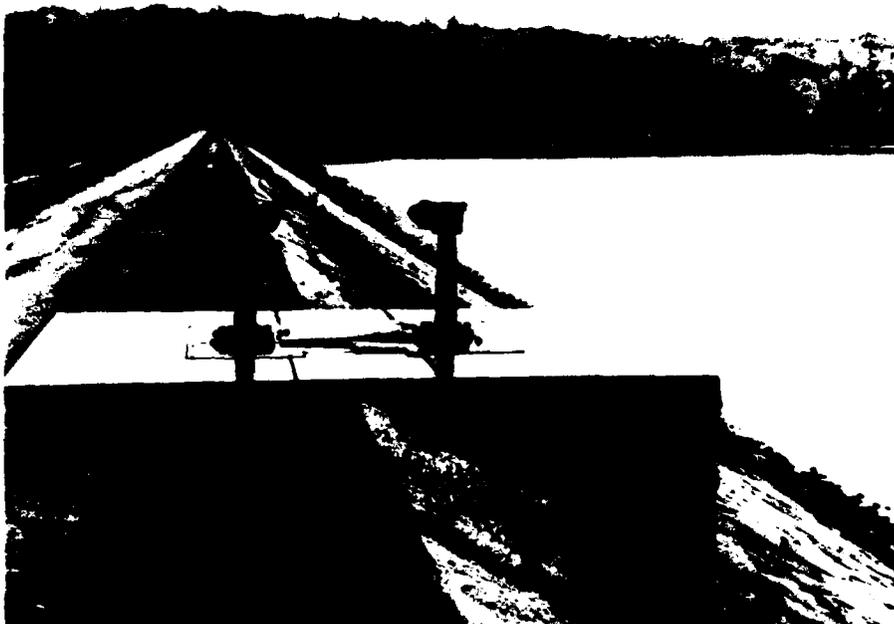
2. Left outlet gate chamber.

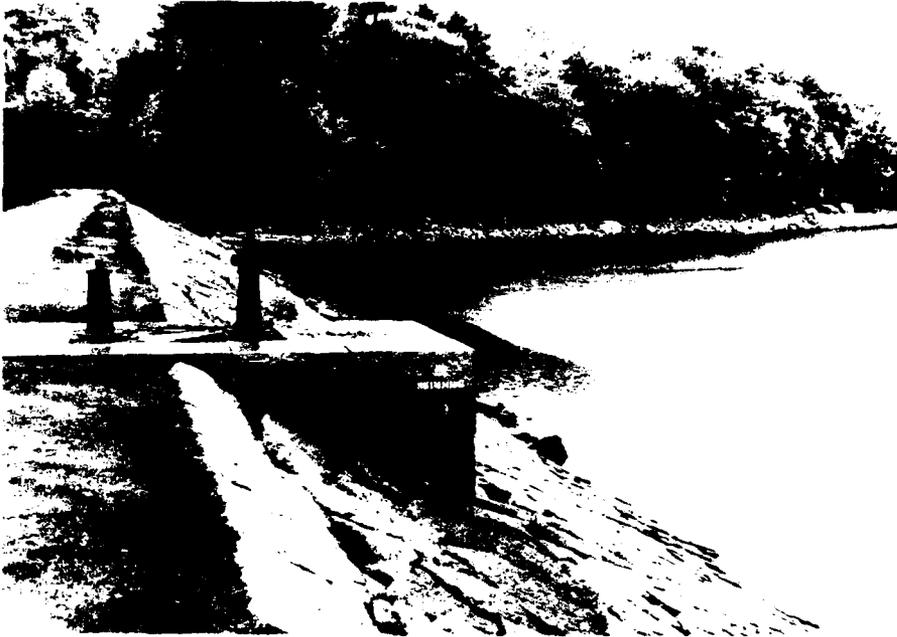
13. Right outlet gate chamber.

(9) Determine if the right outlet structure is operative and if not study the feasibility of making any necessary repairs.
