SUDBURY RIVER BASIN
FRAMINGHAM, MASSACHUSETTS

CENTRAL STREET DAM
MA 00340

PHASE I INSPECTION REPORT
NATIONAL DAM INSPECTION PROGRAM

FEBRUARY 1980

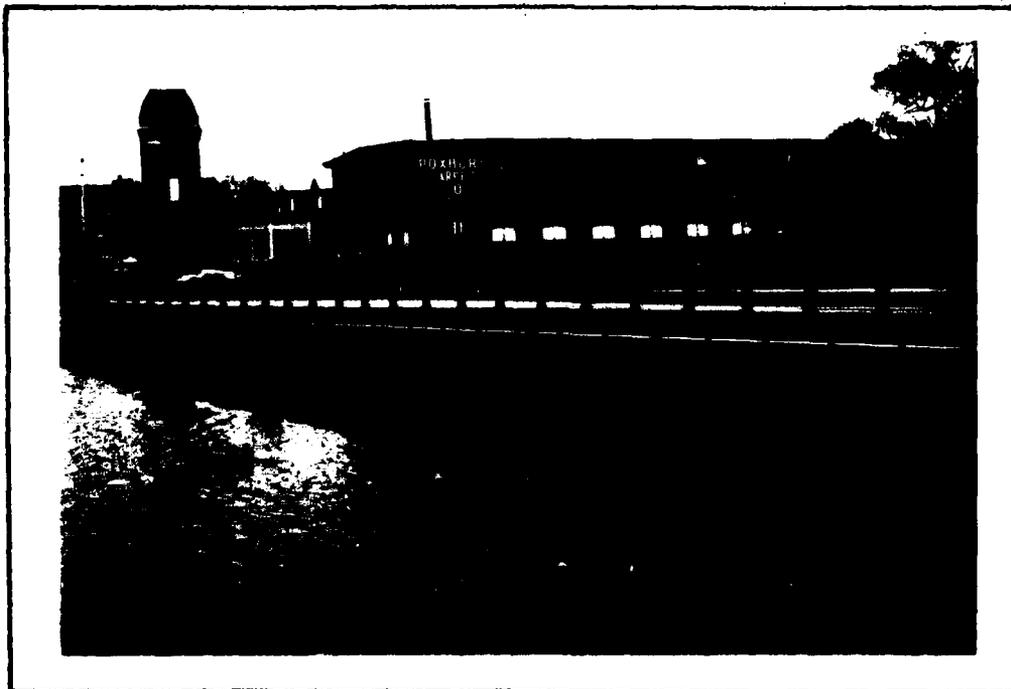
2. LOOKING ACROSS THE SPILLWAY FROM THE RIGHT SIDE SPILLWAY ABUTMENT SHOWING CONDITIONS IMMEDIATELY DOWNSTREAM OF THE DAM. (11/12/79)

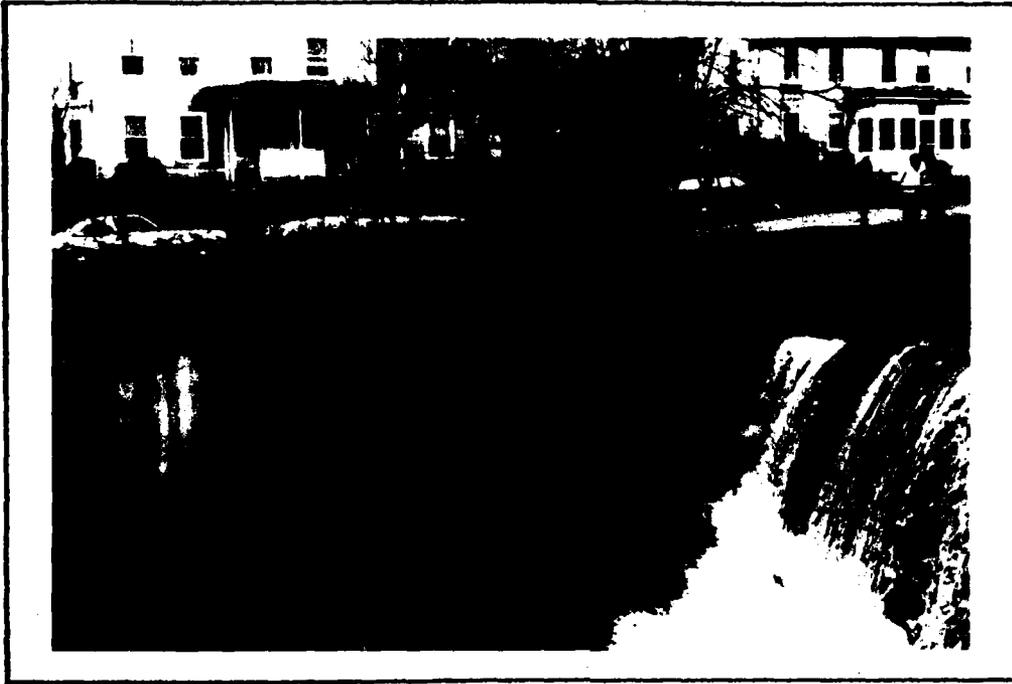
1. The right abutment of the dam consists of a vertical stone masonry wall which extends from a point approximately 30 feet downstream of the spillway to a point several hundred feet upstream of the dam. This wall shows signs of slight settlement, cracking of mortar between the cut granite stones forming its face, and some undermining at its base downstream of the spillway. These features are illustrated on photo 3 of Appendix C.

3. DETAILS OF RIGHT SPILLWAY ABUTMENT. (11/12/79)

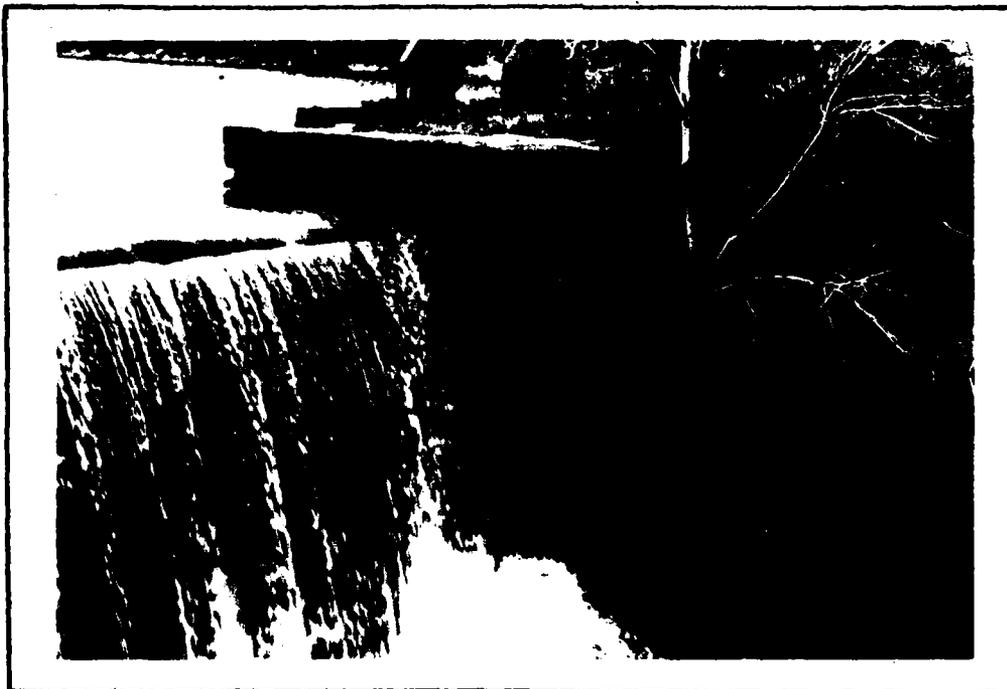
3. The stone masonry spillway abutment wall, the assumed inoperable outlet conduit gate structure and the embankment retaining walls extending to the left (east) of the spillway are in poor condition. Significant cracking and loss of mortar between individual stone blocks is evident. Trees and brush are growing from voids between the blocks in some locations (refer to pgs. C-2, 4 and 5). The spillway abutment wall to the left of the spillway has blocks which are displaced up to 6 inches from their original positions (refer to pgs. C-2, 4, and 5). Spurting seepage estimated at 10 gpm was discharging from the abandoned stone masonry gate structure near its intersection with the Central Street bridge abutment (refer to Pg C-5). It was noted that remedial grouting of the masonry has been performed in the vicinity of the leakage. The embankment section of the dam east of the bridge abutment appears to be in satisfactory condition.

4. CONDITIONS AT THE LEFT SPILLWAY ABUTMENT. (11/12/79)

2. All of the masonry construction, including the spillway and especially the spillway abutment wall and abandoned gate structure east of the spillway, should be inspected during a period of reservoir drawdown to more accurately assess the condition of these structures.

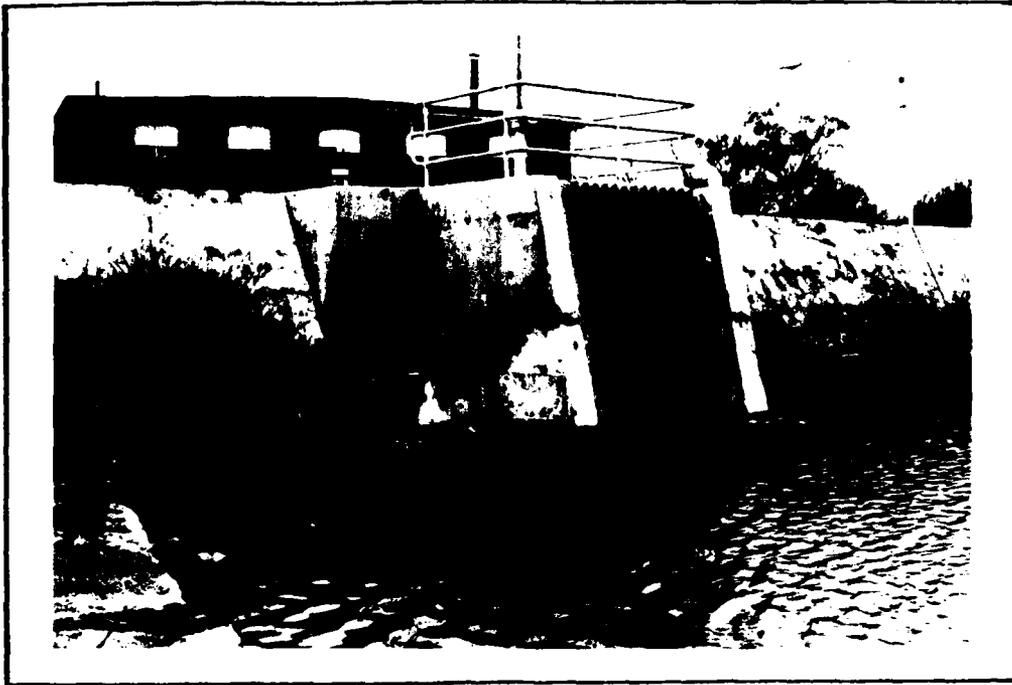
5. INLET DETAILS FOR THE 4-FOOT WIDE BY 6-FOOT HIGH IMPOUNDMENT REGULATING GATE APPROXIMATELY 110 FEET LEFT OF THE LEFT SIDE SPILLWAY ABUTMENT. (11/12/79)

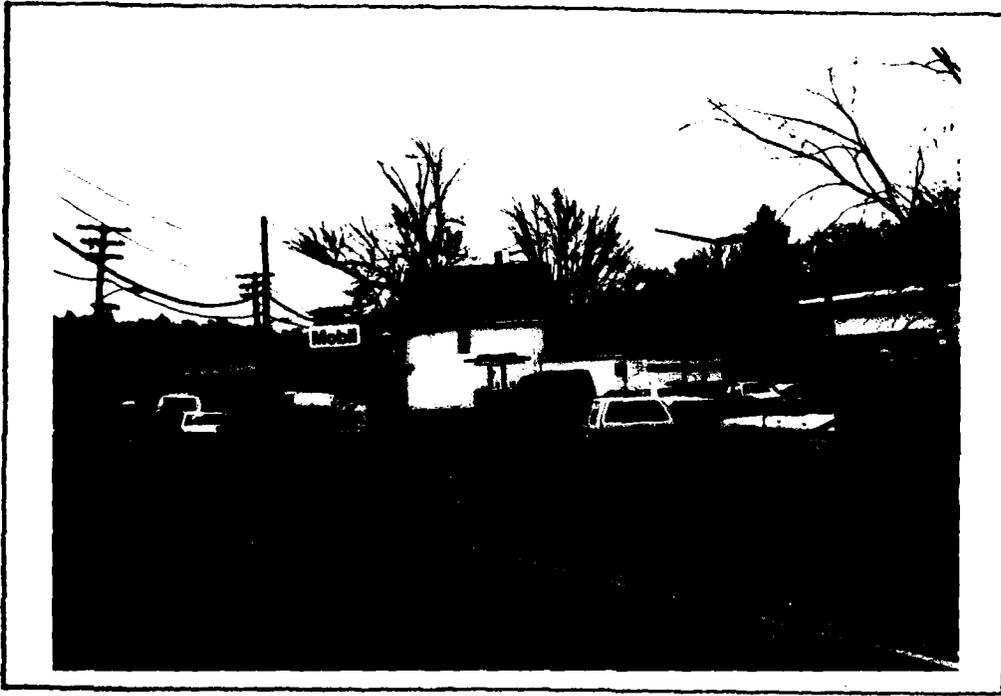
17. LOOKING SOUTH ALONG CONCORD STREET SHOWING A PORTION OF THE AREA NOT PROTECTED BY THE FLOOD WALLS AND DIKES. (11/12/79)
