| REPORT DOCUMENTATION PAGE | | READ INSTRUCTIONS<br>BEFORE COMPLETING FORM |
|--|---|---|
| 4. TITLE (and Subtitle)<br>Reservoir Number One<br><br>NATIONAL PROGRAM FOR INSPECTION OF NON-FEDERAL DAMS | 5. TYPE OF REPORT & PERIOD COVERED<br>INSPECTION REPORT | |
| 11. CONTROLLING OFFICE NAME AND ADDRESS<br>DEPT. OF THE ARMY, CORPS OF ENGINEERS<br>NEW ENGLAND DIVISION, NEDED<br>424 TRAPELO ROAD, WALTHAM, MA. 02254 | 12. REPORT DATE<br>April 1979 | |
| 19. KEY WORDS (Continue on reverse side if necessary and identify by block number)<br>DAMS, INSPECTION, DAM SAFETY,<br>Merrimack River Basin<br>Framingham, Massachusetts<br>Sudbury River | | |

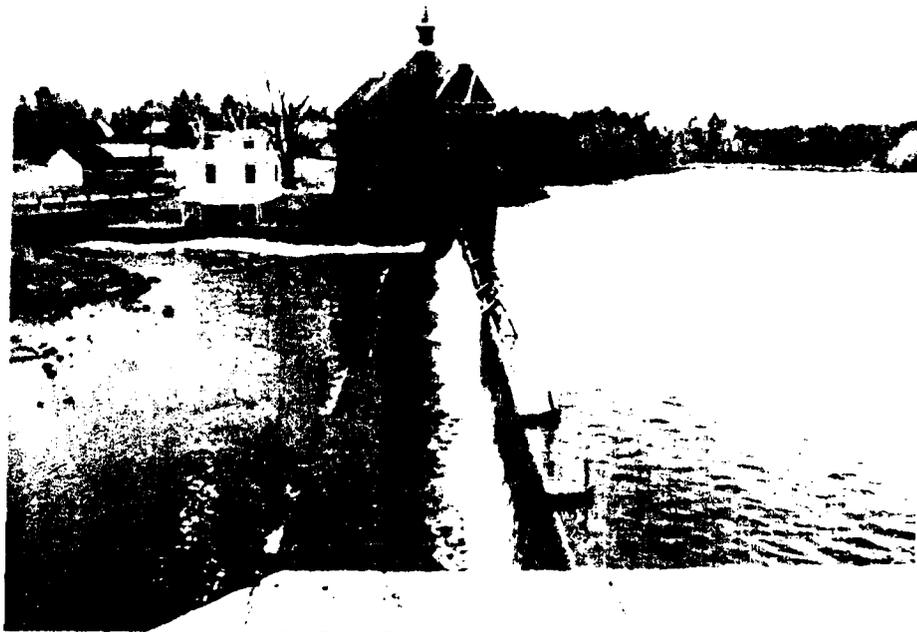
Water over the spillway weir and apron prevented a clear view of the joints. However, the weir and apron show no signs of movement or distress. There were approximately 15 rods observed along the crest of the weir, which may once have supported flashboards. No flashboards were observed on 29 March 1979. On 9 of these rods were attached wooden devices called ducks which are used to reduce the noise of the water flowing over the crest. These conditions are shown in Photos No. 2 and 9. The left and right spillway training walls, Photos No. 5 and 8, exhibit only minor loss of joint mortar.

9. Spillway weir and apron

professional engineer to observe the dam at a time when there is low or no flow over the spillway to 1) assess the condition of the granite masonry spillway weir and downstream apron and 2) the outlet chambers. If indications of seepage are observed, the Owner should then implement corrective measures.

2. Repoint granite masonry on the downstream face of the spillway weir and other walls where necessary.
3. Repair and maintain the gate house to protect the contained equipment, ensure safety of personnel, ensure that equipment is operative and minimize storm leakage into the structure. As a minimum, electric service should be restored to the structure, floor planks placed over open chambers and windows, roof flashing repaired or replaced, and gates examined.

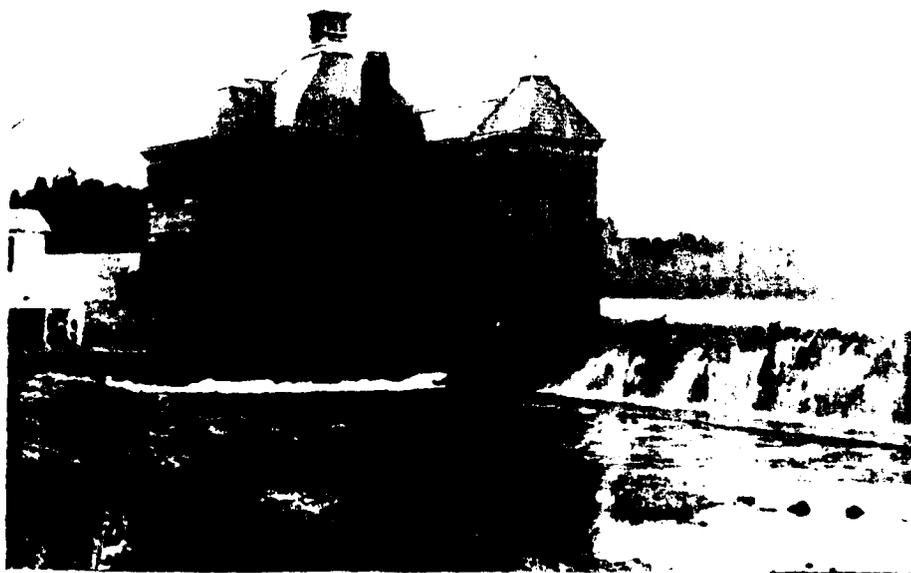
The gate house is a granite masonry structure with a slate-covered roof and is generally in good condition. The joints at and just above waste ports 1, 2 and 3 show signs of staining and efflorescence, Photo No. 10. The windows are in poor condition and some of the panes are broken. Some of the copper flashing along the edge of the roof has broken off. The exterior of the gate house is shown in Photos No. 1, 2, 4, 7, 8, 9 and 10.

10. Gate house and waste gate outlet ports
