JACKSON PLANT DAM

INVENTORY

NH 00121

Feb 1979

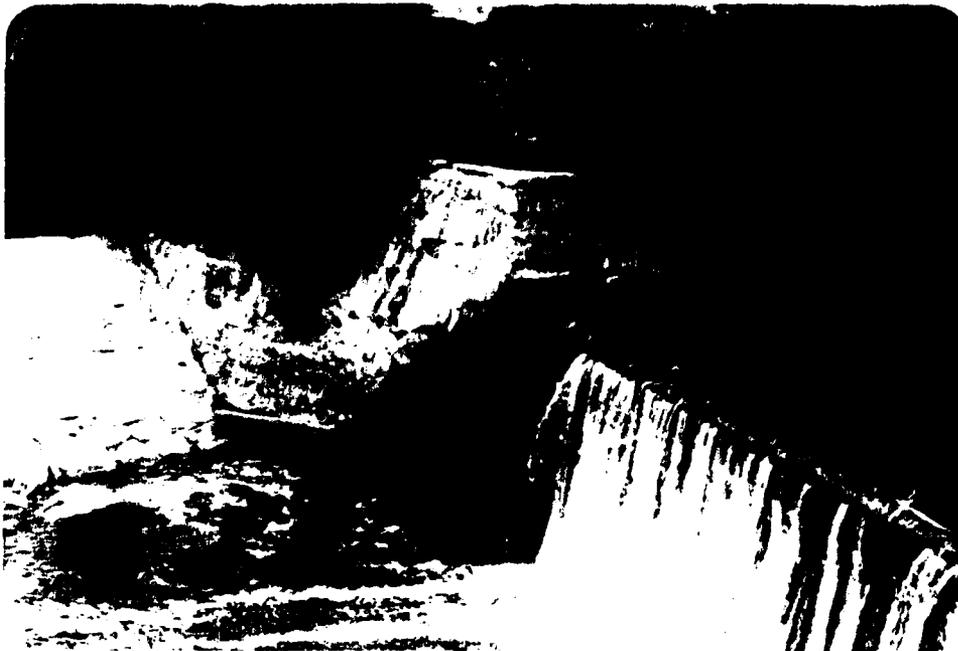
The vertical faces of this structure have spalled over 75% of their surface area to depths of 4 inches. There is considerable patterned horizontal cracking with associated efflorescence. The spalling and cracking reveals a stone masonry structure which has been faced and capped with concrete. The spalling and cracking is attributed to moisture intrusion and alternate freeze and thaw cycles. Vegetation is growing through open joints on the downstream leg of this abutment.

3. View from left side downstream of deteriorated concrete at right abutment

- (1) Repair the deteriorated concrete at the right abutment.
