ATLANTIC OCEAN  
BELFAST, MAINE

LITTLE RIVER LOWER DAM  
ME 00288

PHASE I INSPECTION REPORT  
NATIONAL DAM INSPECTION PROGRAM

NOVEMBER 1979

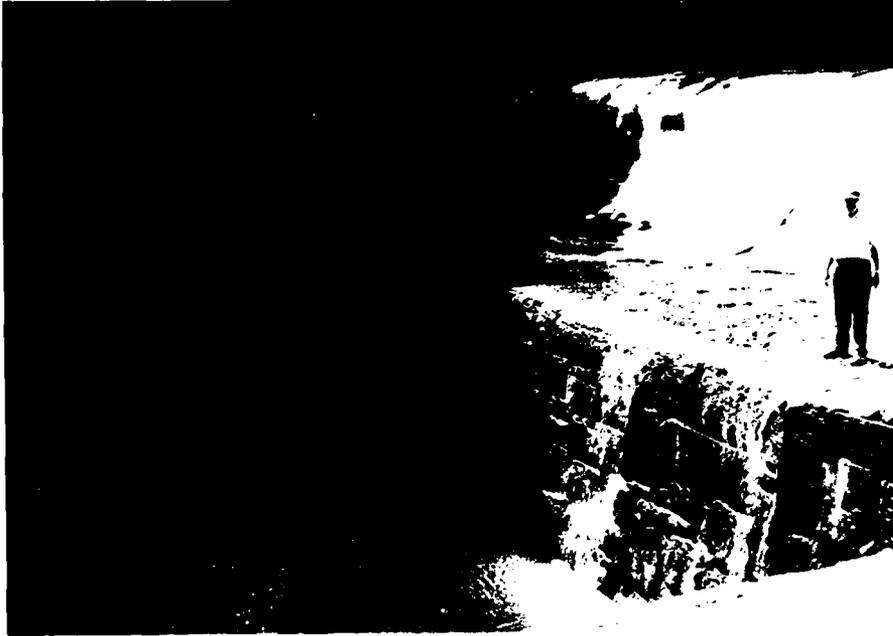
September 17, 1979  
Figure 2 - Downstream face of the dam.

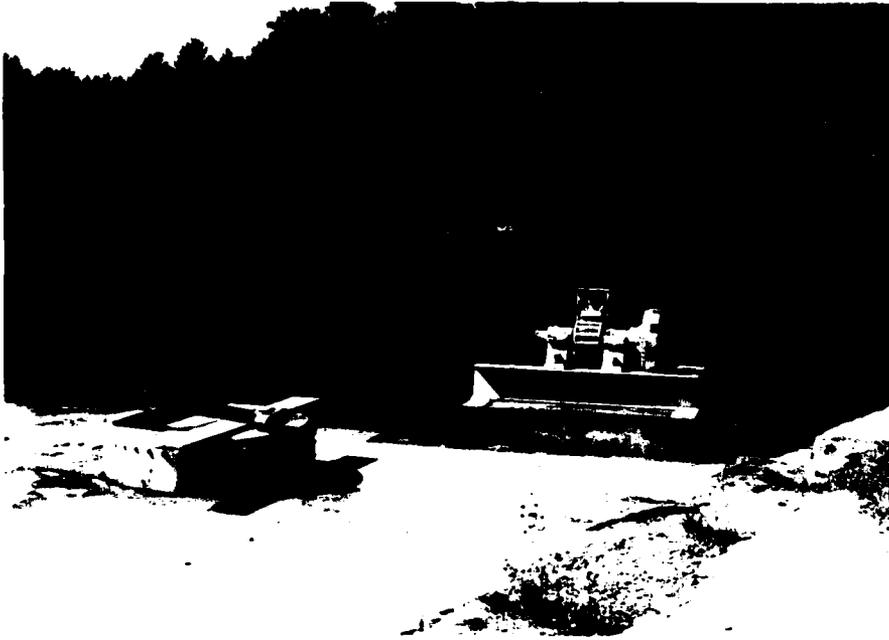
September 17, 1979  
Figure 4 - Gate mechanism at the north abutment.

- (1) Design and implement repairs for the dry-stone-masonry walls at the downstream edge of the spillway apron, on the north bank of the upstream channel, and on the north bank of the downstream channel.
- (2) Design and implement repairs for the erosion on the upstream and downstream sides of the right concrete abutment block.
- (3) Design repairs to the low-level outlet gate, operating mechanism, and outlet pipe as required.

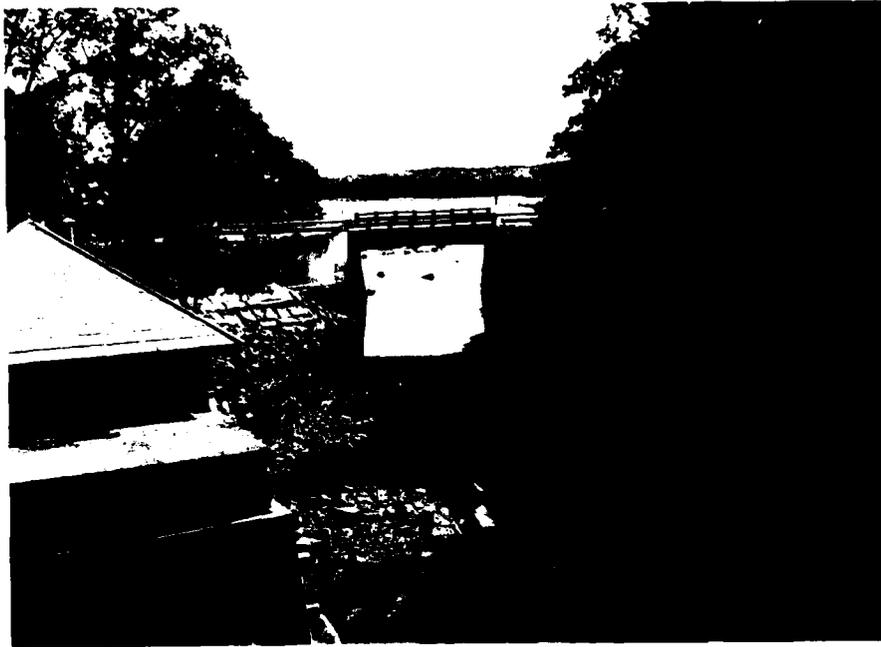
September 17, 1979  
Figure 12 - Looking downstream at U.S. Route 1 bridge  
from the north abutment of the dam.

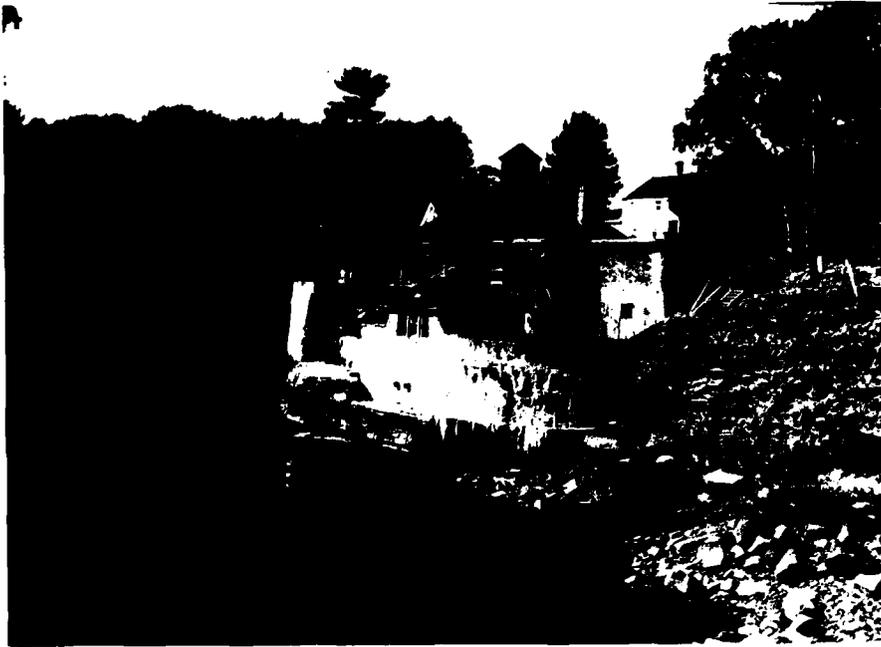
A 5-foot-diameter steel pipe exits at the bottom of the training wall on the north bank of the downstream channel. The outlet of the pipe is plugged with sand and gravel to about one-third of its height. (See Appendix C - Figure 9.) The gate mechanism on the north abutment is inoperable; the gate size is unknown. (See Appendix C - Figure 4.) The mechanism is in poor condition with no indication of maintenance. A pump station building and a filter house for a water supply system is located integrally with the north abutment. A concrete wall which exists on the river side of these buildings is an extension to the downstream retaining wall. (See Appendix C - Figure 10.)

September 17, 1979  
Figure 10 - View of the north bank of the downstream  
channel from the U.S. Route 1 bridge.
