KENNEBEC RIVER BASIN  
MANCHESTER, MAINE

COBBOSSECONTEE LAKE DAM  
ME 00096

PHASE I INSPECTION REPORT  
NATIONAL DAM INSPECTION PROGRAM

NOVEMBER 1979

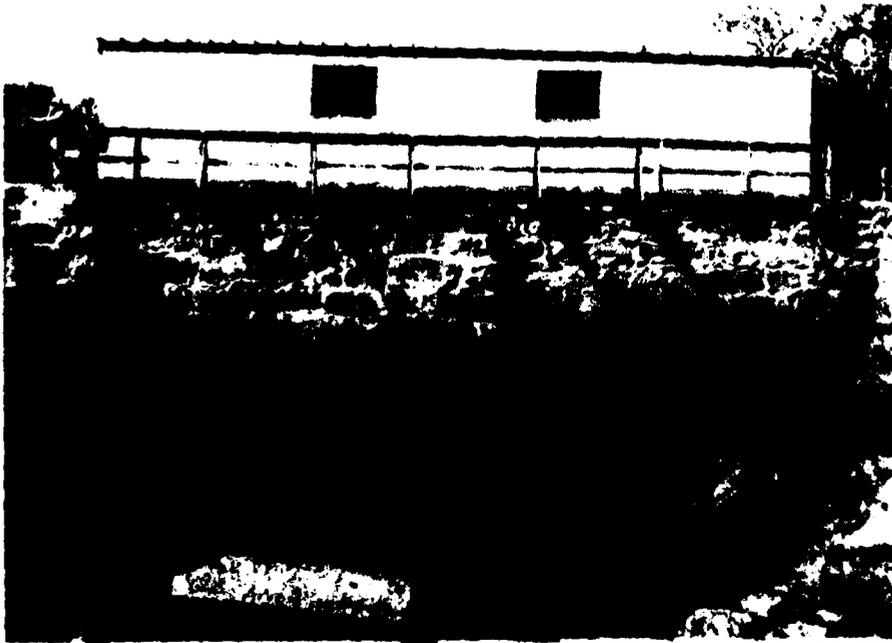
September 18, 1979  
Figure 3 - Looking at the gatehouse and low-level outlets.

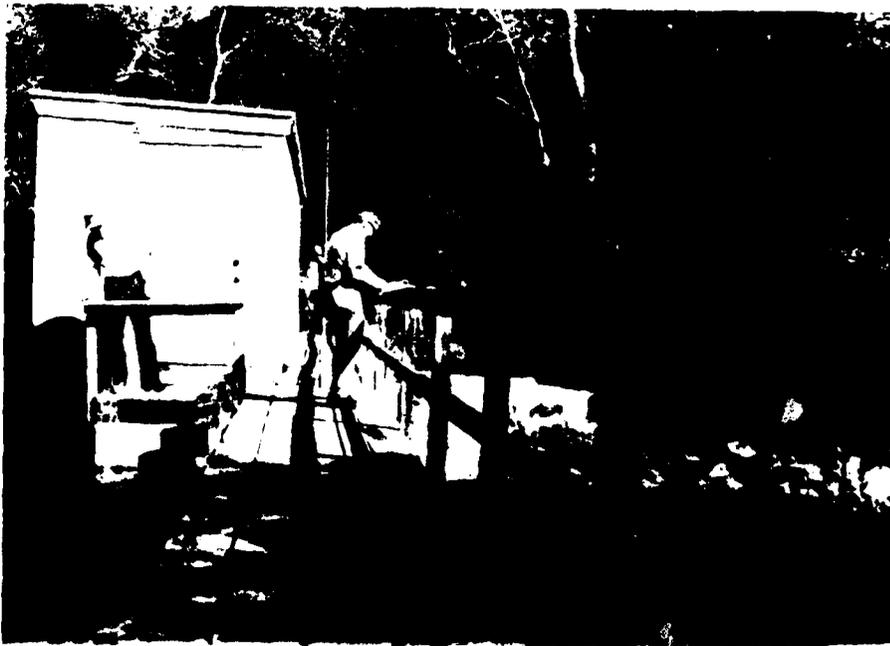
September 18, 1979  
Figure 9 - Looking across the crest of the service  
bridge.

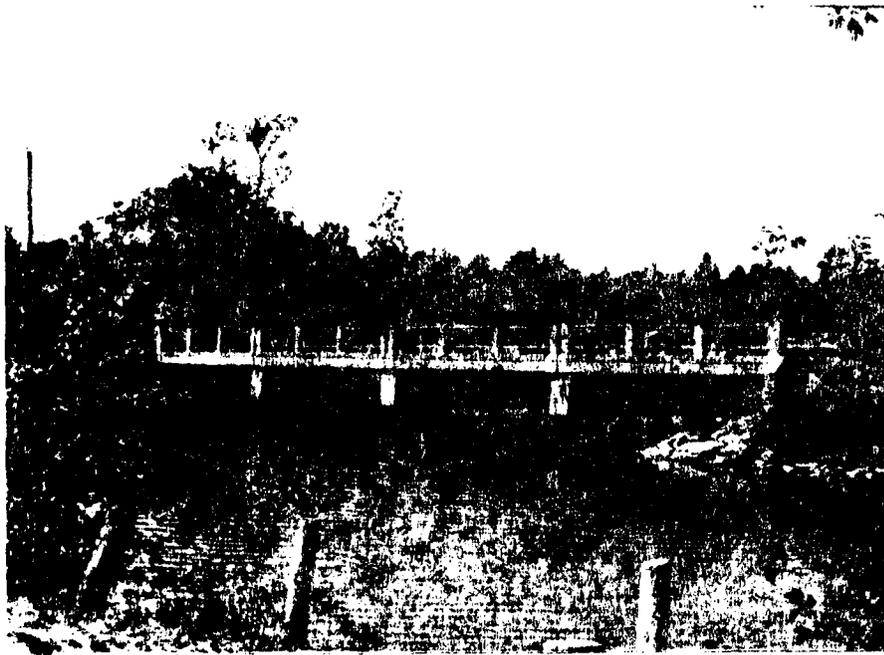
d. Reservoir Area. The watershed above the reservoir is moderately to steeply sloping and partially wooded. About 900 feet upstream of the dam a highway bridge crosses the approach channel. (See Appendix C - Figure 10.) Trees overhang both banks of the approach channel between the highway bridge and the dam. (See Appendix C - Figure 11.) Many camps are located on the shoreline of Cobbosseecontee Lake. No evidence of significant sedimentation was observed.

September 18, 1979  
Figure 10 - Close-up view of the Pond Road bridge.

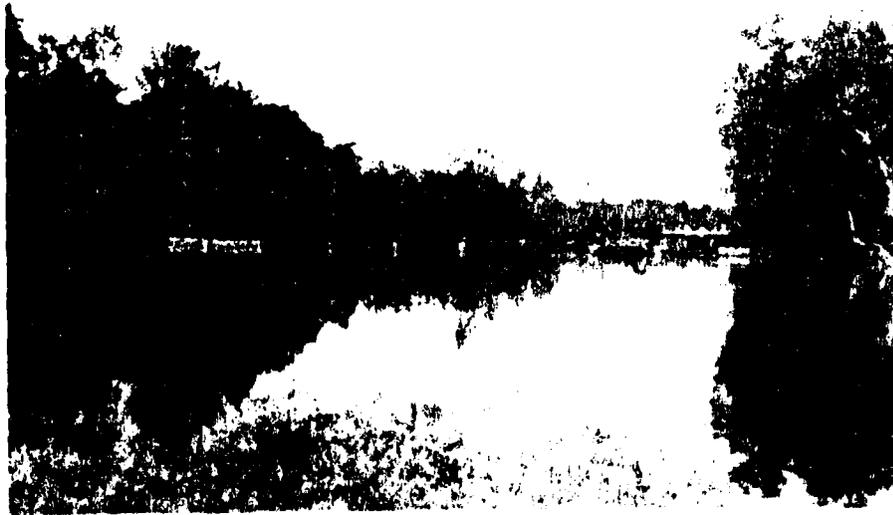
September 18, 1979  
Figure 11 - Looking at the approach channel  
from the bridge.

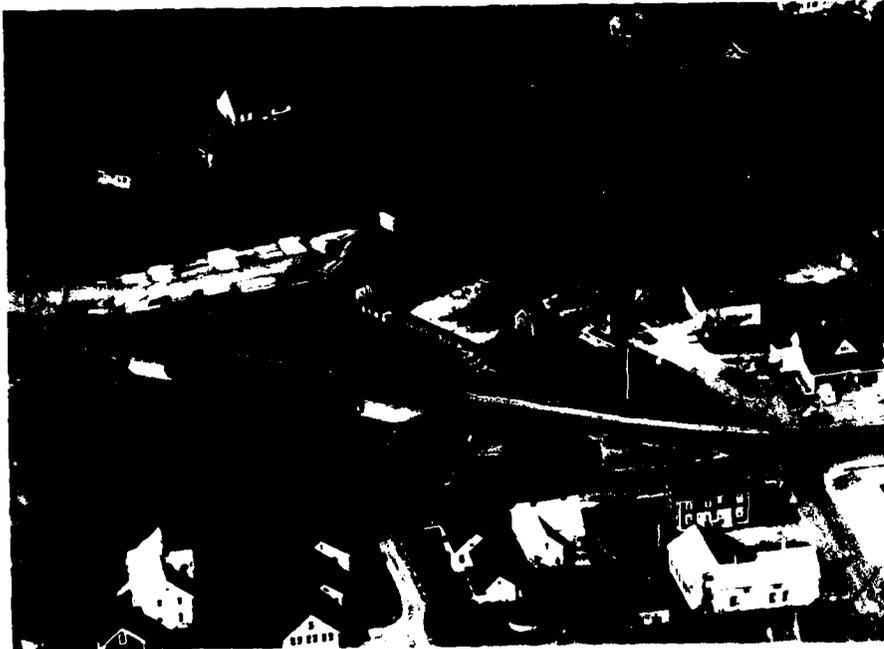
A stage discharge from Pleasant Pond, controlled by Gardiner Water District Dam, (See Appendix C - Figure 14.) was determined by use of the Corps of Engineers HEC-2 backwater computer program. It was determined that with a discharge of 3,250 cfs the elevation of Pleasant Pond would rise to 138.8' NGVD or 4.8 feet above normal level. This would cause backwater from the dam to the High Street bridge. The dam operators at Gardiner Water District Dam report no damage at elevation 138.1' NGVD (top of dam). The dam would be overtopped by 0.7 feet; damage would probably be minor. The 4.8-foot rise in Pleasant Pond would probably cause structural damage to cottages located on the shoreline; no loss of life is probable. Based on the above analysis, Cobbosseecontee Lake Dam was classified Significant Hazard.

October 1979  
Figure 14 - Overview of the Gardiner Water District  
Dam which impounds Pleasant Pond.
