POWDER MILL POND DAM
NH 00248

PHASE I INSPECTION REPORT
NATIONAL DAM INSPECTION PROGRAM

AUGUST 1978
85 06 14 098

Name of Dam Powder Mill Dam
State Located New Hampshire
County Located Hillsborough
City or Town Bennington
Stream Contoocook River
Date of Inspection 6/23/78

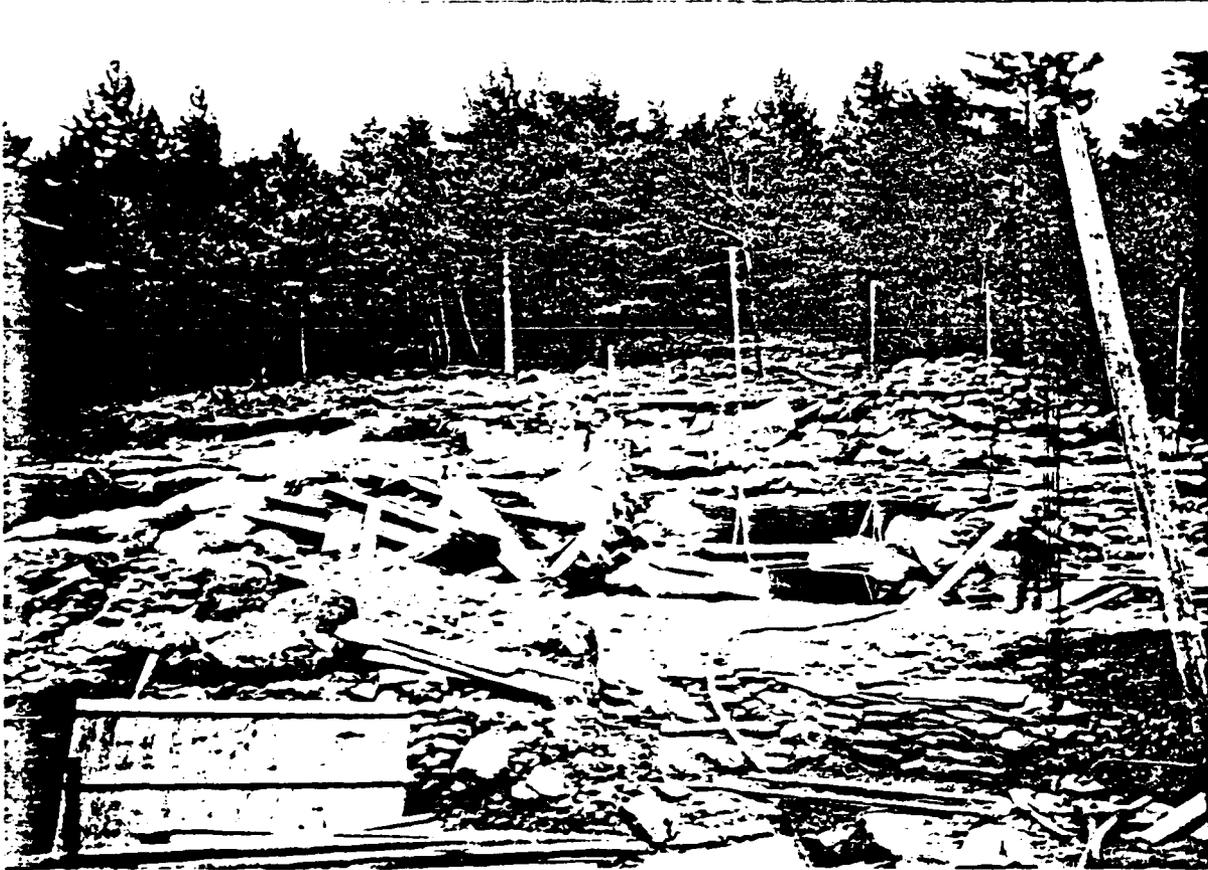
No. 1. Bennington Dam. Taken from the southerly
bank of the river, looking northerly along
proposed crest line of dam. July 1, 1924.
10:50 A.M.

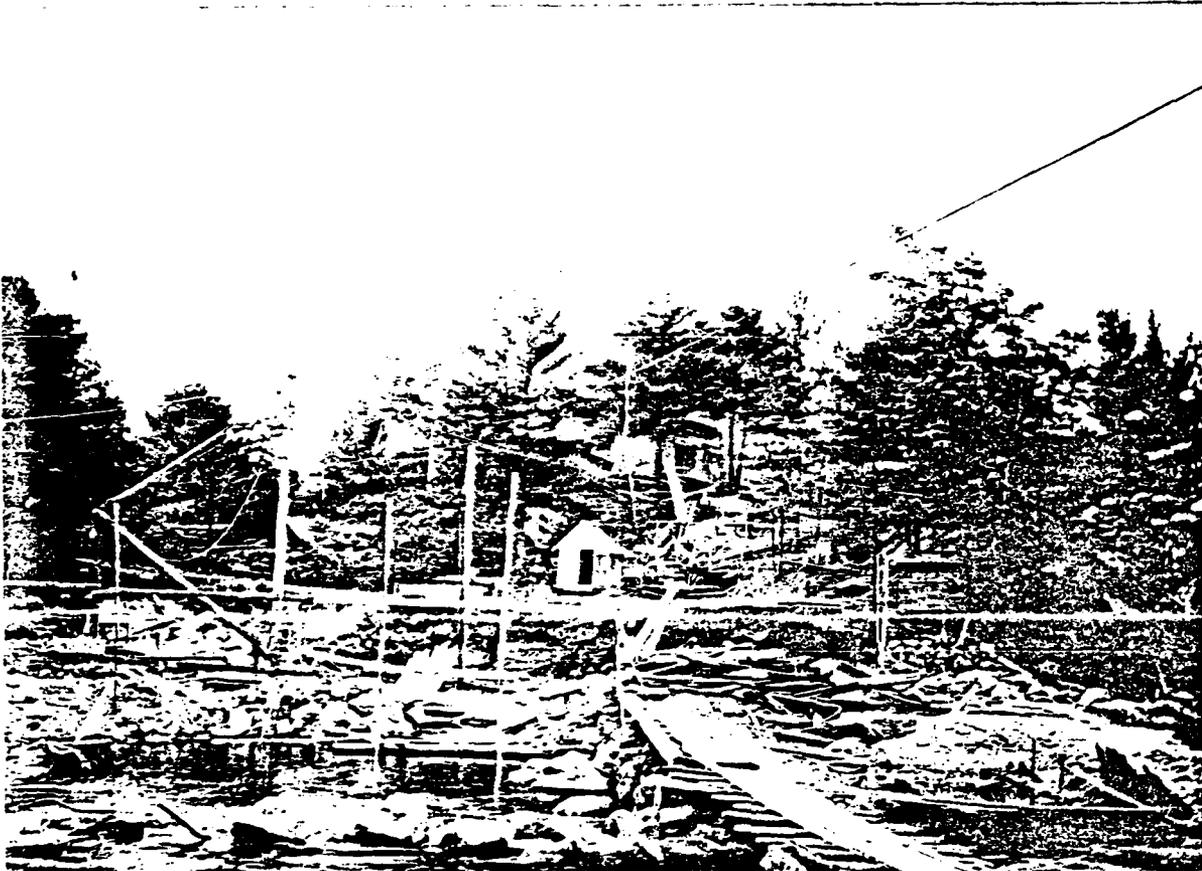
No. 2. Bennington Dam. Taken from the northerly bank of the river, looking southerly along proposed crest line of dam. July 1, 1924, 10:55 A.M.
