REPORT DOCUMENTATION PAGE		READ INSTRUCTIONS BEFORE COMPLETING FORM
1. REPORT NUMBER RI 00701	2. GOVT ACCESSION NO.	3. RECIPIENT'S CATALOG NUMBER
4. TITLE (and Subtitle) Cranston Print Works Pond Dam NATIONAL PROGRAM FOR INSPECTION OF NON-FEDERAL DAMS		5. TYPE OF REPORT & PERIOD COVERED INSPECTION REPORT

20. ABSTRACT (Continue on reverse side if necessary and identify by block number) The dam is a stone-faced earth embankment dam that is about 17 ft. high and 350 ft. long. The dam is considered to be in fair condition. There are some areas of concern which must be corrected to assure the long term performance of the dam. It is small in size with a high hazard potential. The test flood for the dam is the full PMF. There are various remedial measures which must be undertaken by the owner.

CRANSTON PRINT WORKS POND DAM

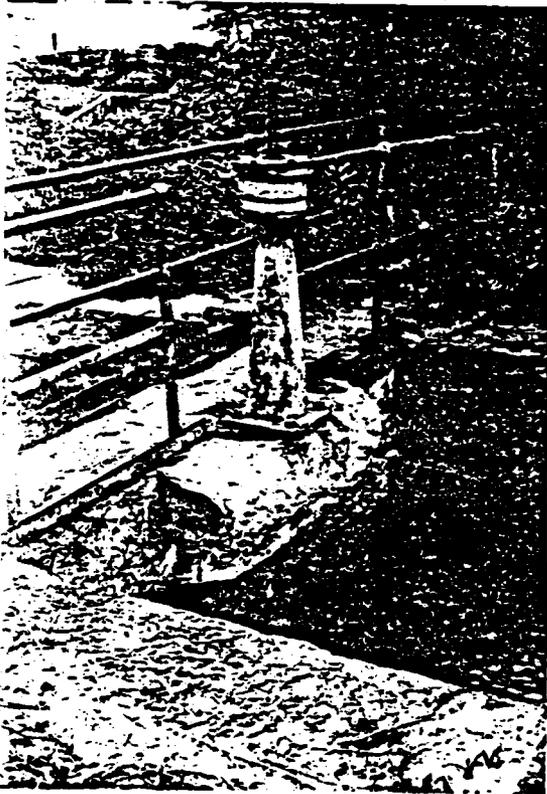
↑ Dismantled remains of "rack & pinion" type gear mechanism at draw-off gate.

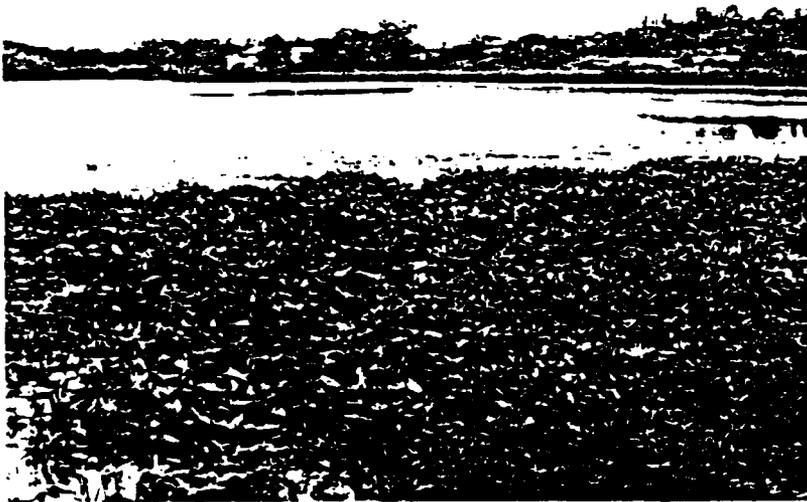
General view looking toward Dyer Pond, showing heavy accumulation of weeds in front of crest of spillway.

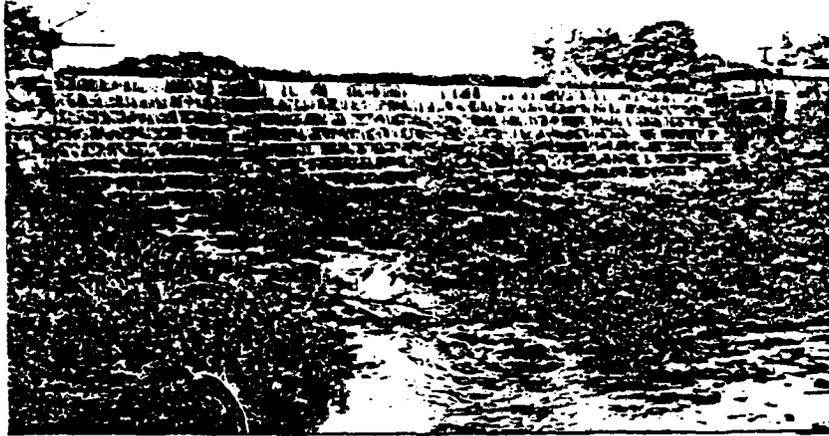
PHOTO #1. General view of stepped masonry face of spillway (also showing growth of vegetation in discharge channel).

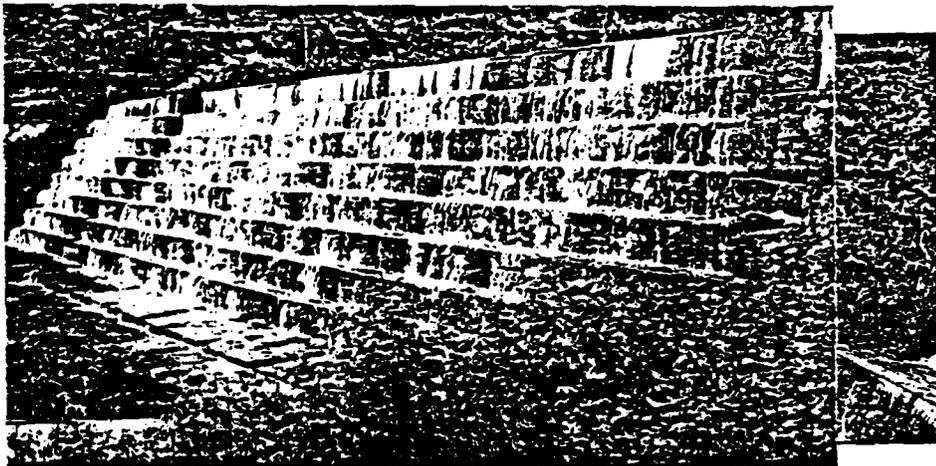
PHOTO #2. Close-up view of stepped masonry face of spillway and stone apron. (UNDER: view across crest also showing heavy growth of weeds. No irregularities noticeable across crest.)
