**WINNIBIGOSHISH DAM
MISSISSIPPI RIVER, MINNESOTA**

**RECONNAISSANCE REPORT FOR
DAM SAFETY ASSURANCE
PROGRAM**

MARCH 1985

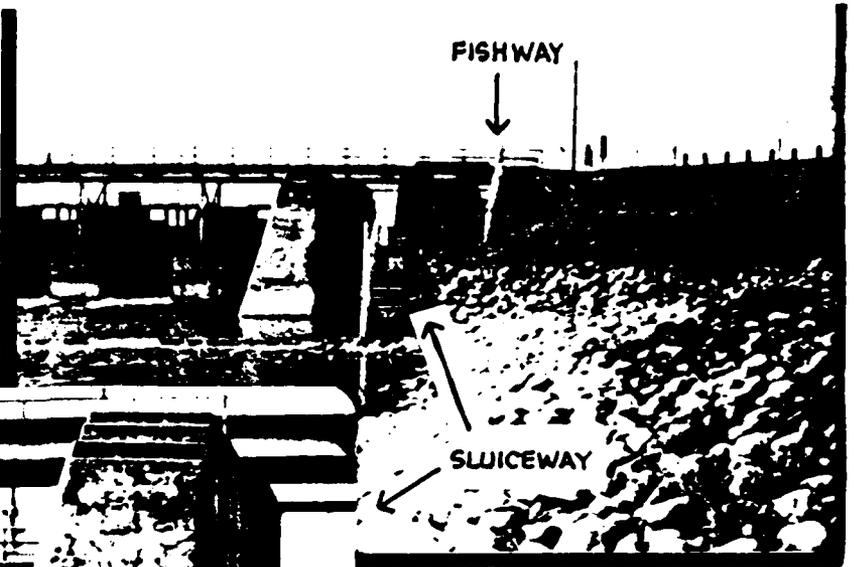
**DOWNSTREAM
SIDE**

24. As reported in PIR No. 1 the concrete in general is in good condition. (Only the concrete above the water surface could be observed because the control structure had not been dewatered). Some signs of deterioration were evident but in terms of stability and safety the concrete was believed to be sound. PIR No. 2 report observed change/additions of the concrete that were old in appearance and probably were those reported during the 1971 inspection. On the upstream side of the log sluice and fishway stoplogs, sand and/or silt has accumulated but no sounding data has been taken upstream of the structure. There are also some rust spots on the gate machinery walkway floor plates.
