REPORT DOCUMENTATION PAGE		READ INSTRUCTIONS BEFORE COMPLETING FORM
1. REPORT NUMBER NH 00479	2. GOVT ACCESSION NO.	3. RECIPIENT'S CATALOG NUMBER
4. TITLE (and Subtitle) Site 1- Basin Brook Dam NATIONAL PROGRAM FOR INSPECTION OF NON-FEDERAL DAMS		5. TYPE OF REPORT & PERIOD COVERED INSPECTION REPORT

DAM: Site 1 - Basin Brook
 IDENTIFICATION NO. NH 00479

Site 1 - Basin Brook Dam
 Chatham, New Hampshire

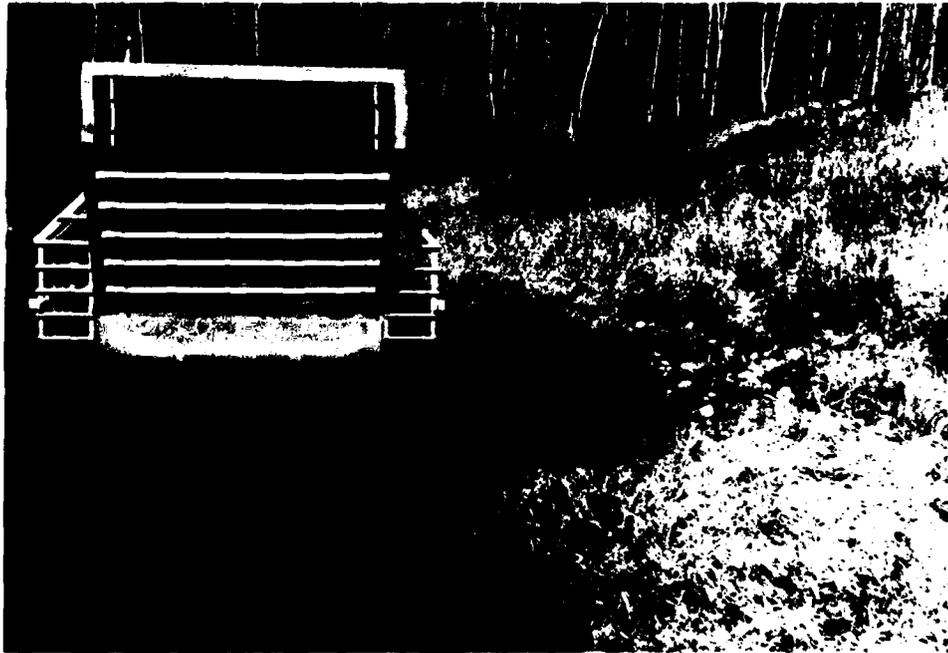
There has been minor erosion and sloughing at the toe of the upstream slope, between the principal spillway and the dam embankment, Photo No. 3. The erosion has cut into the toe of the slope at one point leaving a vertical bank approximately 12 to 15 in. high over a width of about 8 ft. Near the right end of the embankment, a small path about 6 in. deep and 2 ft. wide has been worn by foot traffic and rainfall. Overall, the upstream slope appears to be in good to excellent condition.

AREA EVALUATED	CONDITION
<u>DAM EMBANKMENT</u>	
Crest Elevation	El. 681.5
Current Pool Elevation	El. 662.2
Maximum Impoundment to Date	Unknown
Surface Cracks	None observed
Pavement Condition	No pavement; top of dam is grass covered with some bare areas. Shallow ruts from vehicle traffic present
Movement or Settlement of Crest	None observed
Lateral Movement	None observed
Vertical Alignment	Good
Horizontal Alignment	Curved, see Appendix page B-17
Condition at Abutment and at Concrete Structures	Satisfactory
Indications of Movement of Structural Items on Slopes	No structures on slopes other than principal spillway - See Outlet Works
Trespassing on Slopes	Unrestricted
Animal Burrows in Embankment	None observed
Vegetation on Embankment	Heavy growth of moss, grass and weeds; no brush or trees
Sloughing or Erosion of Slopes or Abutments	None except at upstream toe behind spillway intake structure (see Photo No. 3)

3. Toe of upstream slope adjacent to principal spillway

1. Place well-graded crushed stone fill at the toe of the upstream slope in the area experiencing erosion and sloughing. It is suggested, that due to the limited extent of the erosion, this work be done by manual means so that the slope is not subjected to heavy equipment traffic. The performance of the crushed stone fill should be monitored for evidence of any further erosion and/or sloughing. If the repair is observed not to be effective, the owner should then investigate the means of establishing erosion control in the failed area. This investigation should be conducted under the direction of a registered professional engineer.

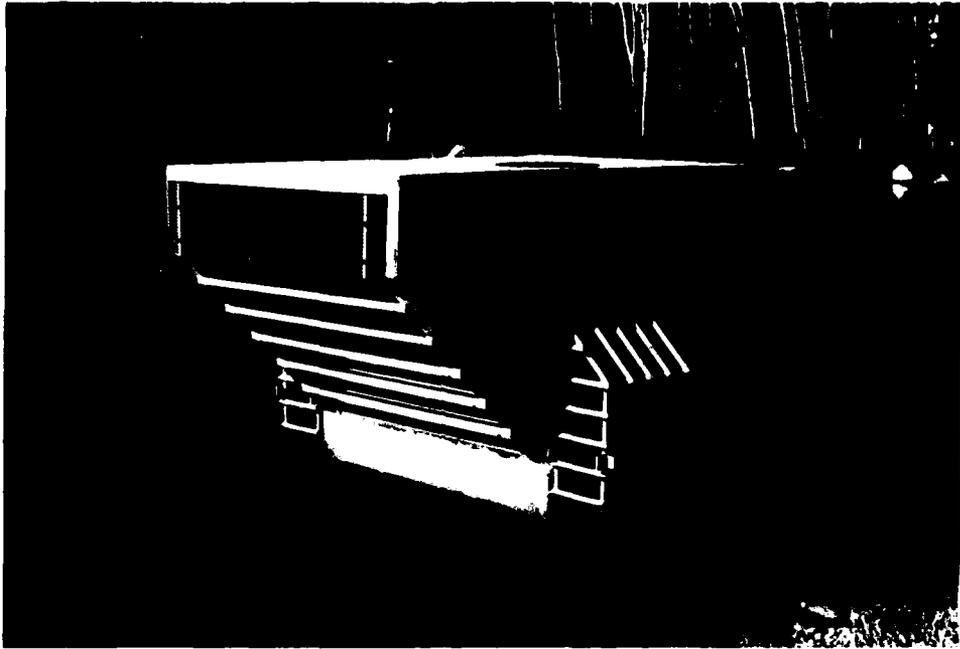
c. Appurtenant Structures. In general, the principal spillway is in good condition, Photo No. 8. The inlets were clear of obstructions and the bar racks were undamaged and intact with only minor surface rust. Although the gate operator for the reservoir drain was not tested, nothing was observed which would indicate potential difficulty in operating the gate. The interior ladder appeared to be in good condition, Photo No. 9.

8. Principal spillway
