AFRPL TR-85-057

Final Report  
for the period  
1 May 1984 to  
31 May 1985

# Acoustical Imaging System Evaluation

**Air Force  
Rocket Propulsion  
Laboratory**

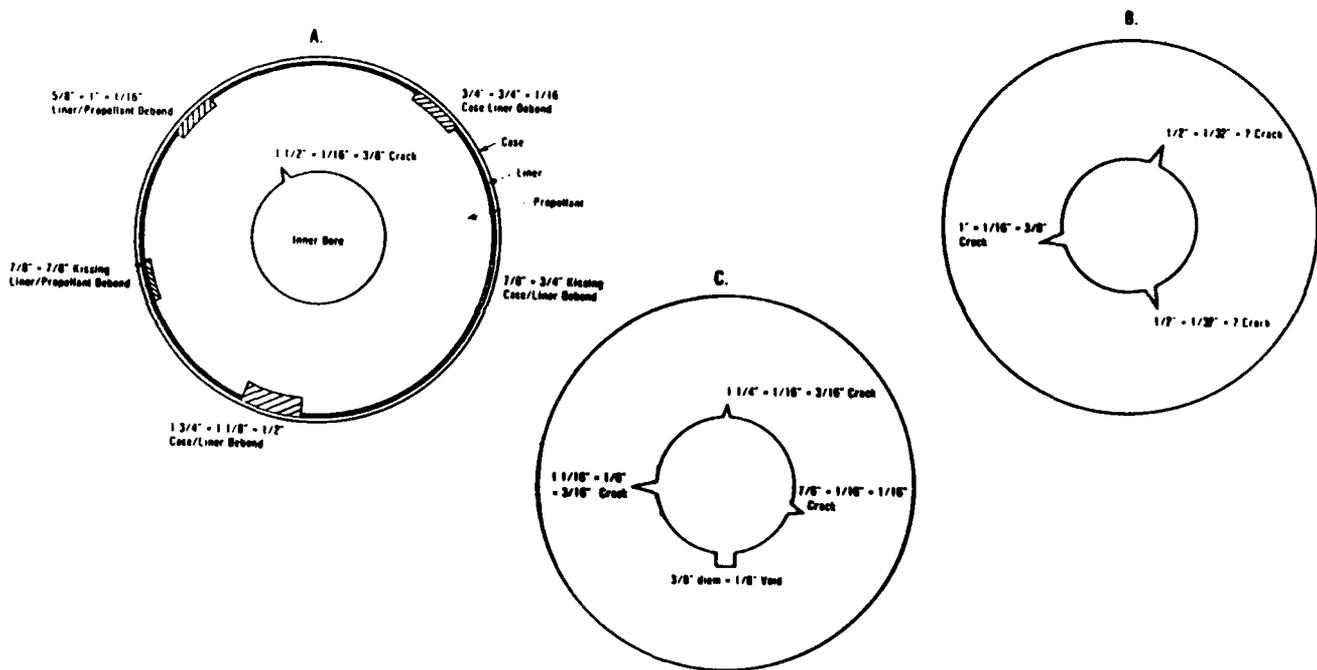
2. TA2 was also an 18-inch Sidewinder section. Five debonds of varying sizes and types (case/liner, liner/propellant, and two kissing debonds) were hand cut in one end of the section (see Fig. 1a). Three naturally occurring cracks were found in the middle of the section (see Fig. 1b). At the opposite end, four inner bore defects of varying lengths, depths, and widths were cut (Fig. 1c). Due to inaccuracies in measuring the cuts, no definitive conclusions were drawn from the TA2 test runs, but the tests did give us a good idea of the Batelle machine's capabilities and guided us in manufacturing TA4.

Figure 1. Test Article 2 (Inert Sidewinder Section). A) Debond End, B) Middle, C) Crack End. All dimensions are length x width x depth.

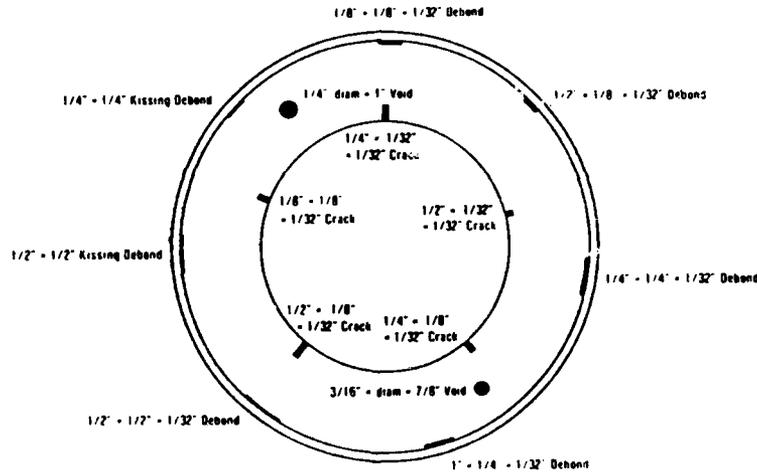
4. TA4, an inert BATES grain that the AFRPL Propellant Laboratory prepared especially for this program, used a phenolic container and an inert propellant that closely simulates the Sidewinder propellant. Teflon shims cut to specific sizes were glued to the mandrel to simulate inner bore cracks and glued to the inside of the case to simulate debonds. Once the vacuum poured propellant set, the shims could easily be removed leaving an air gap of precise dimensions. Two teflon rods were inserted in the middle of the grain to simulate voids in the propellant (see Fig. 2). TA4 was used in the experiment's final phase to determine AIS's exact sensitivity. Note that TA4 does not have a liner. Since the acoustic properties of the liner and the propellant are very similar, and since we knew the AIS could not detect a liner/propellant debond, we decided not to include a liner in the test article, saving us time and reducing the complexity of the manufacturing task.

Figure 2. Test Article 4 (Composite Case BATES). All Dimensions are length x width x depth.

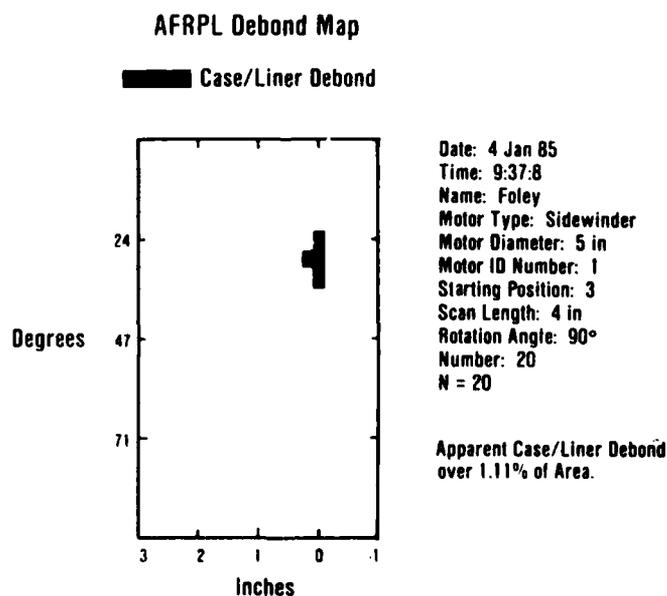
Figure 3. AIS Scan of a 3.4" long x 3/4" wide x 1/16" deep Case/Liner Debond in TA2.

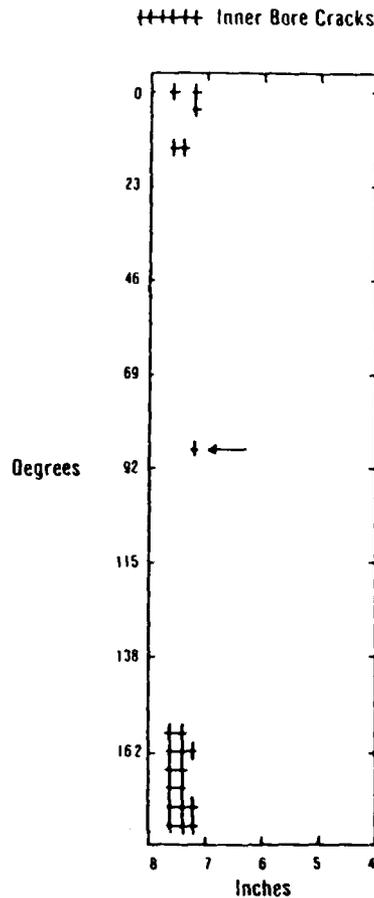
Figure 4. AIS Scan of a Crack (Arrow) 7/8" long x 1/32" wide x 1/16" deep.

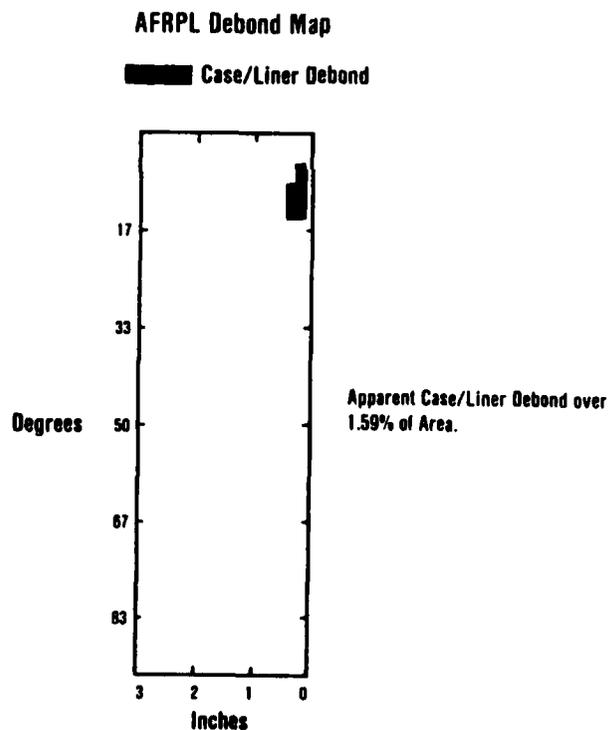
The pulse-echo subsystem can detect a 1/8-in. x 1/8-in. x 1/32-in. case/liner debond with very high repeatability (Fig. 5). A software change, not currently available at the AFRPL, must be made for the system to detect liner/propellant debonds. However, Ref. 1 states that the results of Battelle's liner/propellant debond work were poor.

Figure 5. AIS Scan of a Debond 1/8" long x 1/8" wide x 1/32" deep in TA4.

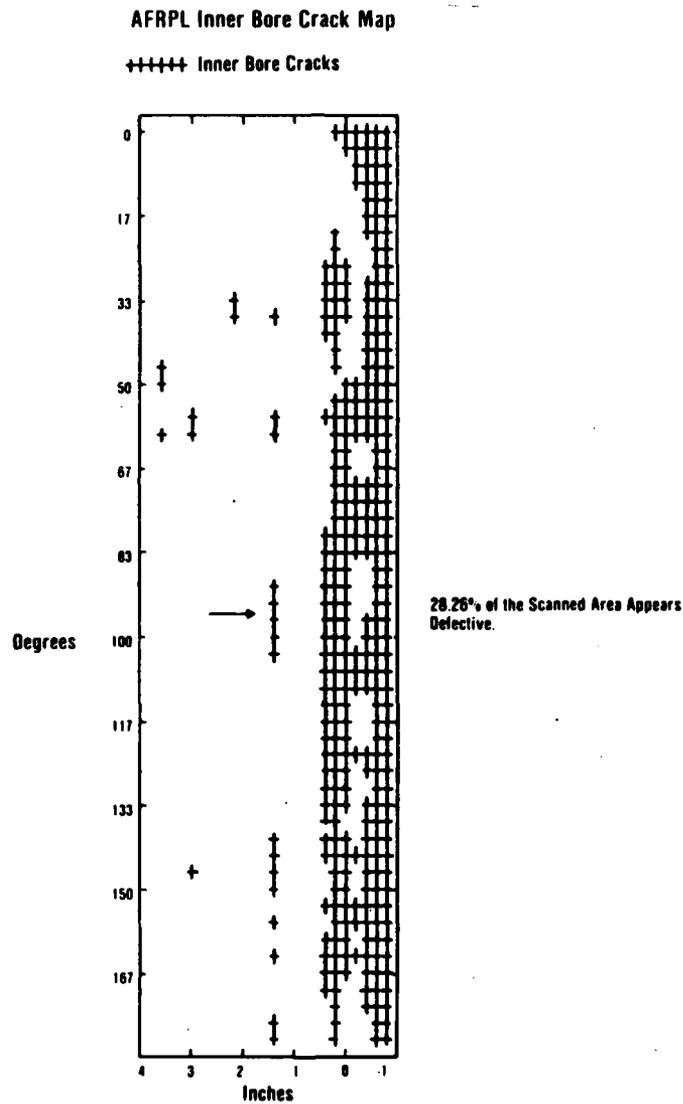
The through transmission system consistently detected 1/8-in. x 1/32-in. x 1/8-in. cracks with only a medium repeatability. (Note the noise problem shown in Fig. 6.) The through transmission system could also detect a 1-in. x 1/4-in. void located in the propellant half way between the case and the inner bore of the BATES grain (about 3/4 inch from the bore). Repeatability for void detection is low because the indication on the map is vague compared to the size of the flaw (Fig. 7).

Figure 6. AIS Scan of a Crack (Arrow) 1/8" long x 1/32" wide x 1/8" deep in TA4.

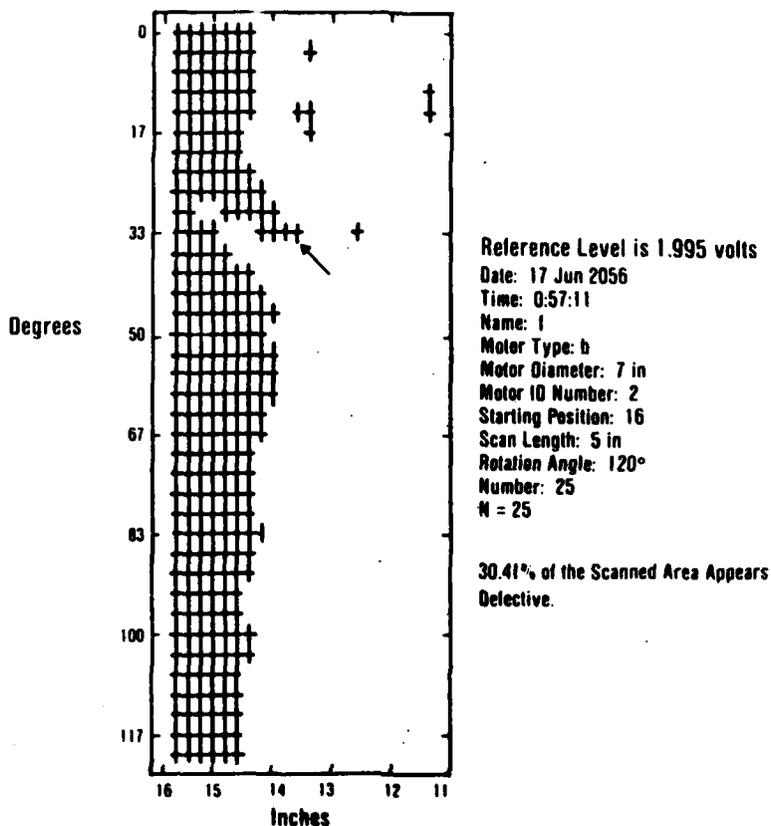
Figure 7. AIS Scan of a Void, 1" long x 1/4" diameter in TA4.

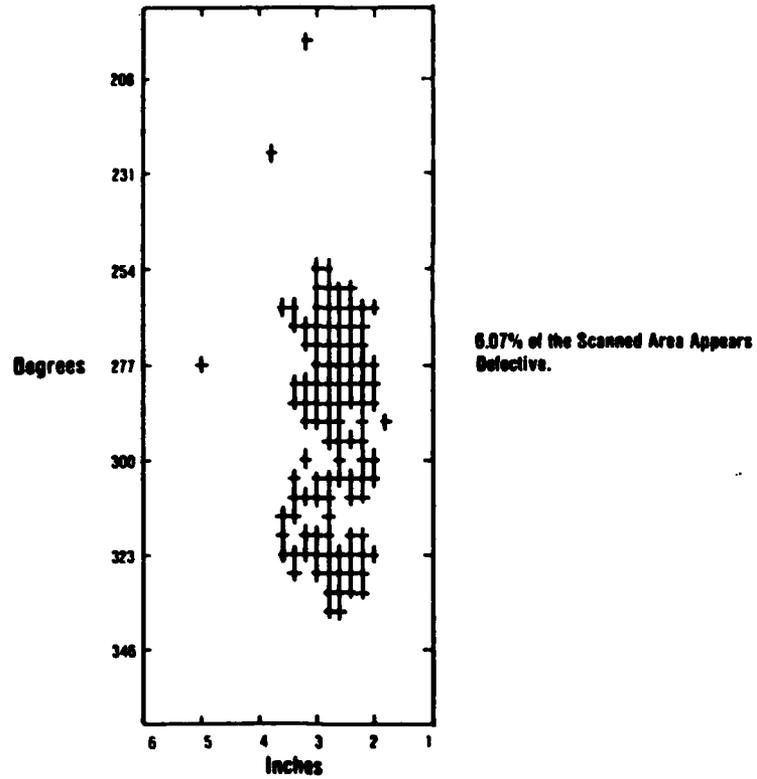
It has been clearly demonstrated that the AFRPL Acoustic Imaging System can reliably detect inner bore flaws and case/liner debonds. Small 1/4 in. x 1/32 in. x 1/16 in. cracks were detected with low repeatability. However, more realistically sized naturally occurring 1-in. x 1/16-in. x 3/8-in. cracks could be detected with high repeatability (Fig. 8). The smallest nonkissing case/liner 1/8-in. x 1/8-in. x 1/32-in. debond tested could be very reliably detected.

Figure 8. AIS Scan of a Crack 1" long x 1/16" wide x 3/8" deep in TA2.
