Technical Memorandum

UNITED STATES NAVY - CANADIAN FORCES
SOLID STATE FLIGHT DATA RECORDER/CRASH POSITION LOCATOR
EXPERIMENT ON THE B-720 CONTROLLED IMPACT DEMONSTRATION

11 November 1985

TM 85-76 SY

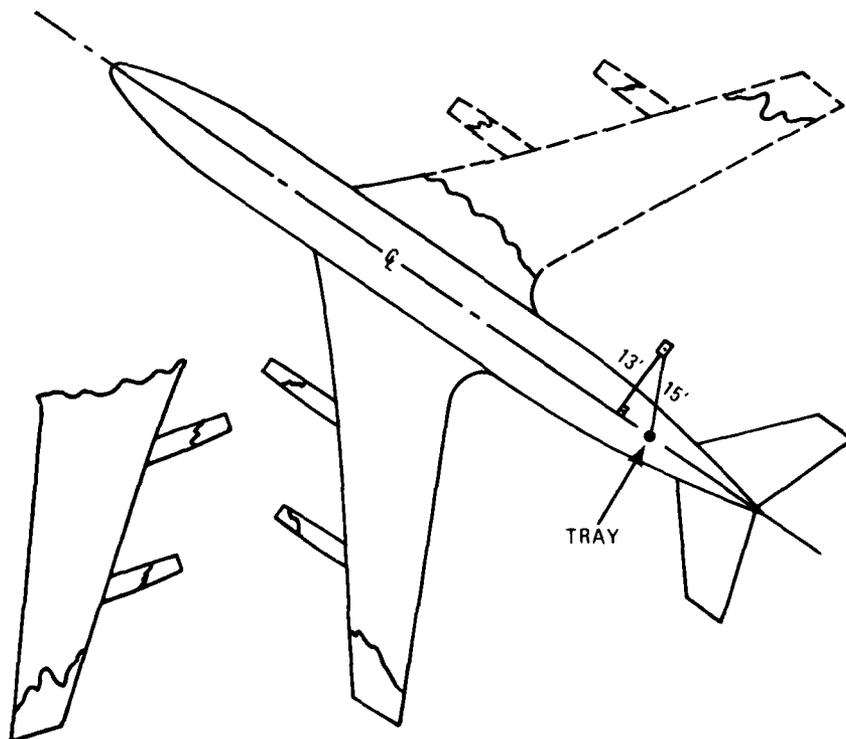
Figure 7
RBA-46 LOCATION RELATIVE TO B-720 AFTER CID

11. Navy personnel access to the crash site was allowed on the morning of 2 December 1984. The CPL RBA-46 was found resting top side up, 15 ft forward and 13 ft perpendicular from the tray location on the starboard side of the aircraft. Figure 7 shows the final location of the CPL RBA-46. An immediate inspection indicated the airfoil suffered moderate fire damage with paint peeling but not intumescing. The VMS lamp housings were intact but extensively burned such that it was impossible to see if the lamps had survived. The airfoil suffered minor structural damage, with assorted dents, etc. The SSFDR cavity was intact with the top surface of the recorder being blackened by fire. Figures 8 and 9 show the CPL RBA-46 as found at the B-720 crash site.

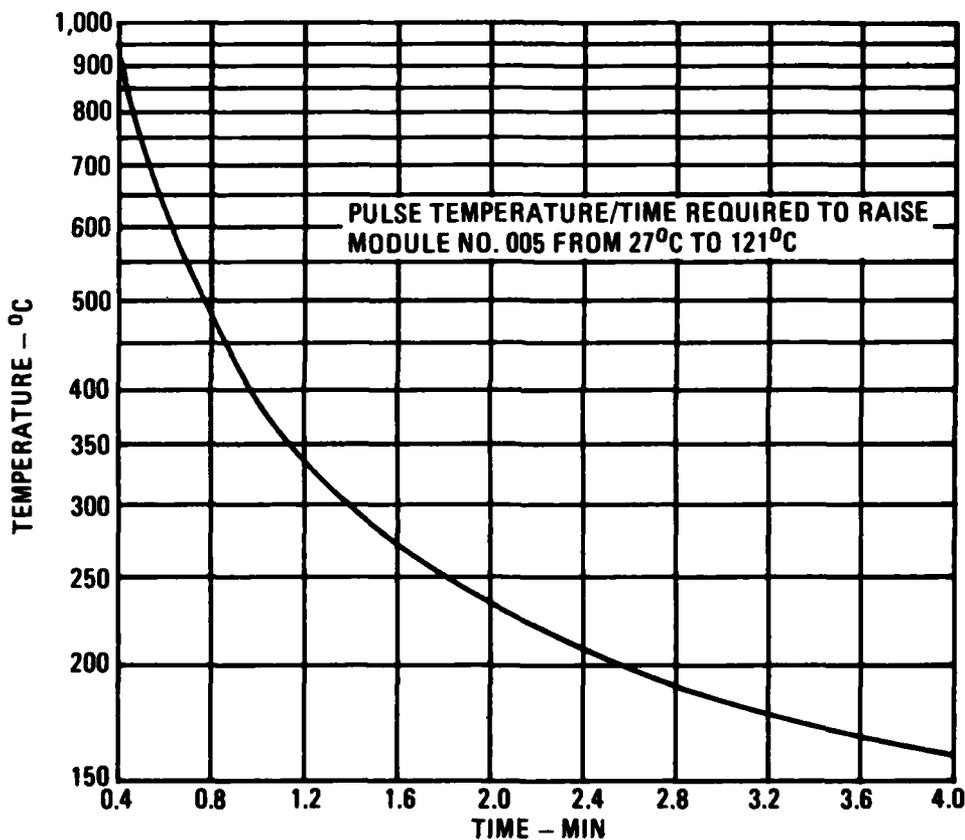
Figure 15
PULSE TEMPERATURE RECEIVED BY SSFDR DURING B-720 CID

26. Analysis of the B-720 video tape indicates the airfoil was awash in flames for approximately 6 sec. Thermal calculations are based upon the 121°C reading on memory module No. 005. As shown in table I, this module could have attained the 121°C by the application of a heat equivalent to a step function temperature as shown in figure 15.

27. The intumescent coating (Ocean 477) used on the SSFDR is manufactured by Ocean Chemicals Inc., Savannah, Georgia. Discussions with Ocean Chemical's technical representative determined that the coating will intumesce in approximately 6 sec when exposed to a temperature of 925°C (1,700°F). Considering that the intumescent paint did not intumesce and that the fire crews were on site within approximately 1 1/2 min, it can be speculated that the temperature seen by the airfoil was equivalent to a pulse temperature of 160°C to 400°C for a duration of 3 min as shown in figure 15.

28. The apparent discrepancy between the airfoil being awash in flame and the calculated pulse temperature can be explained by a film of cool fuel separating the flames and the airfoil during the crash sequence and prior to deployment.
