①
UNDERWATER FACILITIES
INSPECTIONS
AND
ASSESSMENTS
AT

NAVAL AIR STATION
WHIDBEY ISLAND,
OAK HARBOR, WA

FPO-1-83-(41)

SEPTEMBER 1983

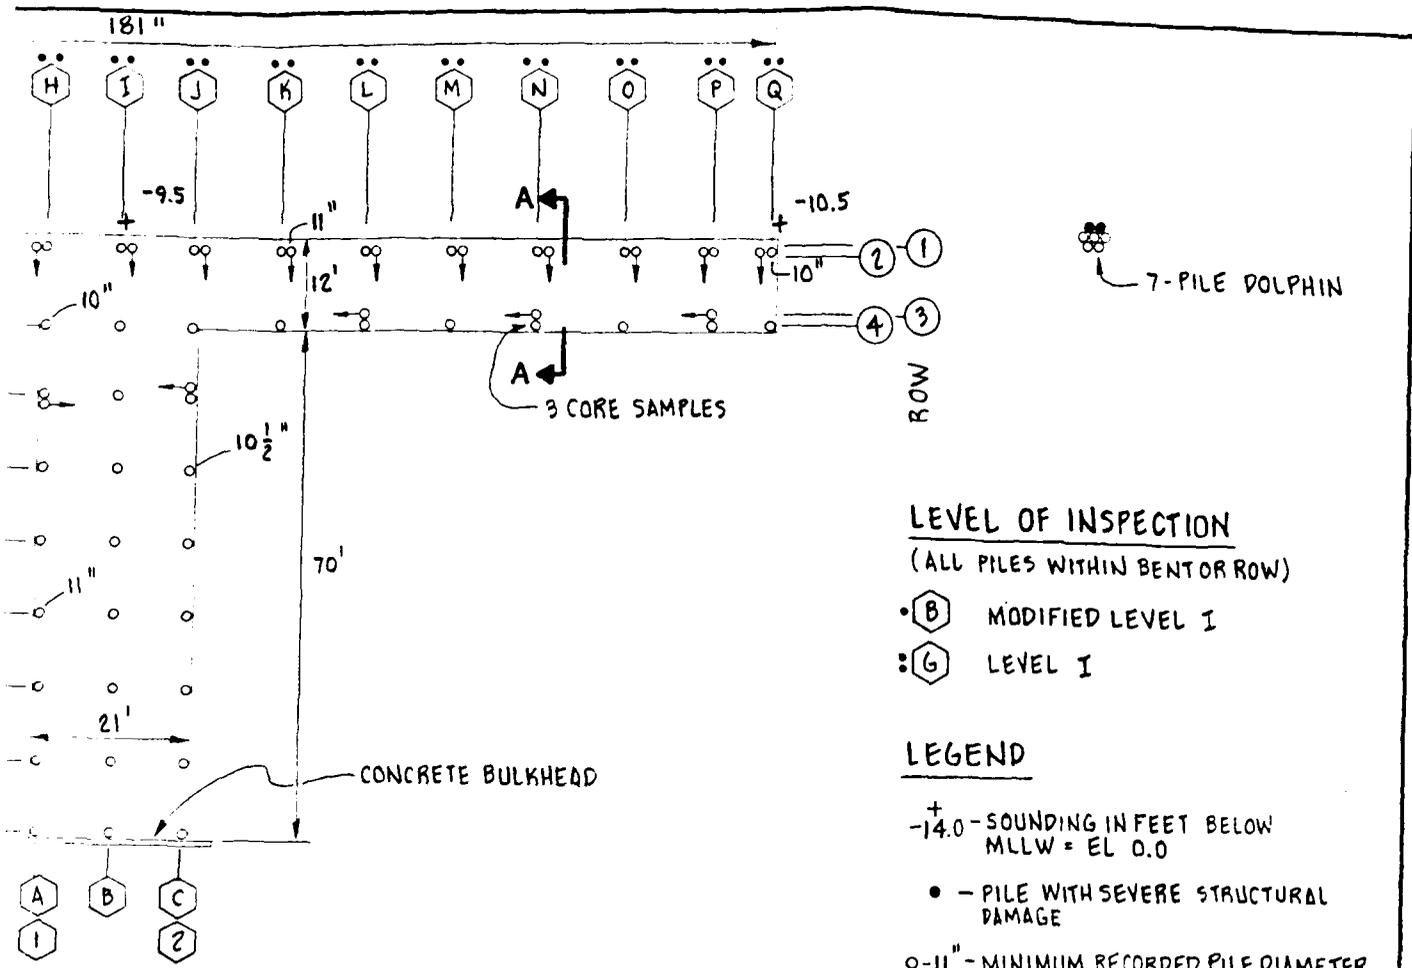
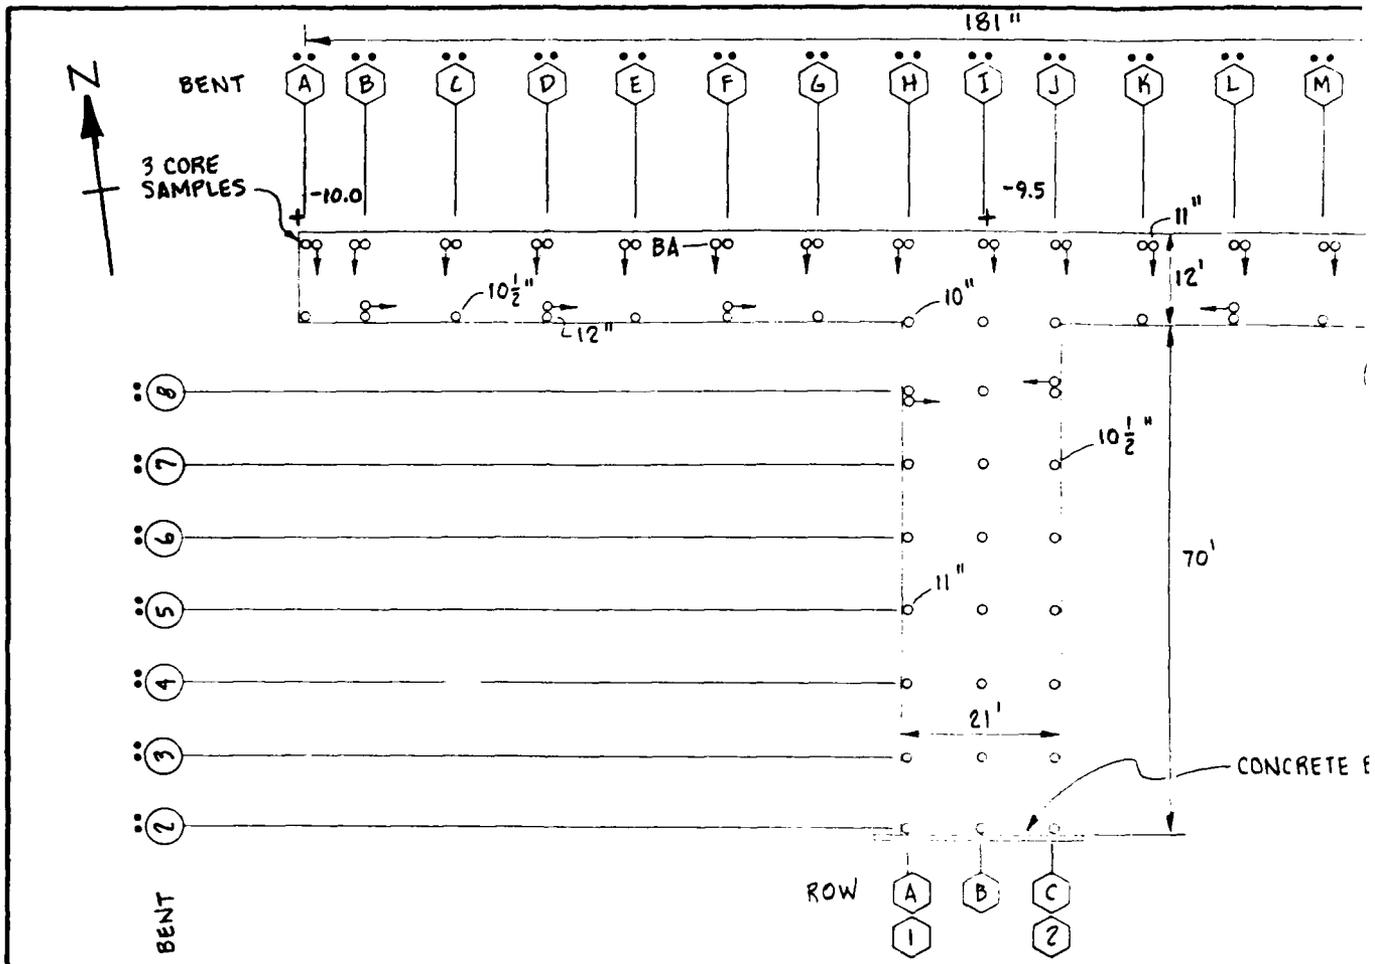
GRAPHIC SCALE	CHILDS ENGINEERING CORPORATION 801 333 WEDFIELD MA	CHESAPEAKE DIVISION NAVAL FACILITIES ENGINEERING COMMAND WASHINGTON D C	
AS SHOWN		NAVAL AIR STATION FUEL PIER	WHIDBEY ISLAND, WA FIG NO 6

are broken approximately 3' below MLLW. It appears the breaks are the result of impact from a berthing vessel (for location see Figure 6.

The two (2) broken piles found in the 7-pile dolphin have seriously reduced this structure's capacity to resist berthing loads. If these piles are not repaired, it is possible that the dolphin will fail if it is subjected to a significant impact.

To return the 7-pile dolphin to design capacity, the two (2) broken piles should be replaced. It is estimated that the cost of this repair is approximately \$8,400.00.
