UNDERWATER FACILITIES

REFIT PIERS 1 & 2
TRIDENT REFIT FACILITY
BANGOR, WASHINGTON

FPO-1-82 (02)

JUNE, 1981

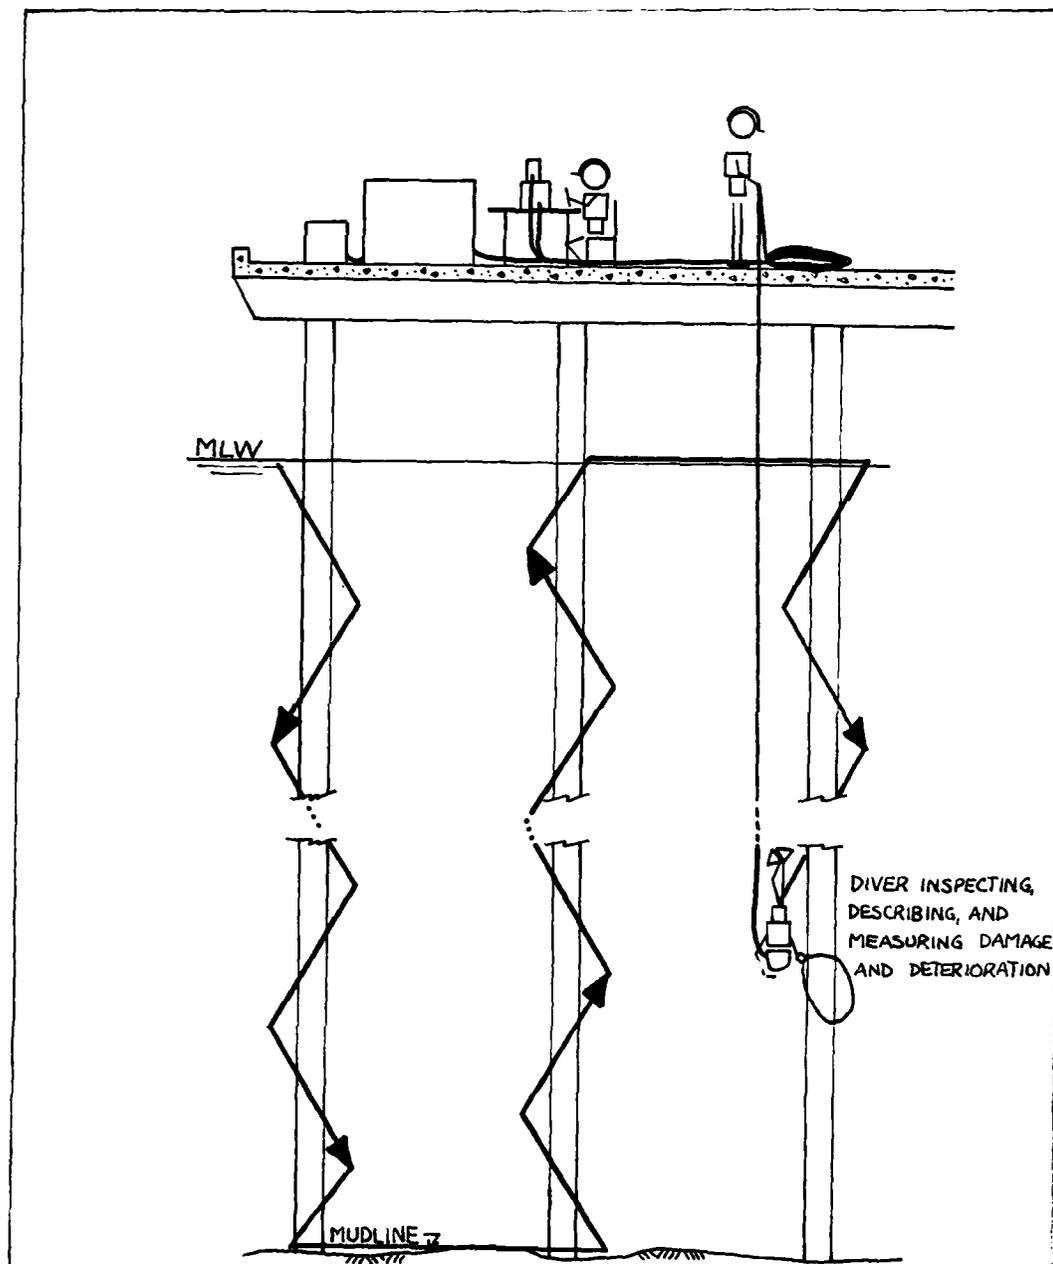
FIG.3 TYPICAL DIVER INSPECTION PATH

The underwater inspection team consisted of one engineer/diver and three inspection diver/tenders. Due to the configuration of the structure, the depths involved, and to insure an accurate inspection and accurate note-taking, surface-air-supplied diving was employed. The dive station consisted of a compressor, volume tank, two-way communications radio, pneumofathometer, and back-up air supply system. Inspection depths and dive durations required a decompression chamber to be operational at the dive location. The surface-air-supplied method of diving allowed the inspecting diver to describe, in detail, any damage or deterioration that was encountered via two-way communications. The inspecting diver would inspect a pile, cleaning growth as necessary, looking for cracks, voids, rust stains, loss of epoxy, exposed reinforcing steel, and other signs of damage or deterioration. After descending down one pile, inspecting it in a semi-spiral fashion to view each face, the engineer/diver would move to the next pile and ascend while inspecting for damage or deterioration. (See Figure 3).

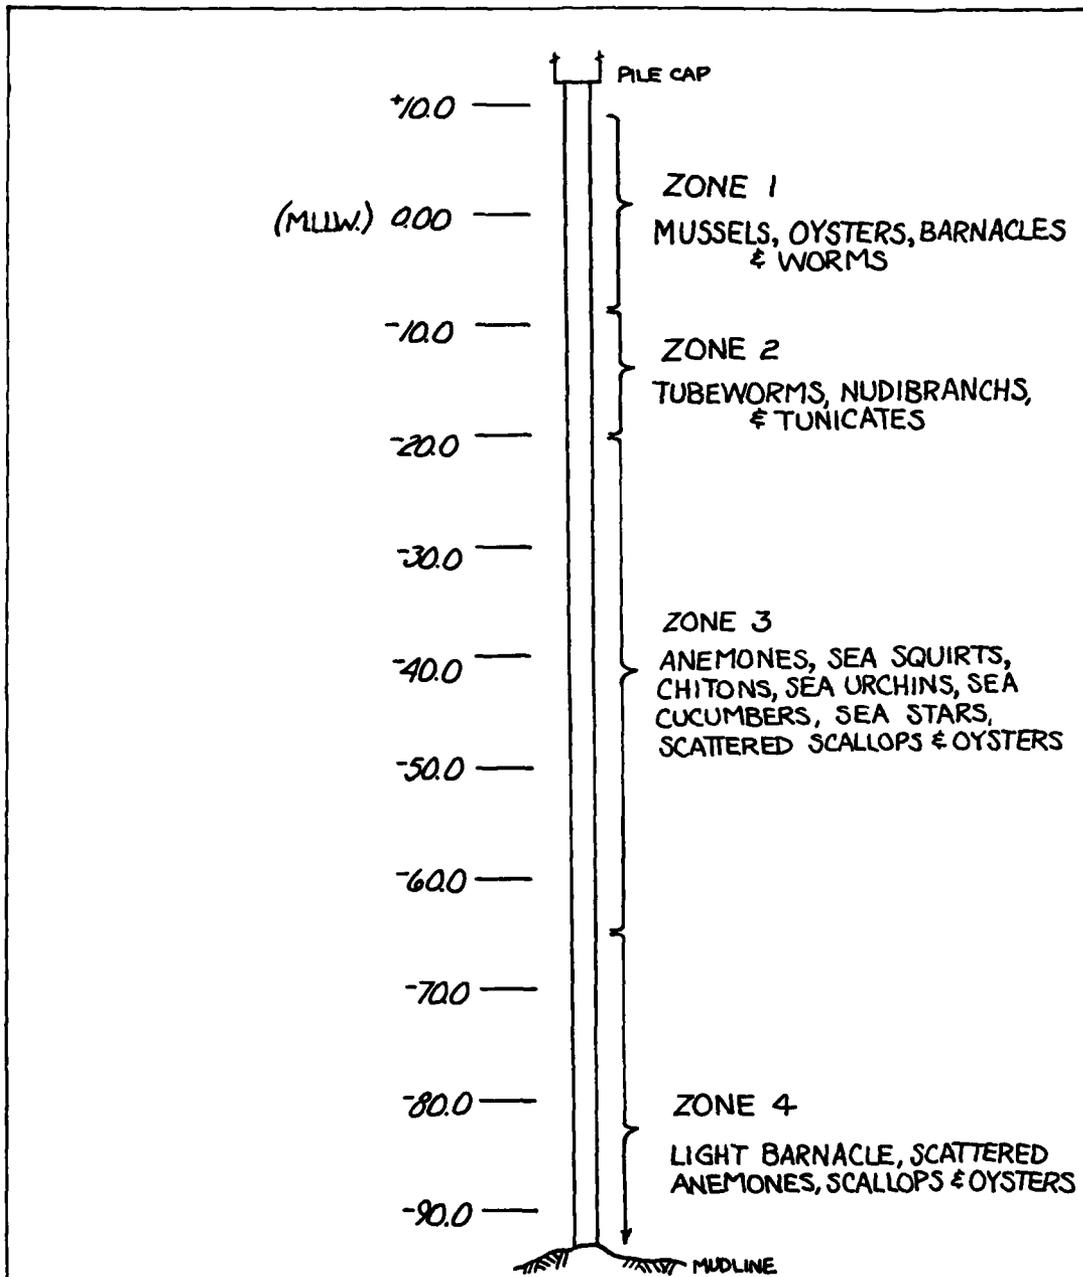
FIG. 4 MARINE GROWTH PROFILE - CONCRETE PILES

Marine growth on the concrete piles was found to be divided into four major zones:

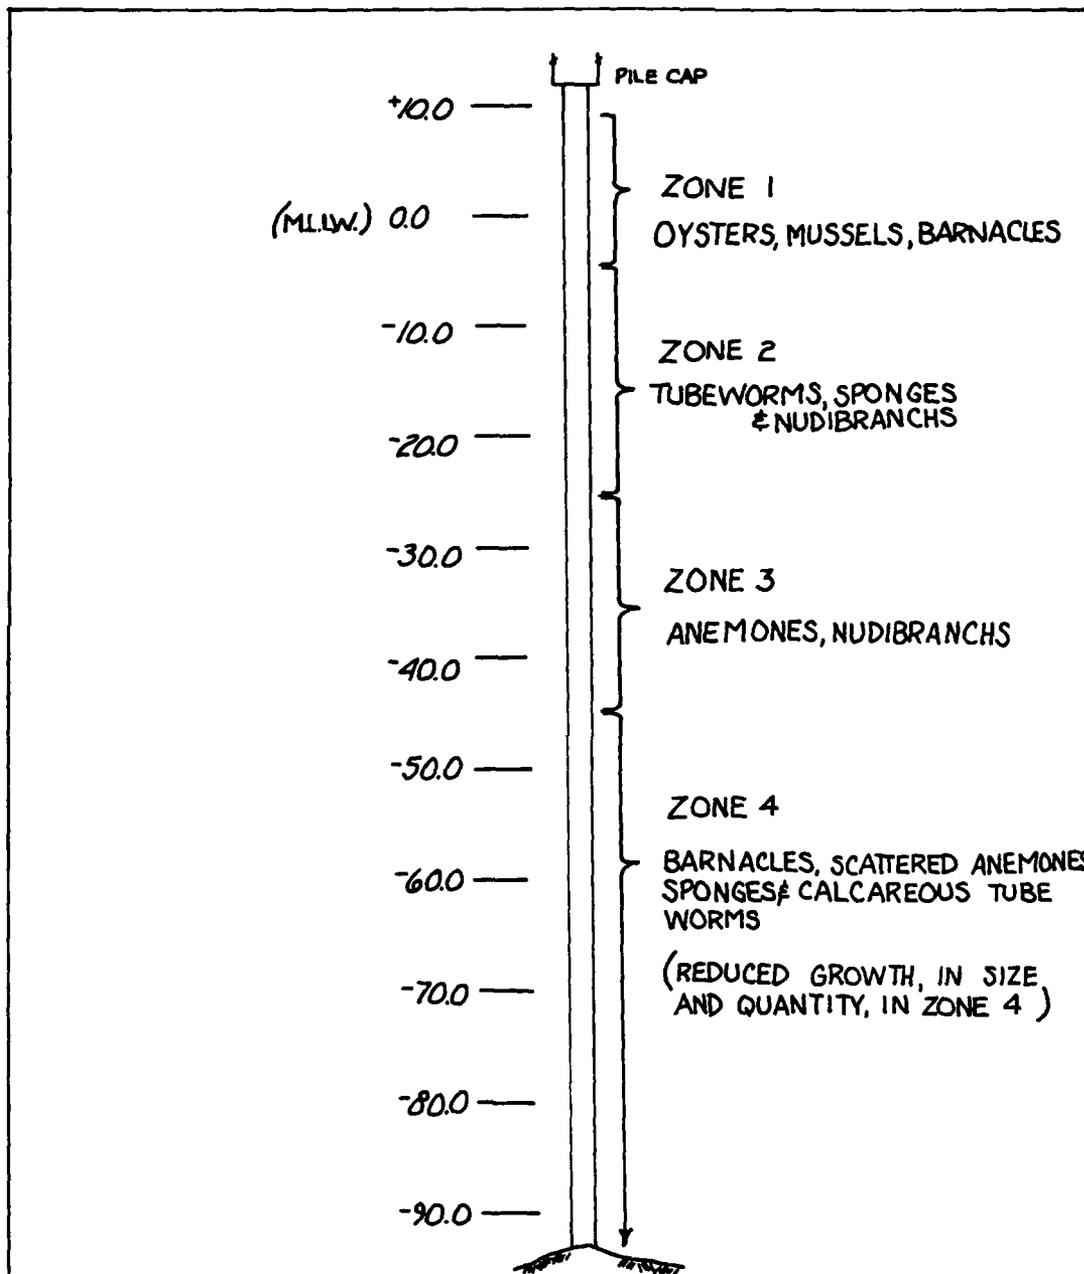
FIG. 5 MARINE GROWTH PROFILE - STEEL PILES

Marine growth on the steel piles differs in three ways from that on the concrete piles. First, it does not exhibit the variety of organisms observed on the concrete piles. Second, the thickness of the growth never approaches that seen on the intertidal areas of the concrete piles. Finally, the thickness and the composition of the coverage is more consistent along the entire length of the pile than what is noted on the concrete piles.
