**NAVAL WEAPONS
STATION
EARLE
FLEET MOORINGS
UNDERWATER
INSPECTION
REPORT**

MAY 1983

OCEAN ENGINEERING
AND CONSTRUCTION PROJECT OFFICE
CHESAPEAKE DIVISION
NAVAL FACILITIES ENGINEERING COMMAND
WASHINGTON, D.C. 20374

FPO-1-83 (16)

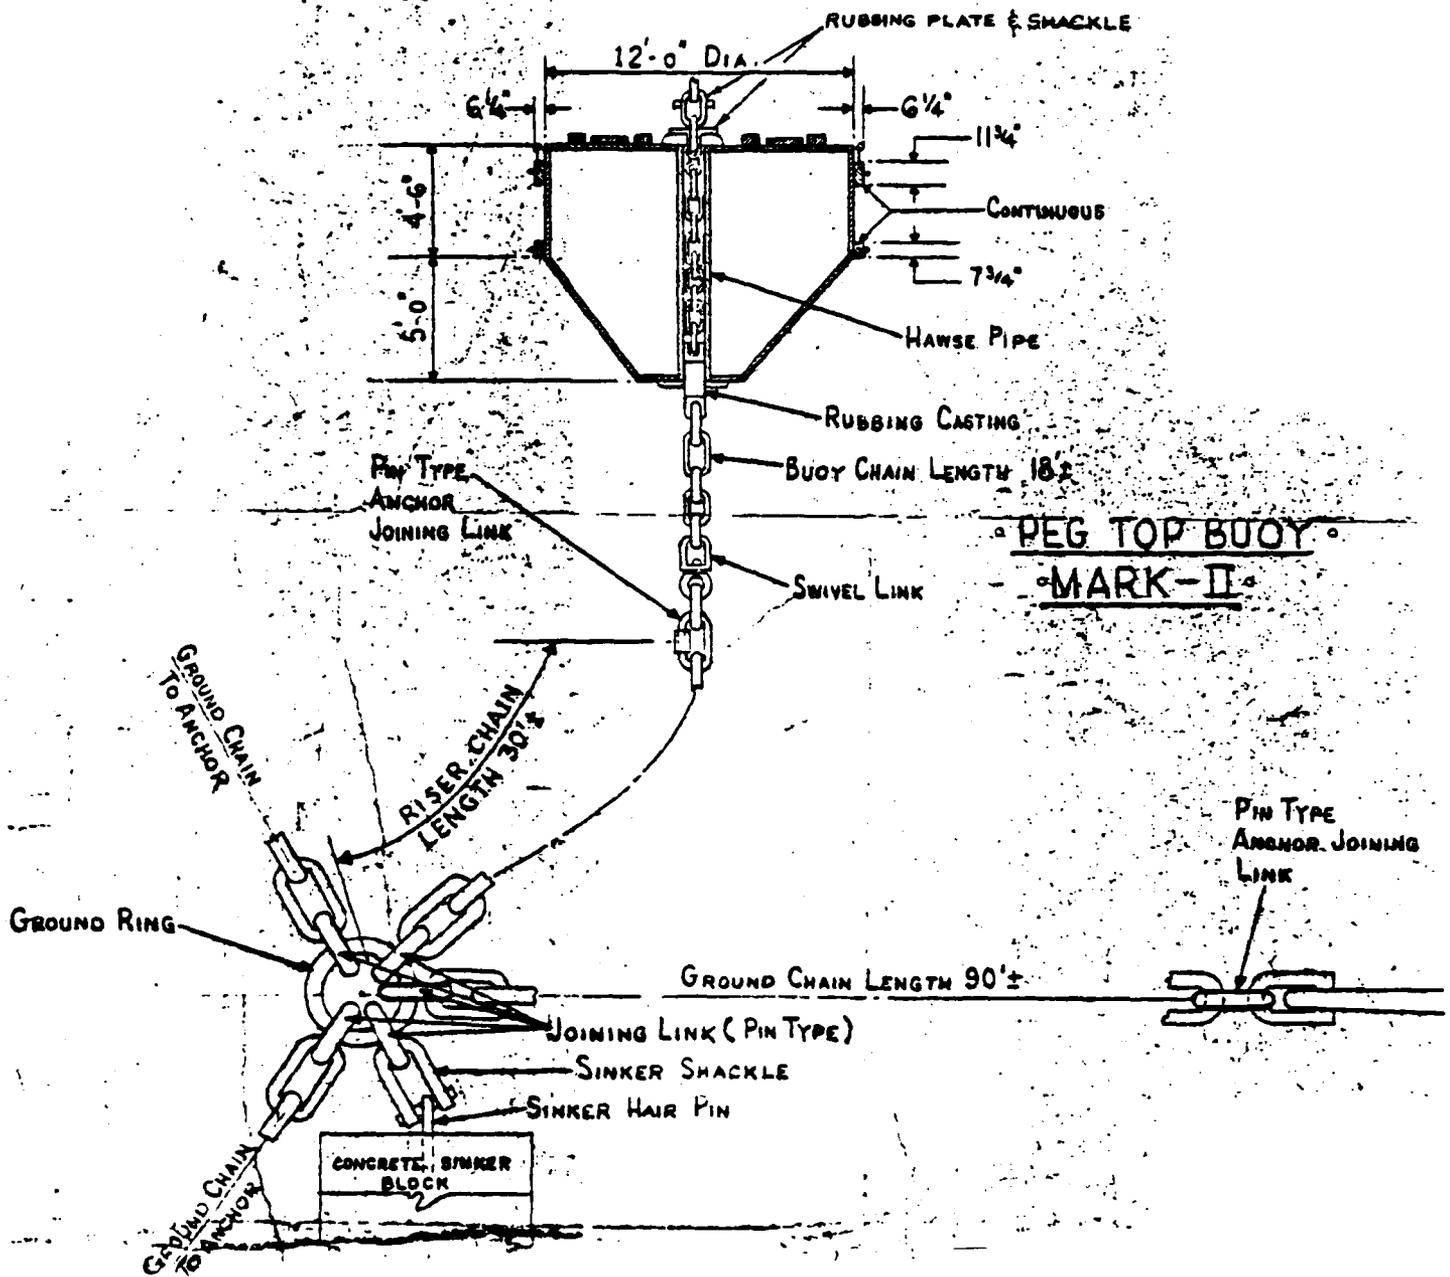
Figure 4. As-Built Drawing

2.3 Riser. To determine chain wear, each riser was inspected by taking three consecutive double link measurements, using calipers, just below the hawse pipe, at the mud line, and about halfway in between. Although the As-Built Drawing of the moorings (Figure 4) indicates that each riser is about 48 feet long (including about 18 feet of "buoy chain") only a total of about 18 feet of chain was visible before it vertically entered the mud.
