PEARL HARBOR Z-LOOP UPGRADE
PROJECT COMPLETION REPORT

FPO-1-83(34)
OCTOBER 1983

PREPARED BY
ROBERT TAGGART INCORPORATED
FAIRFAX, VIRGINIA

FOR
OCEAN ENGINEERING AND CONSTRUCTION PROJECT OFFICE
CHESAPEAKE DIVISION
NAVAL FACILITIES ENGINEERING COMMAND
WASHINGTON, D. C. 20374

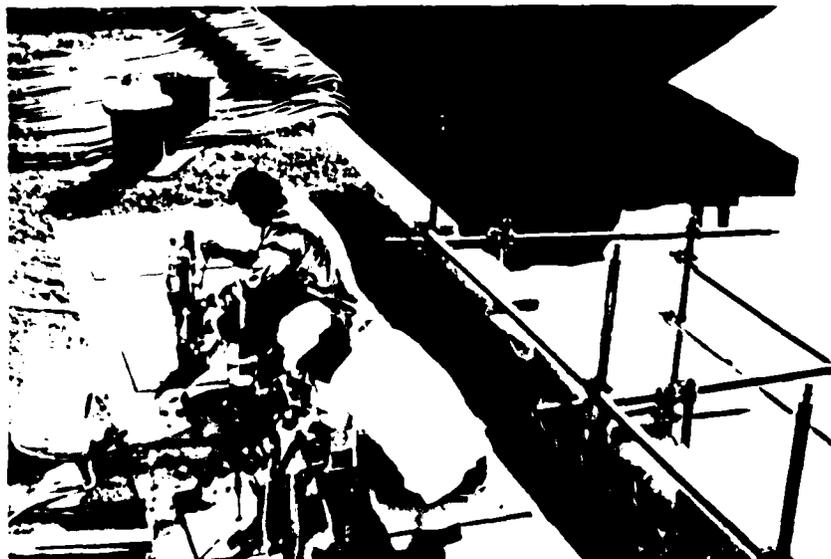
FIGURE 7-8

**PREPARING COUNTERWEIGHT
FOR SUPPORT CHANNEL BASE**

The PWC welding shop fabricated a set of templates as a guide for the drilling of holes for the anchor dowels fastening the base plate assembly to the counterweight. The templates were shimmed with steel spacers to bring them to level. The drilling was completed and the dowels set with epoxy on 16 January. Figures 7-8 and 7-9 show the counterweight and access holes.

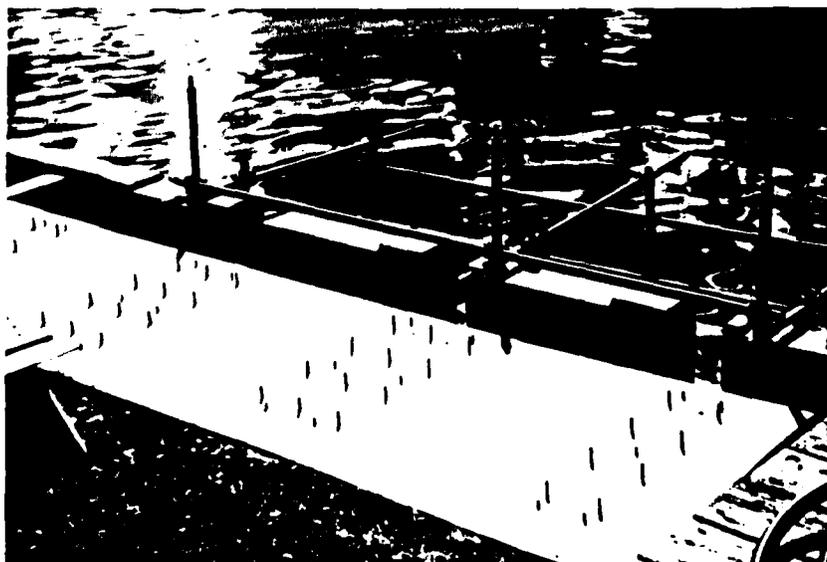
FIGURE 7-9

**CONCRETE COUNTERWEIGHT
READY FOR BASE PLATES**

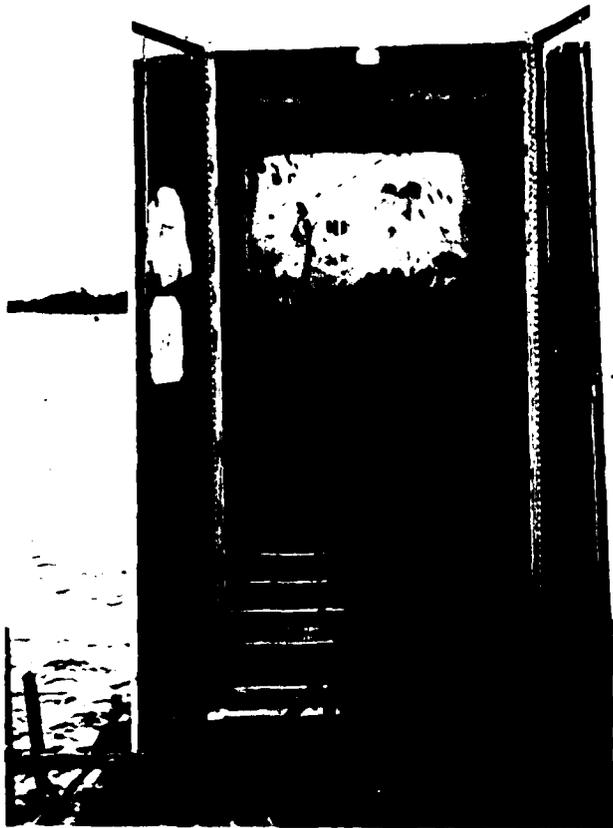
FIGURE 7-15

On 26 January 1983, the original schedule was scrubbed. It was apparent that insufficient time remained to fix adequately the existing electrical system. The remaining cables would be rerouted but no further cables were cut or lugged. Rerouting was completed on 26 January. All but the first 10 cable pairs remained unlugged. Figure 7-15 illustrates the routed but unterminated cables.

INTERIOR OF BOX BEFORE INSTALLATION
OF REDESIGNED TERMINAL STRIPS

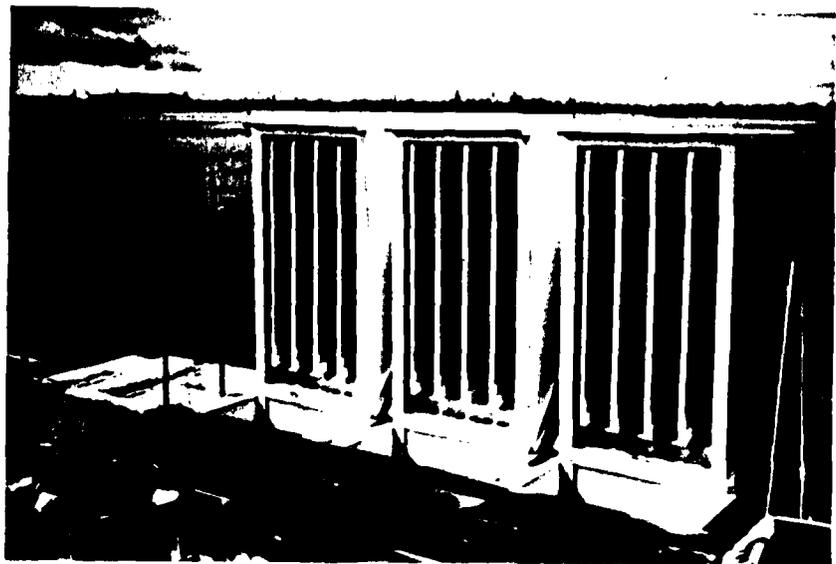
FIGURE 7-19

**BOXES PRIOR TO ATTACHING
NEW DOOR ASSEMBLIES**

log containing the make-up of each parallel circuit and the insulation resistance of each cable when connected is included in this report as Appendix B. Z-loop cable connection work was completed on 27 May 1983. In Figure 7-19, all Z-loop turns have been terminated and installed.

DOOR ASSEMBLY INSTALLATION. The frames and doors were installed on 28 and 29 May. A final top coat was applied to them and the required "High Voltage" decals were applied to the insides and outsides of each of the six doors. This completed the contractor's obligations. The CHESNAVFACENGCOCOM representative remained to complete the installation.
