**DAMAGE ASSESSMENT REPORT  
PIER 4  
NAVAL WEAPONS STATION  
CONCORD, CA**

**FPO-1-82-(28) OCTOBER 1982**

**CHILDS ENGINEERING CORPORATION  
MEDFIELD, MASSACHUSETTS 02052**

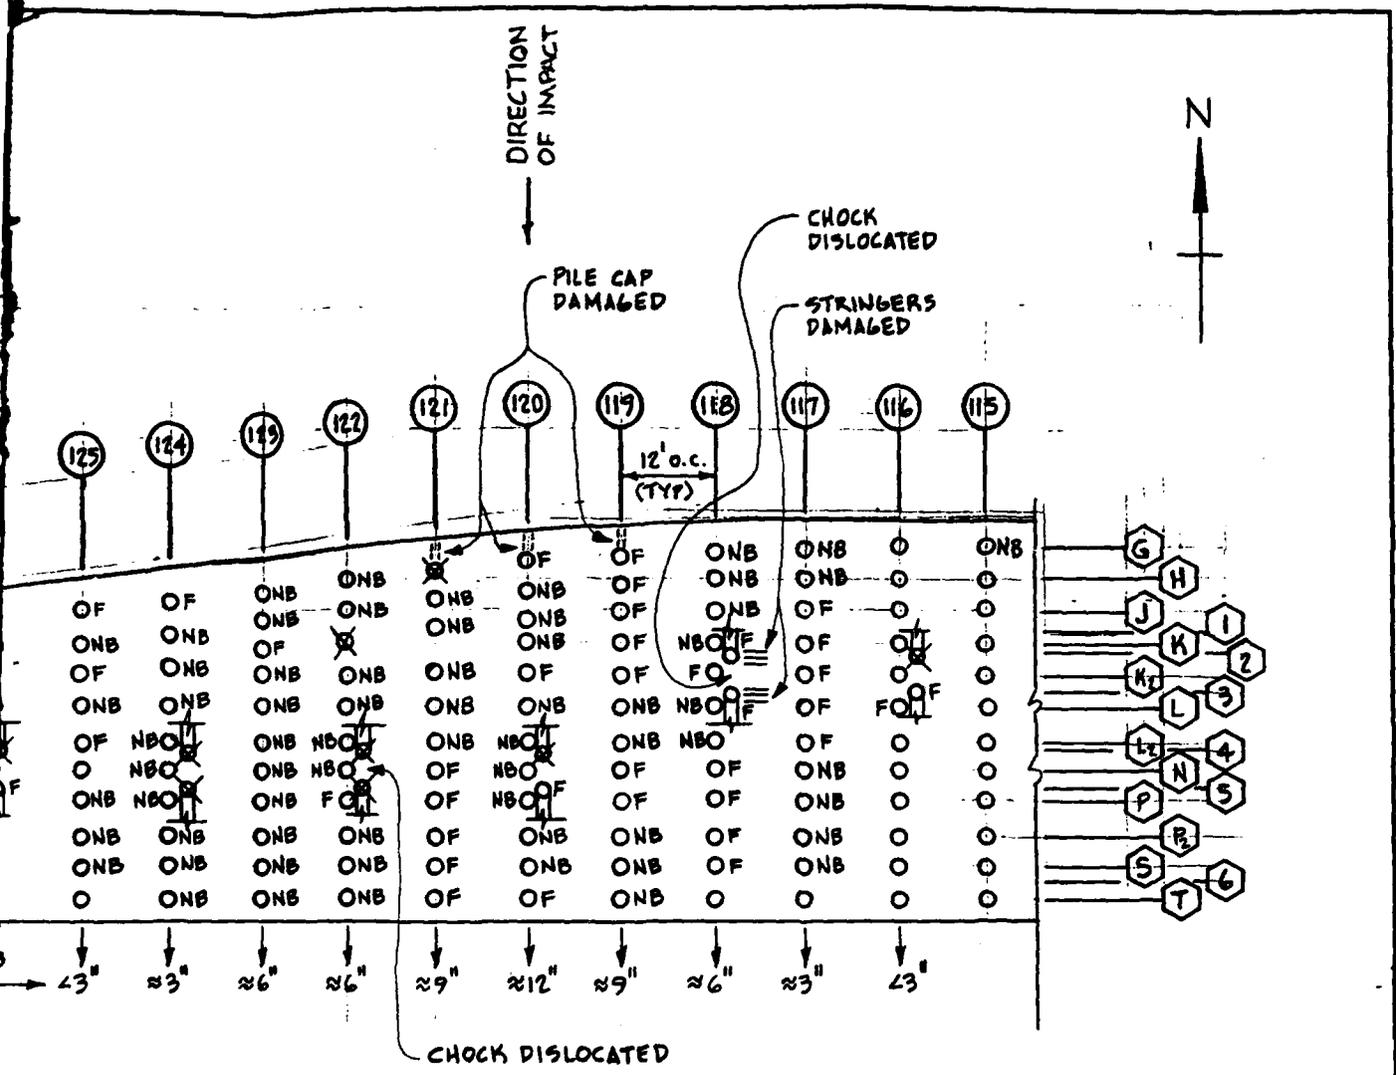
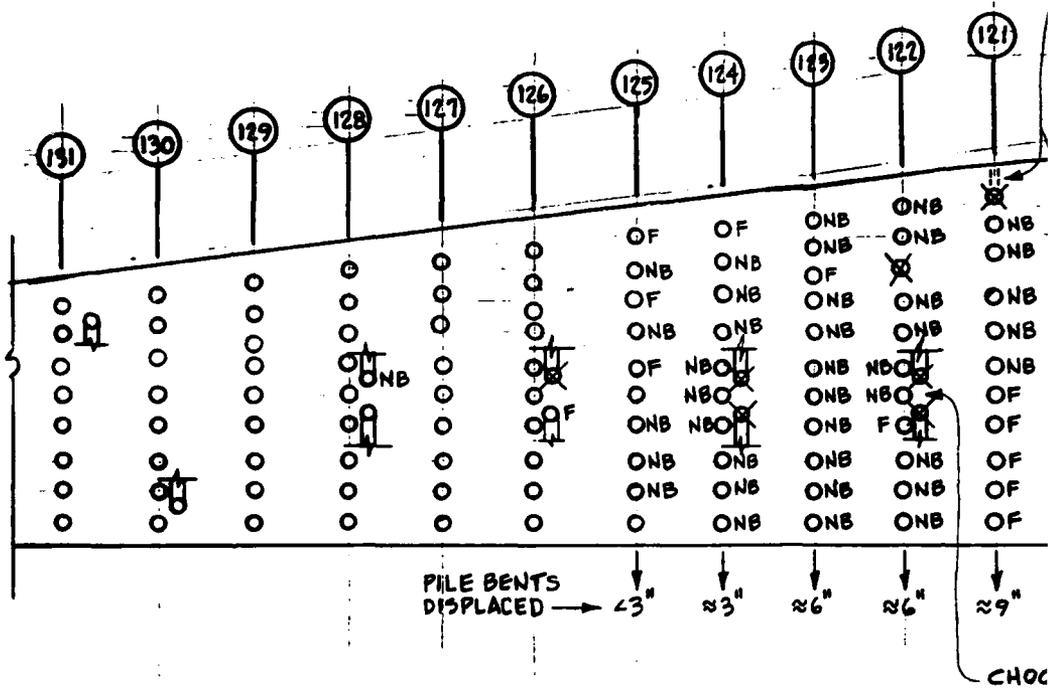
<p>GRAPHIC SCALE</p>	<p>CHILDS ENGINEERING CORPORATION BOX 888 MEDFIELD, MA</p>	<p>CHESAPEAKE DIVISION NAVAL FACILITIES ENGINEERING COMMAND WASHINGTON, D.C.</p>	
		<p>NAVAL WEAPONS STATION CONCORD, CA</p>	<p>FIG. NO. 3</p>

Several elements of the pier have been damaged as a result of the recent collision. Figure 3 is a summary illustration of the damage conditions. Specific structural anomalies are discussed below.
