UNDERWATER FACILITIES INSPECTIONS & ASSESSMENTS

NAVAL AIR STATION,
NORTH ISLAND
SAN DIEGO, CALIFORNIA

FPO-1-84(19)

OCTOBER 1984

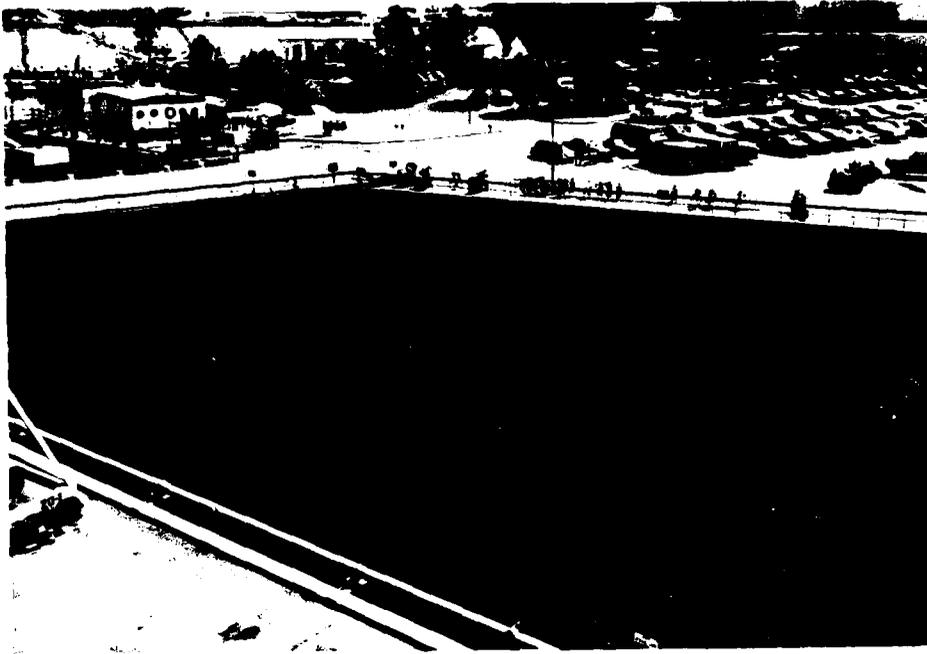
1. Old Air Station Bulkhead at Pier J/K. Picture from derrick platform looking South.

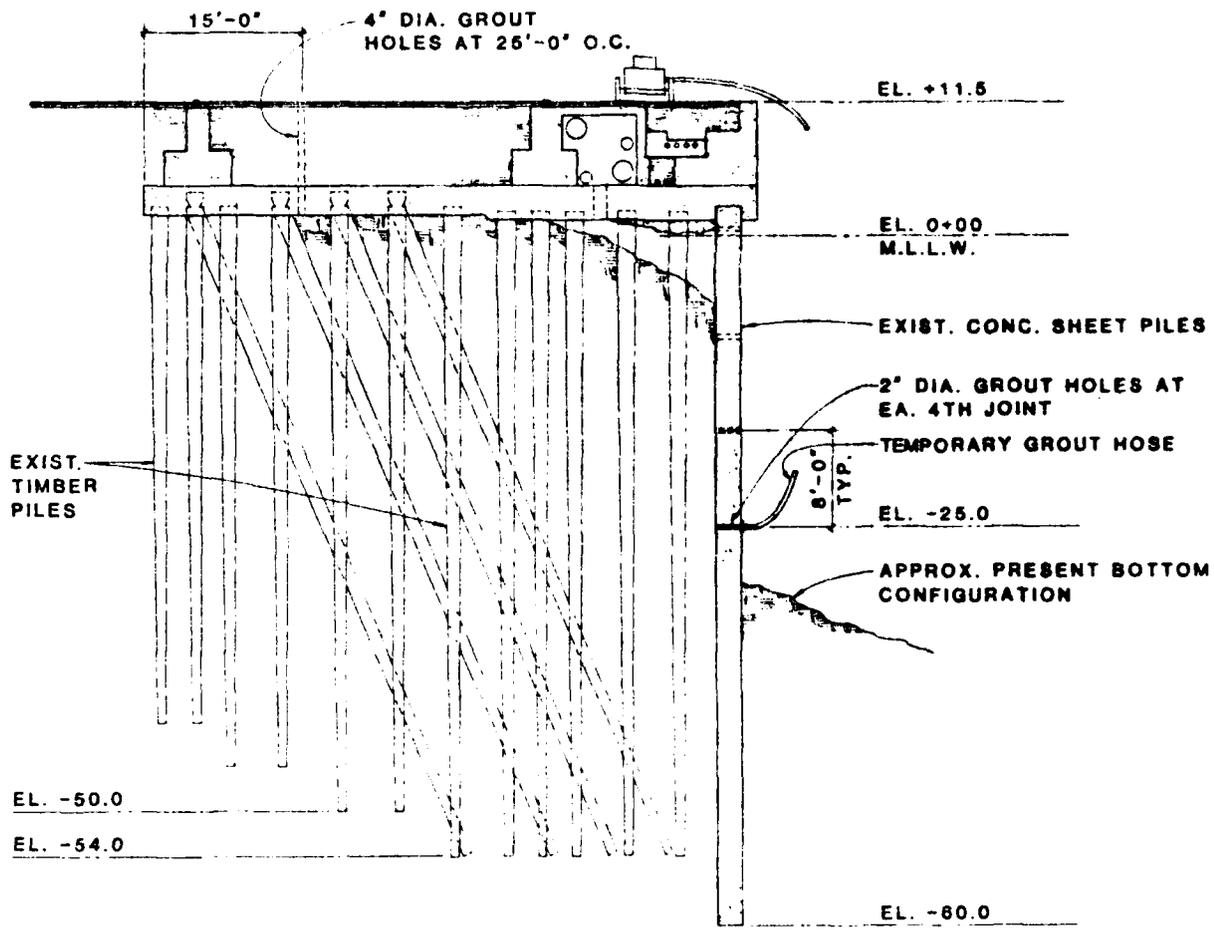
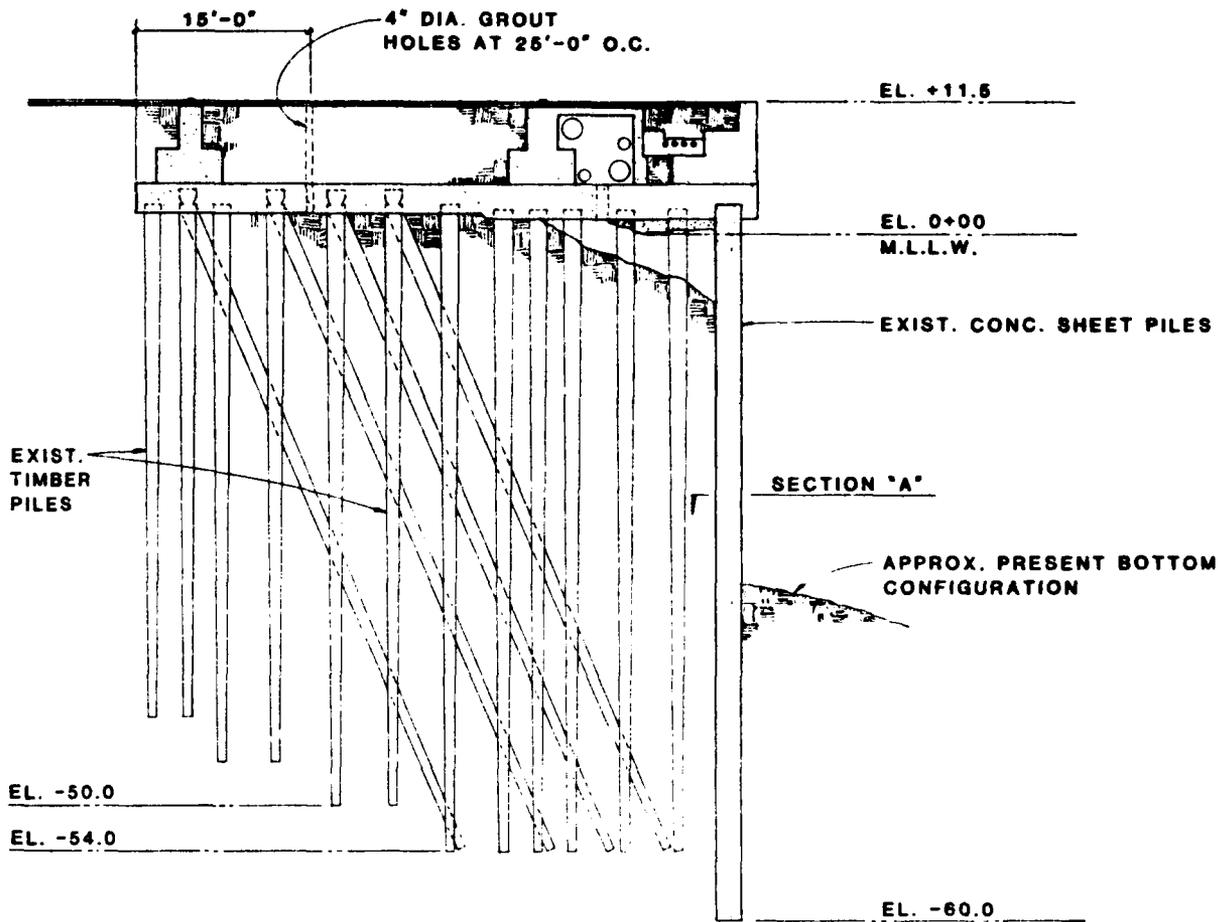
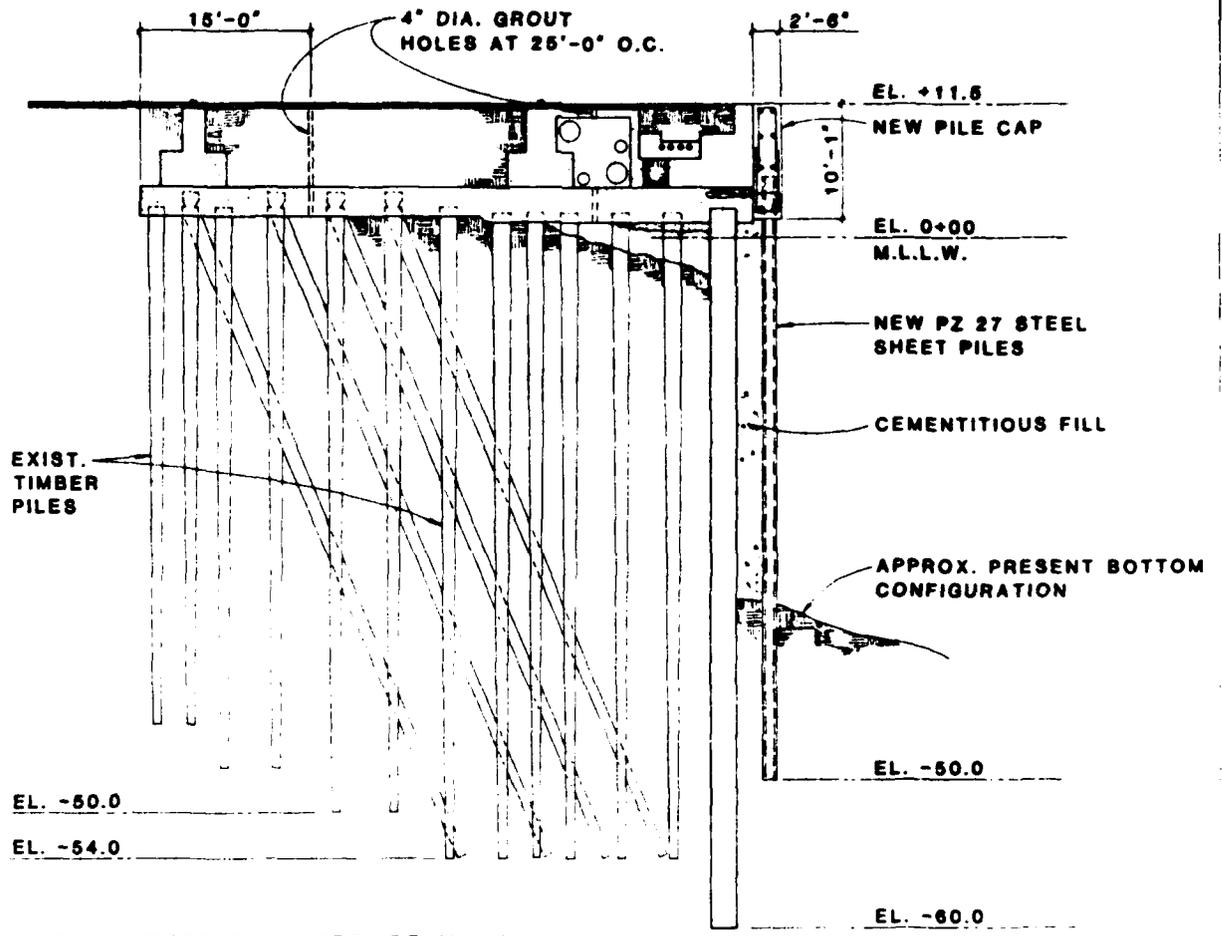
CARRIER QUAY WALL ALTERNATIVE REPAIR METHODS NAVAL AIR STATION - NORTH ISLAND, SAN DIEGO, CALIFORNIA		
Blaylock-Willis and Associates <small>STRUCTURAL ENGINEERS SAN DIEGO, CALIFORNIA</small>	DATE: OCT 1984	FIG. 8

Method 2 would appear to rely very heavily on the selection and successful filling of small joints. Future leakage of the lower wall is also a problem.

Method 3 although the most expensive has the greatest chance of complete success of all methods. This method is recommended.

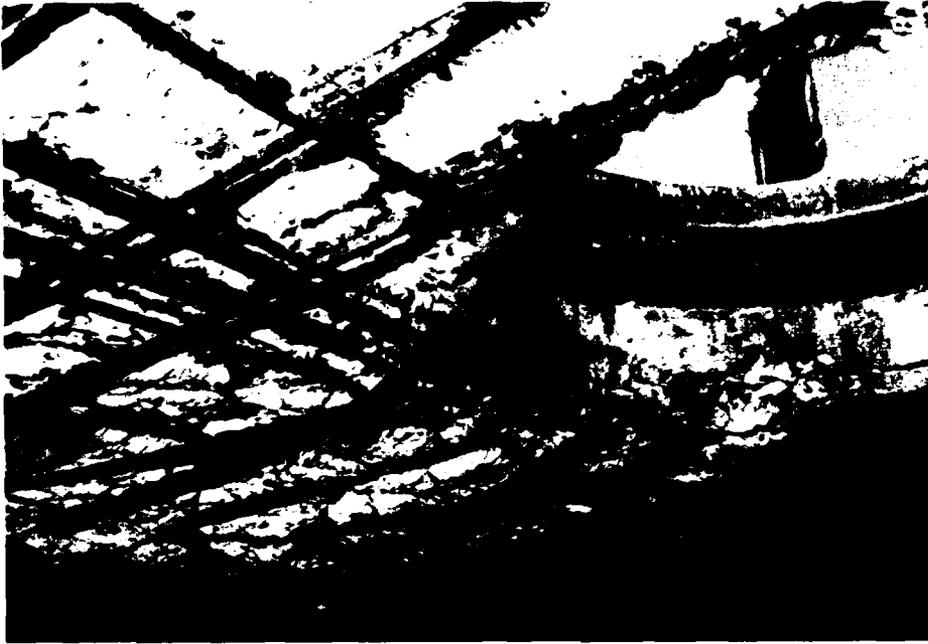
11. Carrier Quay Wall, in utility tunnel at Manhole #8 showing spall areas and rusted reinforcing steel. The capacity of the tunnel ceiling slab to support loads is seriously reduced.

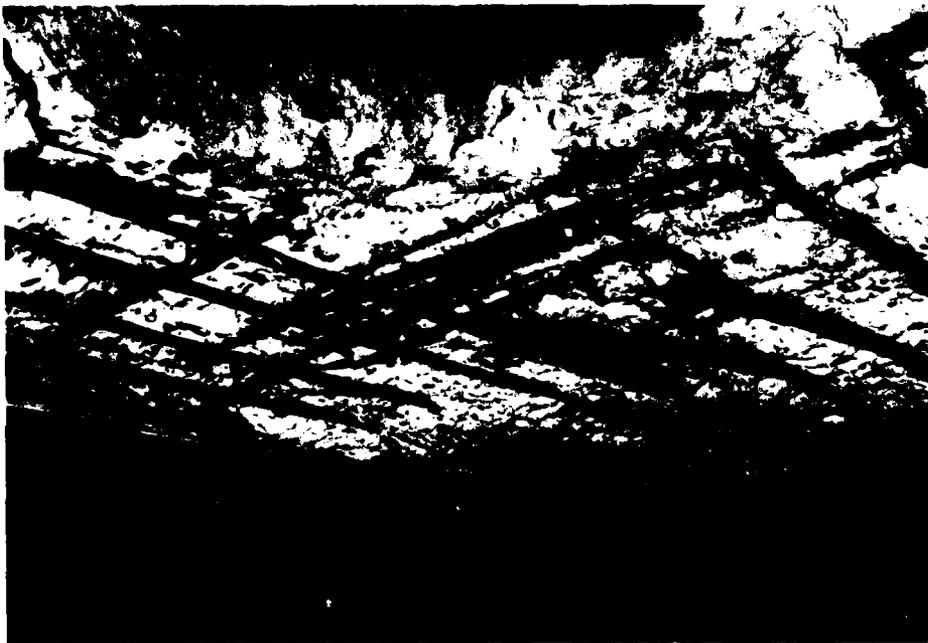
12. Carrier Quay Wall, in utility tunnel. View is to the southeast from Manhole #8. Plywood in background has been placed to prevent spalled concrete from falling on workers in the tunnel.
